Aviation Investigation Final Report

Location:	Victorville, California	Accident Number:	DCA20LA107
Date & Time:	May 19, 2020, 15:16 Local	Registration:	N820TJ
Aircraft:	Boeing 737	Aircraft Damage:	Substantial
Defining Event:	Part(s) separation from AC	Injuries:	95 None
Flight Conducted Under:	Part 121: Air carrier - Scheduled

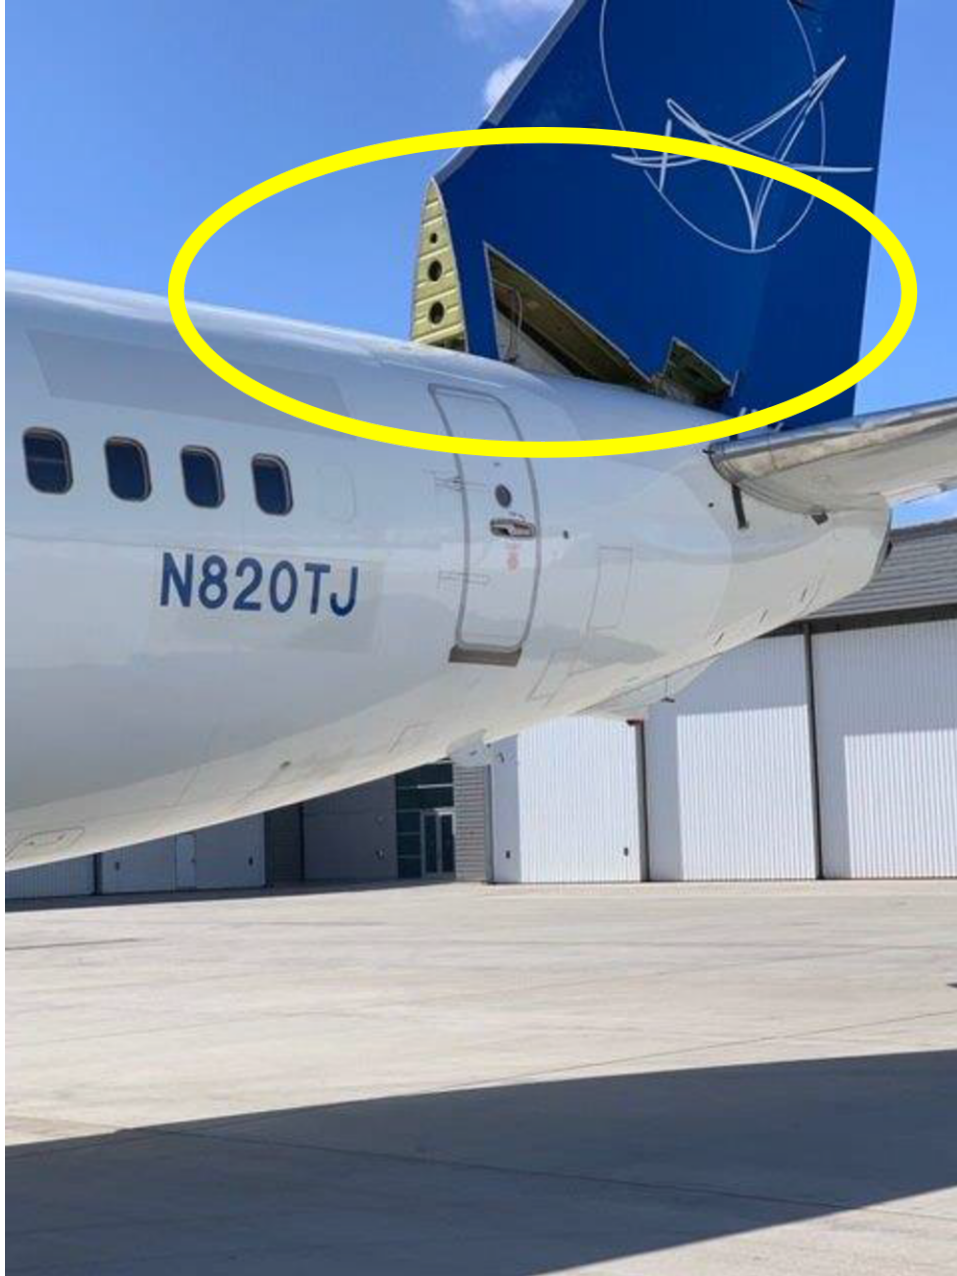
Figure 1. Location of missing dorsal fin and vertical stabilizer panels (Source: FAA).

The dorsal fin and the missing vertical stabilizer panels were not recovered. The fuselage crown skin, left horizontal stabilizer, and vertical stabilizer sustained substantial damage. The upper fuselage crown skin was dented, punctured, and gouged. The left horizontal stabilizer leading edge, lower skin, and upper skin had multiple dents, gouges, and punctures. The left horizontal stabilizer front spar upper chord was fractured, the lower chord was deformed, and the web was gouged in two locations. The panel attach structure on the lower left side of the vertical stabilizer was fractured and deformed in several places.

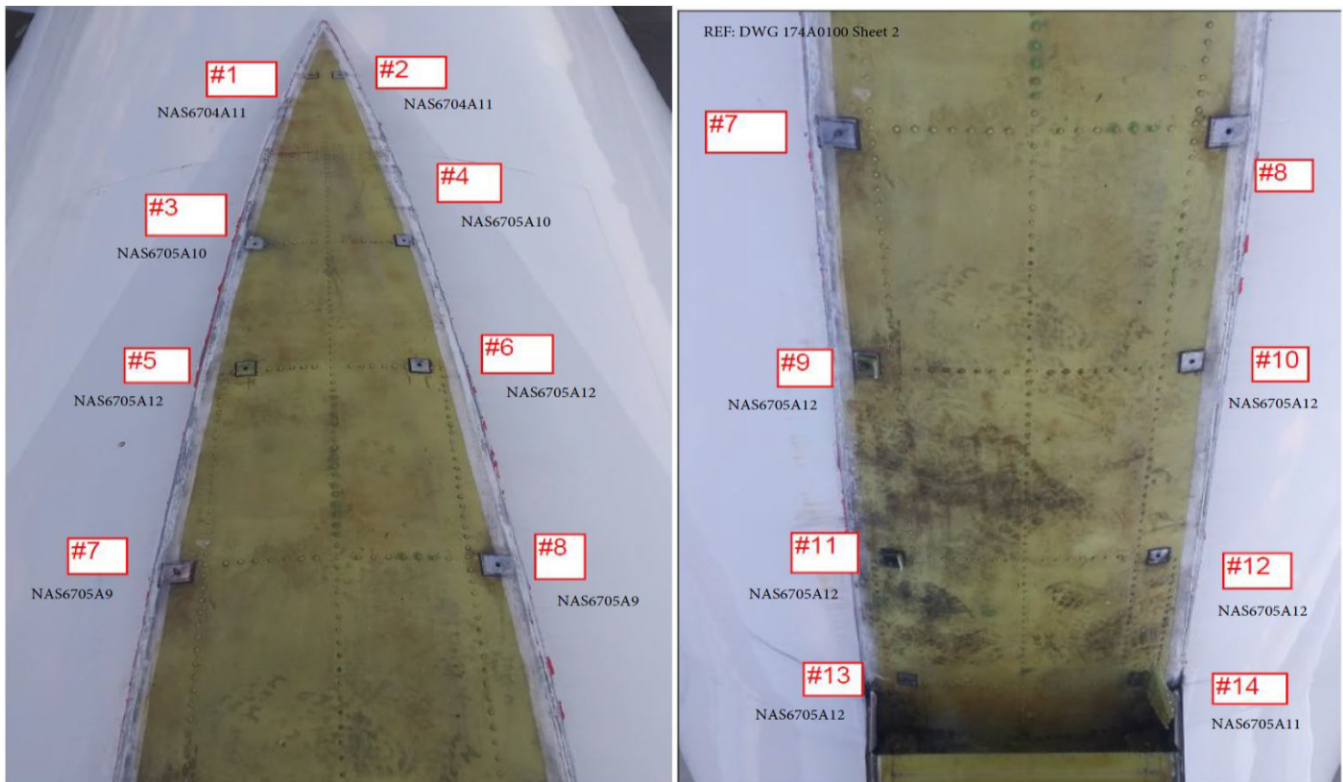
The dorsal fin is attached to the upper fuselage at 14 locations. Figure 2 shows the attach points on the accident airplane with the holes numbered sequentially in red and the required fastener (bolt) part numbers in black.

Figure 2. Dorsal fin attach points and bolt part numbers (Source: Swift Air and Boeing Company).

On February 26, 2019 (less than 3 months before the accident), the fuselage skin under the dorsal fin was inspected at iAero Repair Station, Miami, Florida. This inspection was done every 24,000 flight cycles to identify and remove corrosion. The maintenance instructions for the dorsal fin indicated that the mechanic should note the type and location of the bolts removed to ensure that each bolt would be returned to the same location from where it was removed. (The dorsal fin had different bolts with varying grip lengths.) Once the bolts were reinstalled, sealant was applied to the bolt heads.

Further, on February 15, 2022, Boeing updated the dorsal fin removal and installation instructions in its *737-600/700/800/900 Aircraft Maintenance Manual*. The note in the manual to install the bolts in the same location from where they were removed was changed to a caution to emphasize the importance of matching the correct bolt and grip length. The caution states the following:

MAKE SURE THAT YOU MONITOR WHERE YOU REMOVE EACH FASTENER AT EACH LOCATION. THERE ARE DIFFERENT SIZES FOR THE FASTENERS. IF YOU INSTALL THE FASTENERS AT THE INCORRECT LOCATIONS, DAMAGE TO THE AIRPLANE CAN OCCUR.

MAKE SURE THAT YOU INSTALL EACH FASTENER AT THE CORRECT LOCATION. THERE ARE DIFFERENT DIMENSIONS FOR THE FASTENERS. IF YOU DO NOT INSTALL THE FASTENERS AT THE CORRECT LOCATIONS, DAMAGE TO THE AIRPLANE CAN OCCUR.

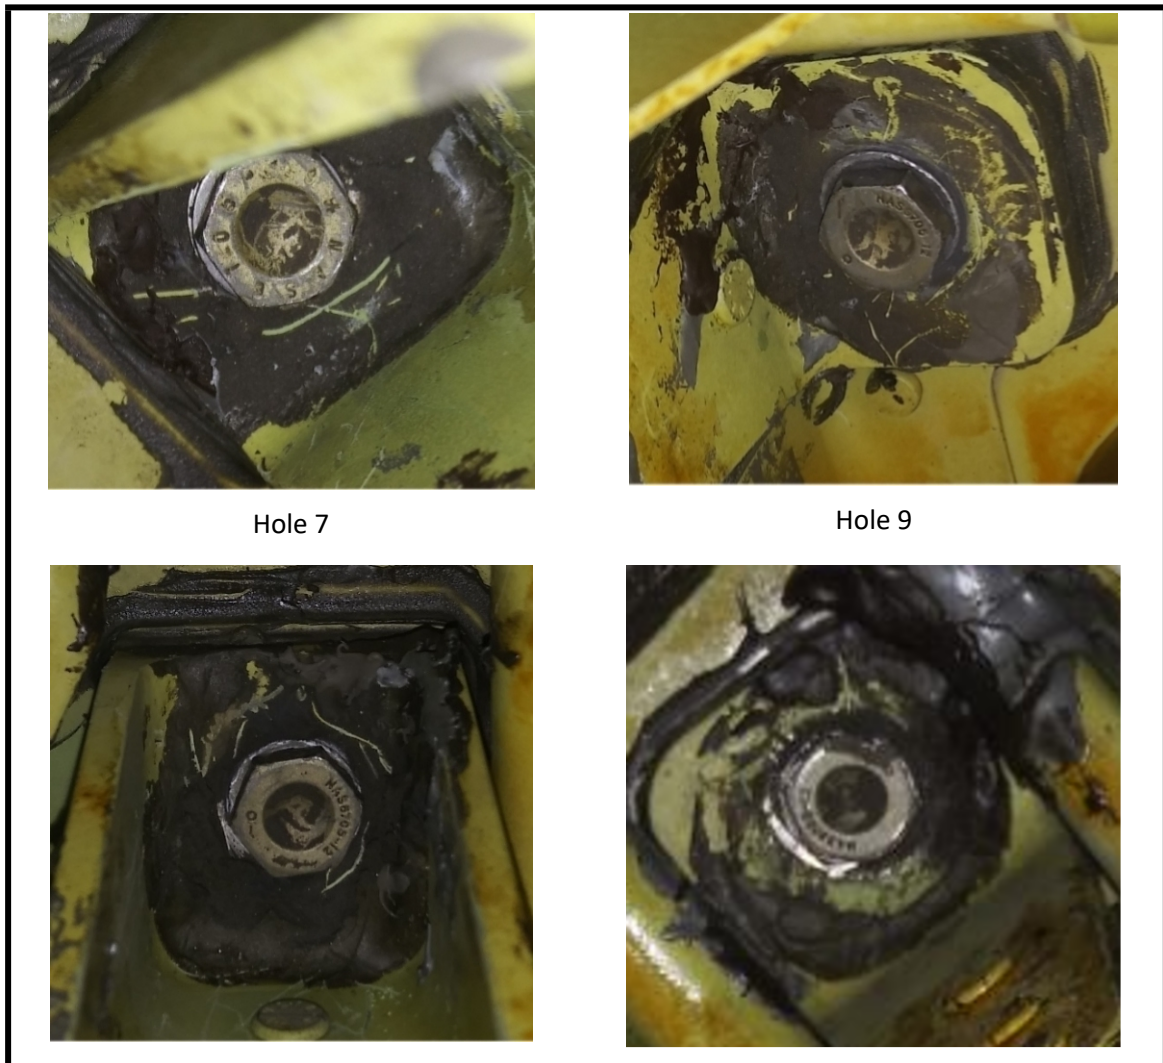
No bolts were found in holes 1-6, 8, 10, 12, and 13. Bolts remained in holes 7, 9, 11, and 14. Pieces of the dorsal fin rib structures remained attached to the bolts in holes 9, 11, and 14. Three loose bolts were recovered on the interior ceiling panels beneath the dorsal fin location.

The airplane operator provided photographs of the four installed bolts (7, 9, 11, and 14; see figure 3). The bolt installed in hole 7 was marked NAS6705-9, and the bolts in holes 9, 11, and 14 were each marked NAS6705-12. One of the three loose bolts was marked NAS6705-9, one was marked NAS6705-12, and the marking on the other loose bolt could not be fully discerned but contained an 8, a 3, a 0, the number and letter 1M, and an S (see figure 4).

Figure 3. Bolts that remained in place (Source: Swift Air).
