Aviation Investigation Final Report

Location:	Redlands, California	Accident Number:	WPR20LA169
Date & Time:	June 5, 2020, 08:01 Local	Registration:	N9217B
Aircraft:	Cessna 175	Aircraft Damage:	Substantial
Defining Event:	Loss of control in flight	Injuries:	3 Fatal
Flight Conducted Under:	Part 91: General aviation - Personal

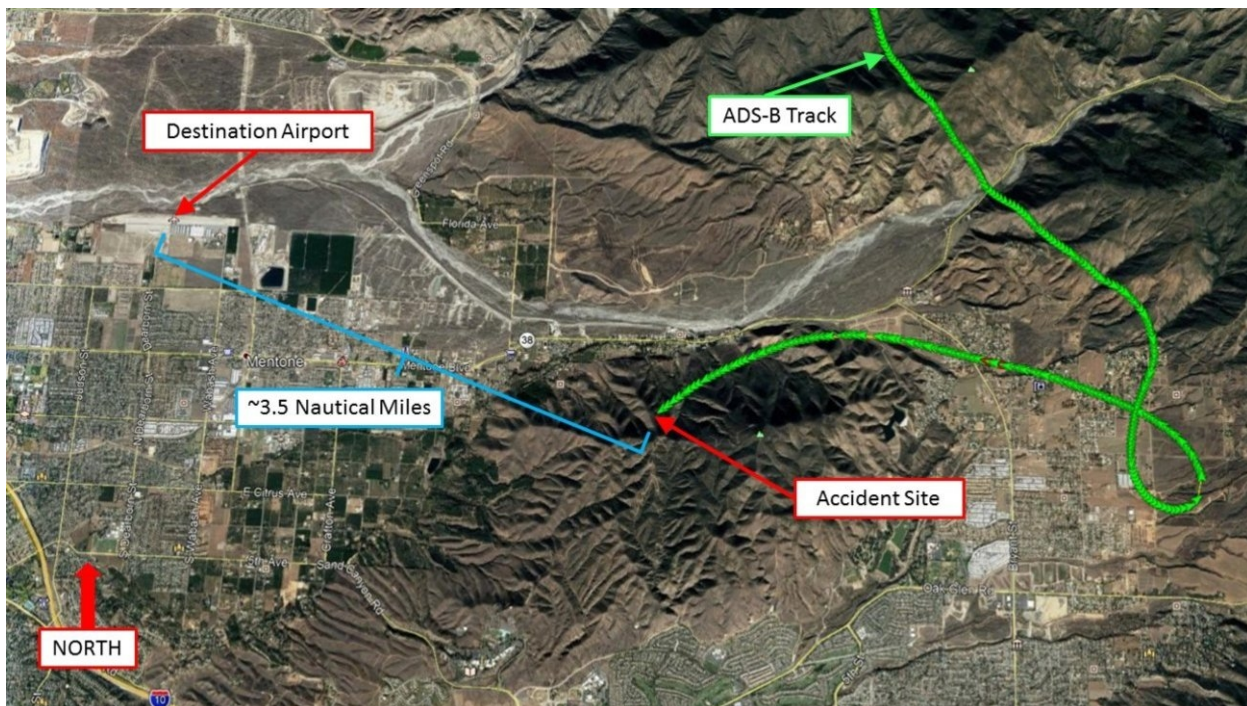
About 6 minutes, 12 seconds later, a right turn to a southerly heading was observed when the airplane was at an altitude of about 5,150 ft msl. The airplane then entered a left 270° turn, which it completed at an altitude of about 5,275 ft msl. About 1 minute later, a left turn to a southwesterly heading at 3,975 ft msl was observed. The airplane remained on a southwesterly heading and continued to descend until ADS-B contact was lost at 0800:58, at an altitude of 2,775 ft, about 436 ft northeast of the accident site.

Figure 1: ADS-B data overlay on Google Earth image.
