Aviation Investigation Final Report

| Location: | Lander, Wyoming | Accident Number: | WPR20LA170 |
| Date & Time: | June 7, 2020, 08:30 Local | Registration: | N595KF |
| Aircraft: | Kitfox Kitfox | Aircraft Damage: | Substantial |

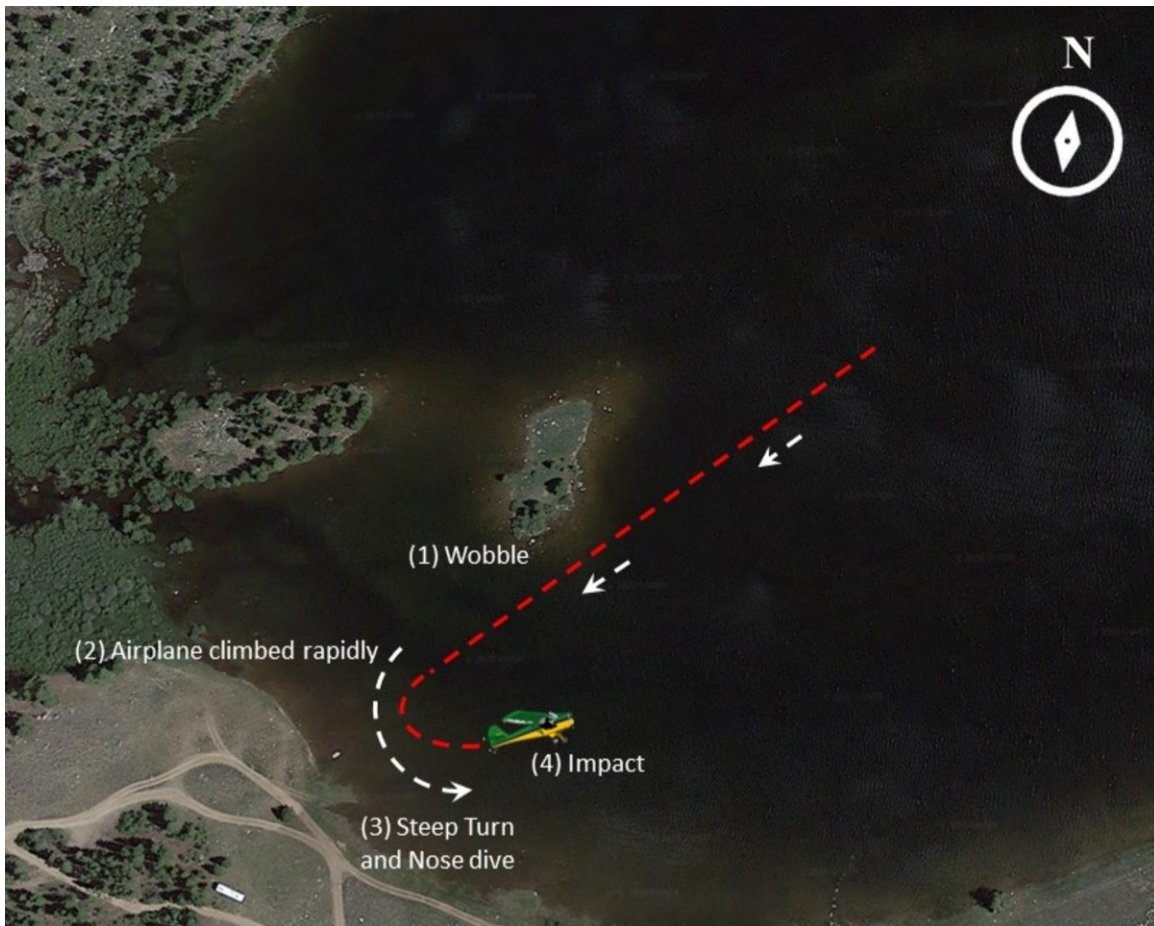
Figure 1: Witness Observations of the Airplane's Final Movements

According to multiple witnesses, the airplane came into view over the lake on a southwest heading. Witness observations indicated that the airplane was about 25 ft agl when it began to “wobble.” The airplane then entered a climb, which was immediately followed by a steep left turn, and then a nose down dive. See Figure 1. According to the witnesses, the airplane impacted the water in a near vertical nose-down attitude and a fire ensued shortly after impact.
