# Aviation Investigation Final Report

<b>Location:</b>	Beecher, Illinois	<b>Accident Number:</b>	CEN20LA219
<b>Date &amp; Time:</b>	June 8, 2020, 09:46 Local	<b>Registration:</b>	N257V
<b>Aircraft:</b>	Flight Design CTLS	<b>Aircraft Damage:</b>	Destroyed
<b>Defining Event:</b>	Loss of engine power (partial)	<b>Injuries:</b>	1 Fatal
<b>Flight Conducted Under:</b>	Part 91: General aviation - Personal

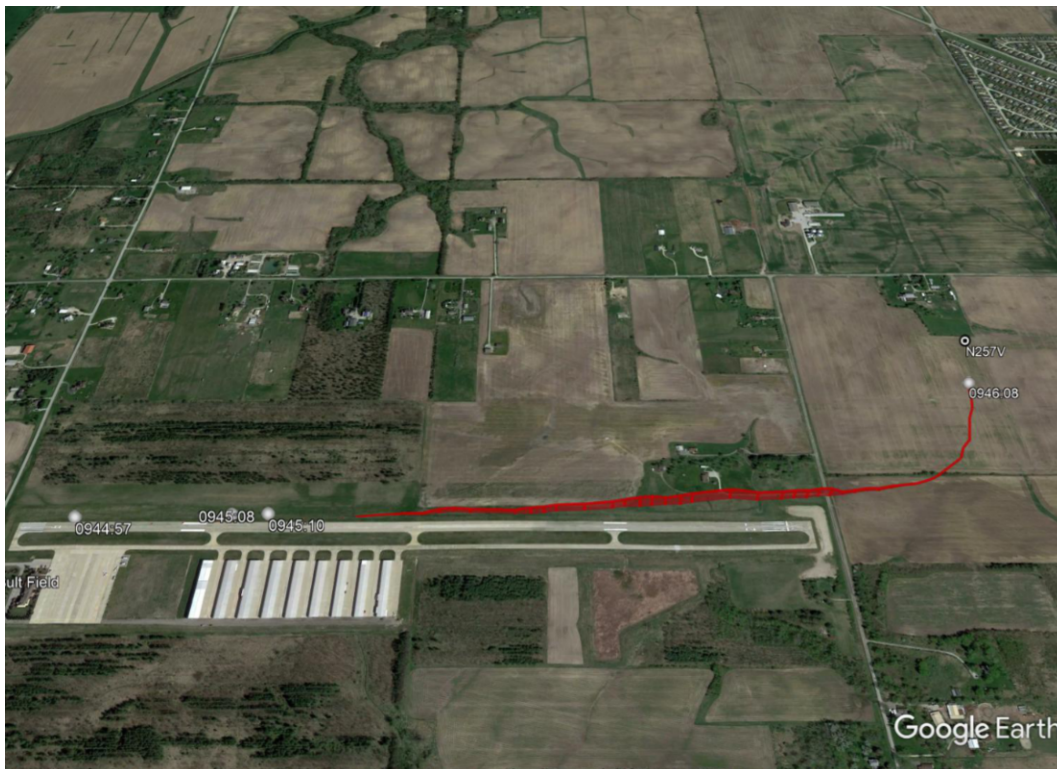
Figure 1: Accident Flight Track

There were no witnesses to the accident; automatic dependent surveillance-broadcast (ADS-B) data showed the airplane accelerated to about 60 knots (kts) groundspeed and climbed to about 75 ft above ground level (agl). The groundspeed then decreased to about 50 kts while the altitude continued to increase until reaching about 175 ft agl. At that time, the airplane was about 300 ft short of the departure end of the runway and began a descending left turn. During the turn, the groundspeed remained about 50 kts. The accident site was in a harvested corn field about 0.4 mile northeast of the departure end of the runway and about 300 ft and 10° from the last recorded data point (see figure 1).

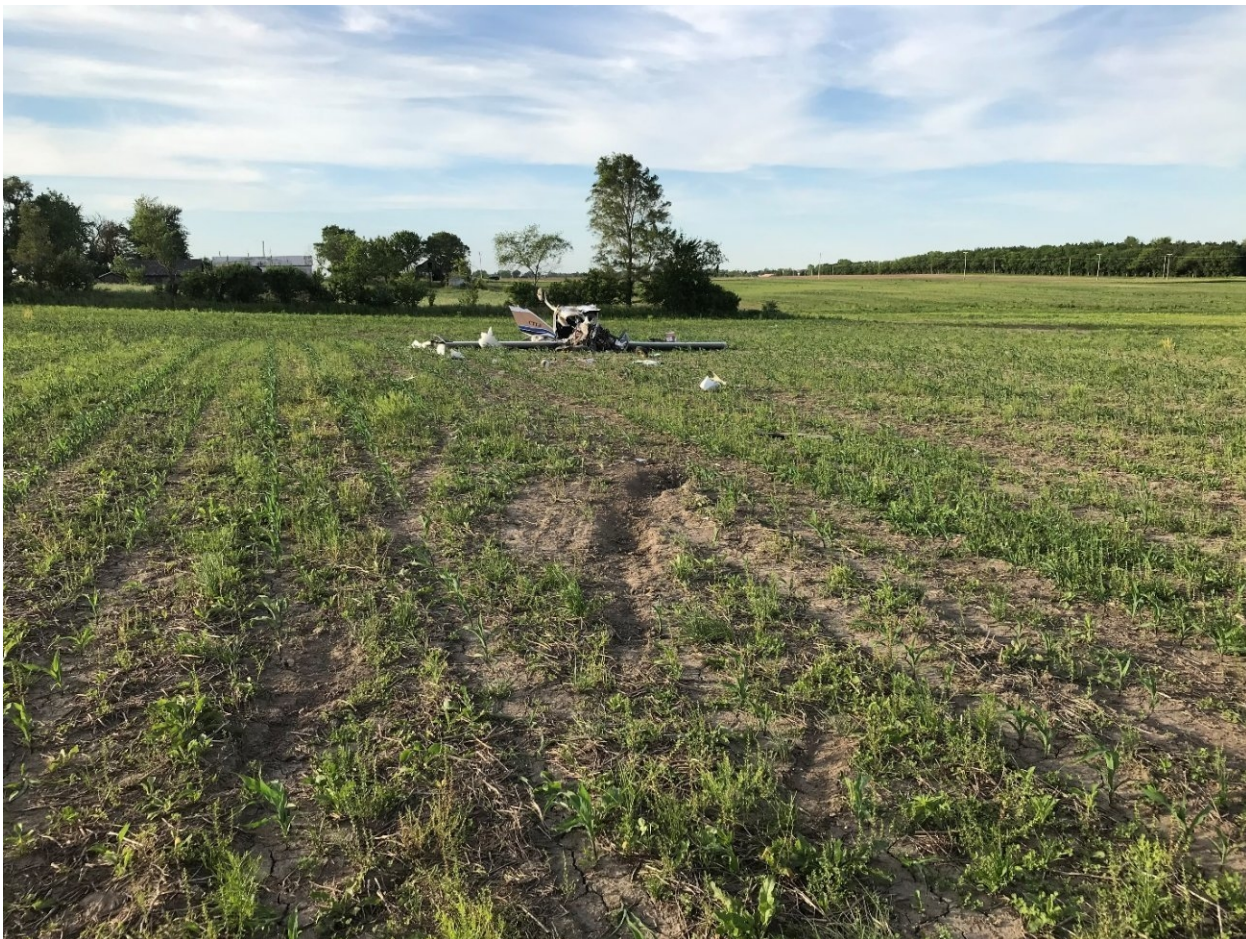
Figure 2: View of aircraft wreckage from initial impact point.

The field was a flat and recently planted corn field. The corn plants were about 3 to 4 inches tall, and the ground was firm, dry, and hard packed. Three linear marks at the accident site were consistent with the airplane's tricycle landing gear. The center depression among the three marks was deeper and longer, indicating that the airplane impacted in a nose-low attitude (see figure 2). The airplane's nose landing gear and right main landing gear separated

from the airplane, and the airplane nosed over on its back. The forward fuselage was crushed rearward and upward into the cabin area. The wings were predominately intact and still attached to the fuselage. The empennage of the airplane was intact but separated from the remainder of the fuselage at the leading edge of the vertical tail.
