Aviation Investigation Final Report

| Location: | Anchorage, Alaska | Accident Number: | ANC20LA059 |
| Date & Time: | June 8, 2020, 09:45 Local | Registration: | N3188M |
| Aircraft: | Piper PA 12 | Aircraft Damage: | Substantial |

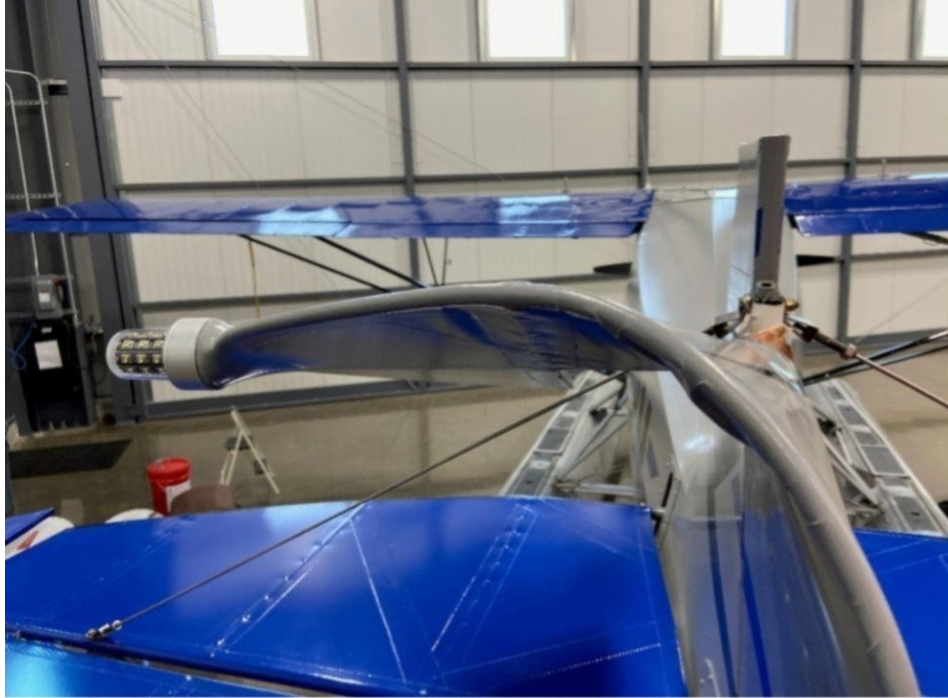
Thus, the rudder failure on the accident airplane was due to the fatigue fracture of the AISI 1025 carbon steel rudder post. Contributing to the fatigue failure was the post's susceptibility to fatigue cracking under normal service conditions.

An examination of the rudder revealed that the vertical rudder post fractured above the upper hinge point and the top portion of the rudder folded over the horizontal stabilizer tail brace wires (see figure).

Figure - Photo of the damaged rudder. Photo provided by FAA.

Further NTSB examination identified evidence of a progressive fracture mechanism on each of the rudder posts, including fatigue fracture features on three of the rudder posts. The fracture surfaces on the accident rudder post and the remaining rudder post were too damaged to conclusively identify the specific fracture mechanism. Corrosion, scratches, or surface roughness features were found on each of the rudder posts near the fractures. Fracture origin areas were damaged on all the rudders, but corrosion pits or scratches on the exterior surface were associated with the fatigue origin areas on two of the examined rudder posts.
