Aviation Investigation Final Report

Location:	Anchorage, Alaska	Accident Number:	ANC20LA059
Date & Time:	June 8, 2020, 09:45 Local	Registration:	N3188M
Aircraft:	Piper PA 12	Aircraft Damage:	Substantial
Defining Event:	Aircraft structural failure	Injuries:	2 None
Flight Conducted Under:	Part 91: General aviation - Instructional

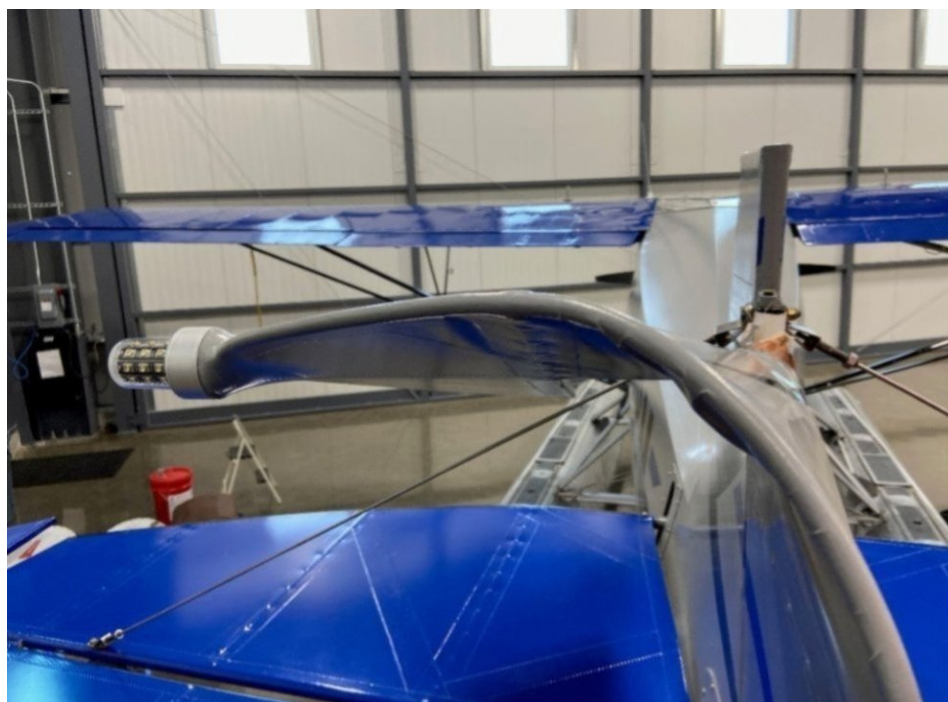
Thus, the rudder failure on the accident airplane was due to the fatigue fracture of the AISI 1025 carbon steel rudder post. Contributing to the fatigue failure was the post’s susceptibility to fatigue cracking under normal service conditions.

An examination of the rudder revealed that the vertical rudder post fractured above the upper hinge point and the top portion of the rudder folded over the horizontal stabilizer tail brace wires (see figure).

Figure - Photo of the damaged rudder. Photo provided by FAA.

Further NTSB examination identified evidence of a progressive fracture mechanism on each of the rudder posts, including fatigue fracture features on three of the rudder posts. The fracture surfaces on the accident rudder post and the remaining rudder post were too damaged to conclusively identify the specific fracture mechanism. Corrosion, scratches, or surface roughness features were found on each of the rudder posts near the fractures. Fracture origin areas were damaged on all the rudders, but corrosion pits or scratches on the exterior surface were associated with the fatigue origin areas on two of the examined rudder posts.

FAA Advisory Circular 23-27, "Parts and Materials Substitution for Vintage Aircraft," published in 2009, specifically advises that AISI 4130 low-alloy steel may be substituted for AISI 1020 or AISI 1025 carbon steel, including for structural posts on applicable aircraft. The advisory circular clarifies that this is because AISI 4130 low-alloy steel is more widely available and generally has more desirable material properties, such as higher tensile ultimate strength, yield strength, and fatigue strength.
