Aviation Investigation Final Report

Location:	Renton, Washington	Accident Number:	WPR20LA180
Date & Time:	June 12, 2020, 10:00 Local	Registration:	N36339
Aircraft:	Bellanca 7KCAB	Aircraft Damage:	Substantial
Defining Event:	Loss of engine power (total)	Injuries:	2 Minor
Flight Conducted Under:	Part 91: General aviation - Instructional

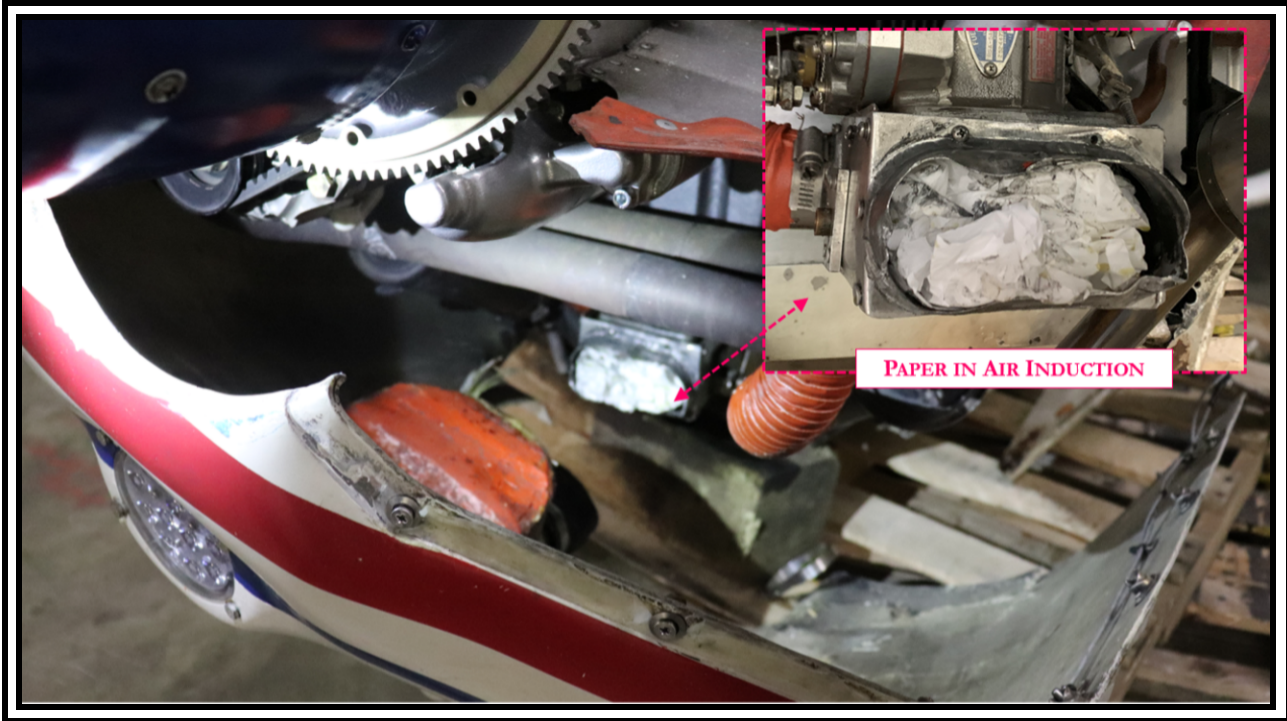
Figure 1: Picture of Air Induction

Postaccident examination revealed that the air induction box contained a piece of bunched up paper that likely restricted the inlet cavity. As part of the annual inspection, a repair person completed a small fiberglass patch and painting on the lower cowling. He could not recall the specific repair on the airplane but said he often placed paper in the induction to prevent debris from entering the engine. After the maintenance, the airplane sat for a day with the lower cowling not fastened but maintenance personnel did not recognize the blockage. They also did not find the paper during the post-maintenance inspections and returned the airplane into service with an unsafe condition.

Maintenance personnel's inadequate post-maintenance inspections that resulted in the total loss of engine power due to a blockage in the air intake.

During a postaccident examination, investigators discovered the air induction box contained an approximate two by three feet piece of bunched up paper that was white and had a plastic type coating. The paper appeared to have mostly restricted the inlet cavity (see figure 1).
