Aviation Investigation Final Report

Location:	Titusville, Florida	Accident Number:	ERA20LA237
Date & Time:	July 3, 2020, 11:57 Local	Registration:	N89MA
Aircraft:	Piper PA46	Aircraft Damage:	Substantial
Defining Event:	Sys/Comp malf/fail (non-power)	Injuries:	3 None
Flight Conducted Under:	Part 91: General aviation - Personal

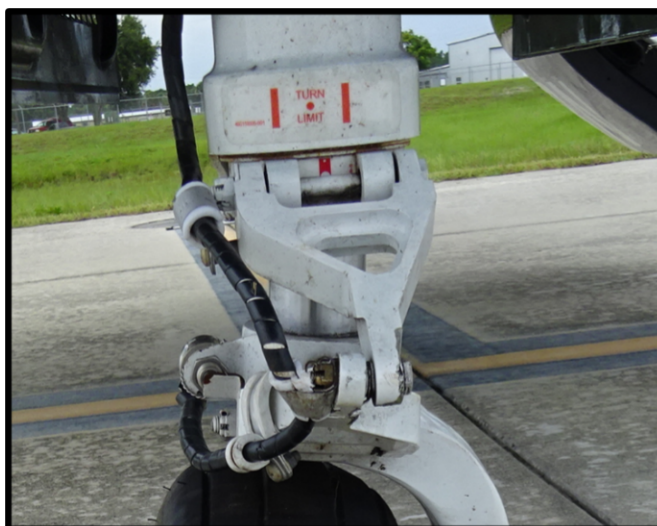
The airplane could be maneuvered on the ground by power equipment using a tow bar attached to the NLG axle. The airplane manufacturer had established turn limits for towing, and a placard installed on the lower end of the NLG trunnion assembly limits turning to about 20° right and left. Corresponding red lines on the NLG strut allow the operator to see the relationship between the turn angle of the NLG strut and the towing limits (see figure 1).

Figure 1 - NLG turn limit placard.

If the NLG is externally turned beyond the left or right placard limits, mechanical stops will engage where portions of the NLG and steering mechanism contact. If turned beyond the right limits, a machined stop on the lower portion of the rotating strut assembly will contact a machined stop on the lower end of the stationary trunnion assembly. The right stops will engage when the NLG tire is turned right about 36°. Further, turning right may damage the machined stops and will load the strut-trunnion interface; however, it will not affect the steering arm or steering horn. If turned beyond the left limit, the steering arm left flange aft face will contact the steering arm mount plate on the engine mount. The left stops will engage when the NLG tire is turned about 30.5° left. Further, turning left may damage the steering arm and the three bolts that attach the steering horn assembly to the top of the NLG strut. The rudder primary and secondary mechanical stops do not allow the mechanical turn limit stops to be engaged through pilot rudder inputs.

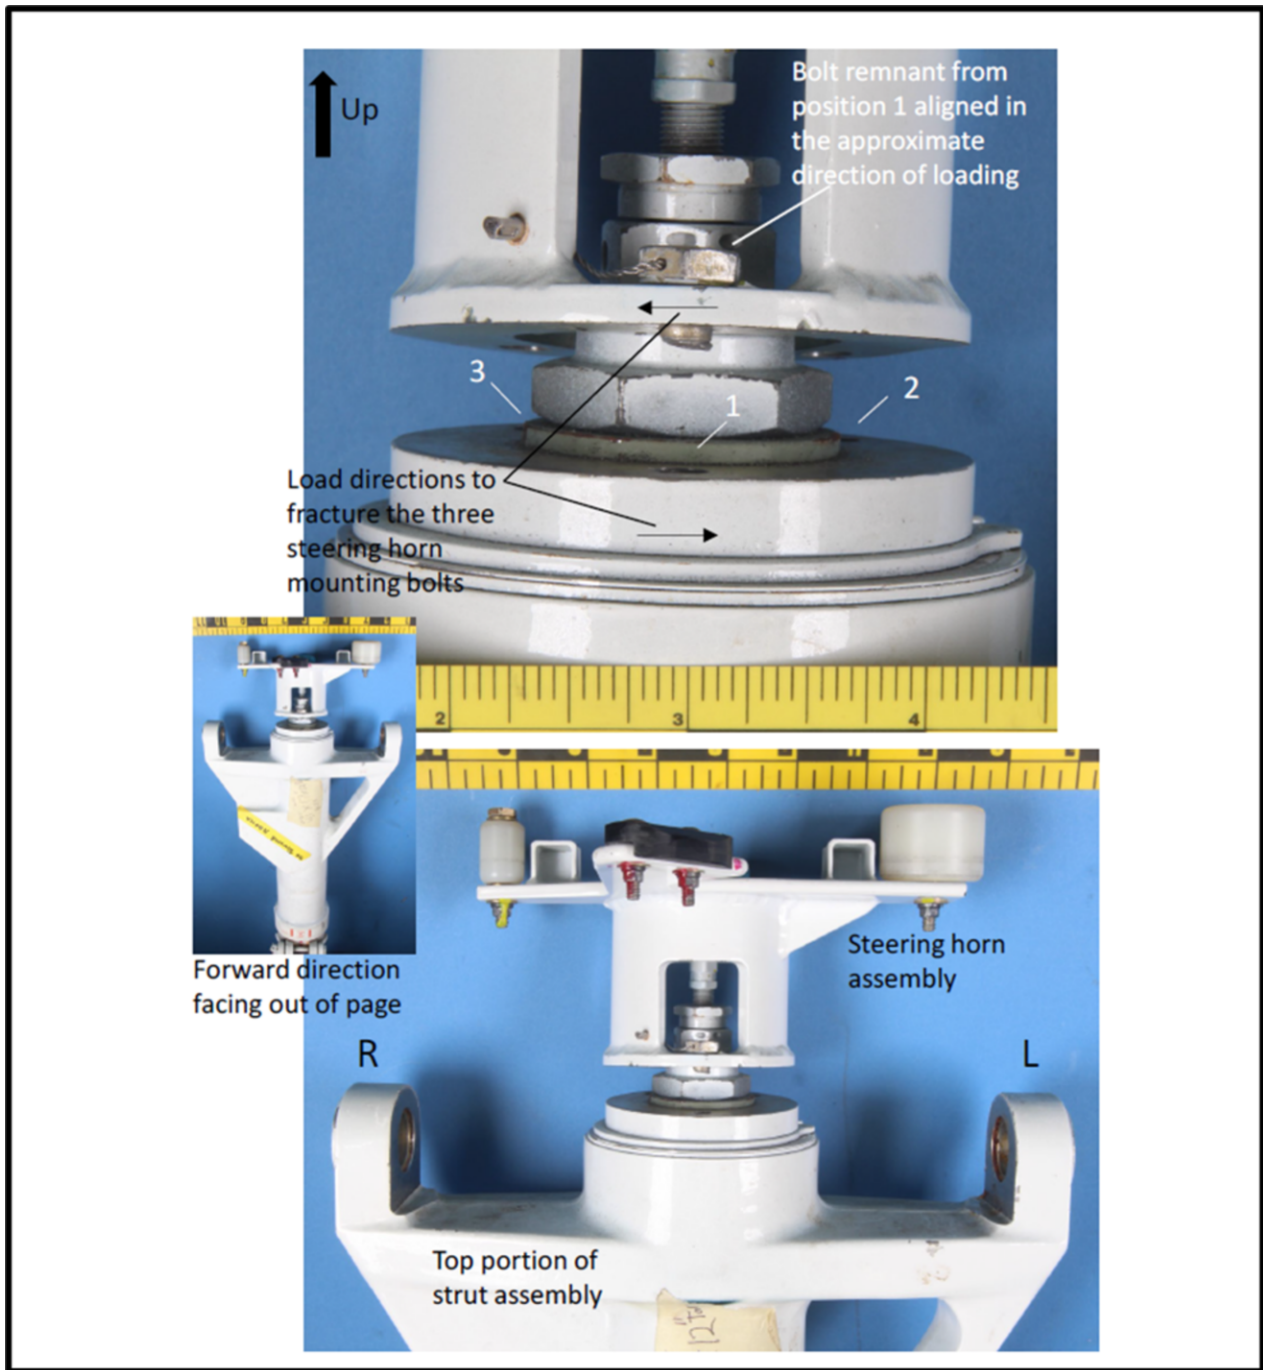
The three bolts that secured the NLG steering horn to the strut were fractured, and the steering horn was found separated from the strut. Examination of the bolt fracture faces, the steering horn bolt holes, and the damage to the top of the strut indicated the left aft bolt fractured predominantly in tension with some shear, the aft right bolt fractured in shear with some bending, the forward bolt fractured in shear with increased bending, and all the bolts fractured in overstress. The direction of the shear failures on the bolts and the strut damage indicated that the strut was rotated left with respect to the steering horn. It was determined that the aft left steering horn bolt fractured first, followed by the aft right bolt and then the forward bolt. The steering horn was reworked at the factory before delivery to better align the steering pad faces with the rollers. The steering horn was deformed during the accident sequence, which precluded taking all the dimensional measurements. The deformation of the left roller could be partially explained due to the exceedance of the left turn limits because the roller should be up to 0.020 inch forward of the steering pad. The remaining measurements did not indicate any gross discrepancies with the steering horn. Therefore, the steering horn was likely fully intact and manufactured in accordance with the drawing.

Examination of the three steering horn attachment bolt fracture faces, the steering horn bolt holes, and the damage to the top of the strut revealed that the left aft bolt fractured predominantly in tension with some shear, the aft right bolt fractured in shear with some bending, the forward bolt fractured in shear with increased bending, and all the bolts fractured in overstress. The direction of shear failures on the bolts and the strut damage indicated that the strut was either rotated left with respect to the steering horn or that the steering horn was rotated right with respect to the strut to produce the bolt failures and associated damage (see figure 2).

Figure 2 - Photographs of the steering horn placed near the top of the strut on the NLG assembly.

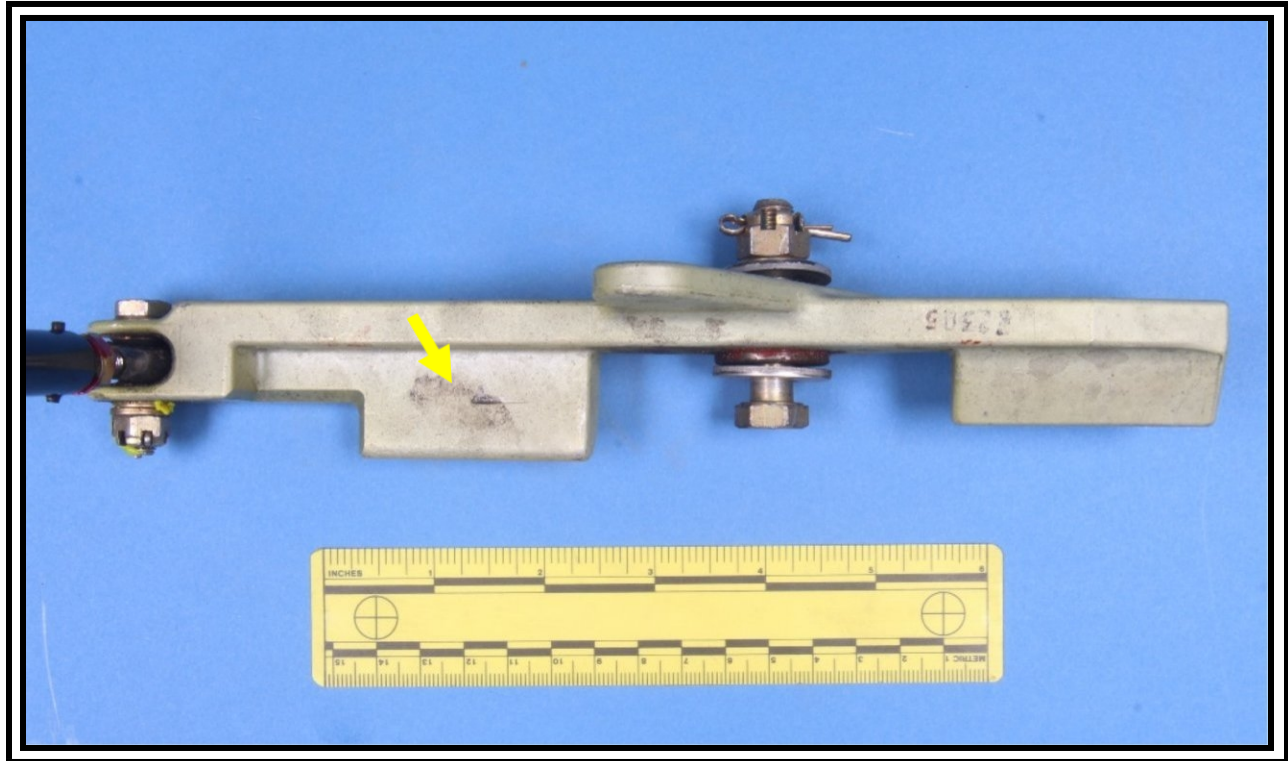
Postaccident examination of the NLG steering system revealed that the aft face of the steering arm's left flange exhibited a witness mark that matched the location and shape of the steering arm mount plate on the engine mount. The steering arm can only contact the mount plate if an external force is applied that turns the NLG left beyond the turn limits indicated on its placard. Therefore, at some point before the accident landing, the NLG had been turned left beyond the placard limits, which resulted in the steering arm contacting the mount plate.

Paint was missing on the NLG assembly's right machined mechanical stops on the trunnion and strut assemblies, and the surface texture of the trunnion stop was embossed on the surface of the strut stop. The aft face of the steering arm left flange exhibited a witness mark that matched the location and shape of the steering arm mount plate on the engine mount (see figure 3).

Figure 3 - A photograph of the steering arm showing a witness mark consistent (yellow arrow) with it contacting engine mount plate.

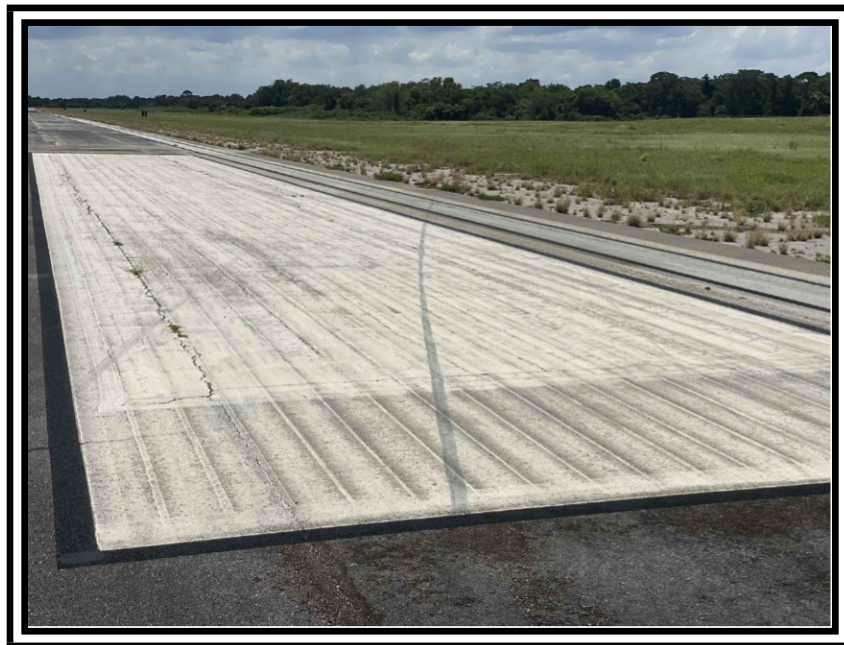
Examination of the runway revealed distinct tire marks from the NLG and both MLG on the runway extending from the touchdown point to where the airplane exited the right side of the runway, which transitioned to ground scars in the grass. The NLG tire mark was a dark wide line with no evident tread pattern, consistent with the airplane skidding from the touchdown point to the runway departure point. The MLG tire marks had an evident tread pattern, consistent with the tires rolling while braking was being applied. A ground scar near where the airplane came to rest was consistent with a left-wing strike. Examination of the NLG and MLG revealed that dirt and grass were embedded between the NLG's left tire bead, that the tire rim and left sidewall exhibited crosswise scuffing, and that the NLG fork was bent right about 25°. Both MLG tires also exhibited crosswise scuffing on the tread. Further, a review of the airplane's avionics data revealed that, shortly after the left MLG touched down, the airplane's heading and track began to diverge and remained apart throughout the ground roll and that its lateral acceleration increased. All of these factors are consistent with the NLG tire having been turned to the right at touchdown, and with the tire then skidding throughout the rollout.

Examination of the runway revealed distinct tire marks from the NLG and both MLG on the runway extending from the touchdown point toward where the airplane exited the right side of the runway, as

shown in figure 4. Both MLG tire marks showed four parallel lines with spaces between them consistent with the tire tread patterns and the tires rolling with brakes applied. The left MLG tire marks were darker than the right MLG tire marks with no tread pattern, consistent with a skidding tire. A short dark skid mark was found preceding the hold lines in line with the continuous NLG tire marks. The marks became darker and arced to the right along their length. The tire markings indicated that the airplane departed the right side of the runway centered about 1,140 ft from the threshold.

Figure 4 – Tire marks on runway 27.
