# Aviation Investigation Final Report

<b>Location:</b>	Coeur d'Alene, Idaho	<b>Accident Number:</b>	WPR20FA206
<b>Date &amp; Time:</b>	July 5, 2020, 14:22 Local	<b>Registration:</b>	N6373U (A1); N2106K (A2)
<b>Aircraft:</b>	Cessna TU206 (A1); De Havilland DHC-2 (A2)	<b>Aircraft Damage:</b>	Destroyed (A1); Destroyed (A2)
<b>Defining Event:</b>	Midair collision	<b>Injuries:</b>	2 Fatal (A1); 6 Fatal (A2)
<b>Flight Conducted Under:</b>	Part 91: General aviation - Personal (A1); Part 91: General aviation - Aerial observation (A2)

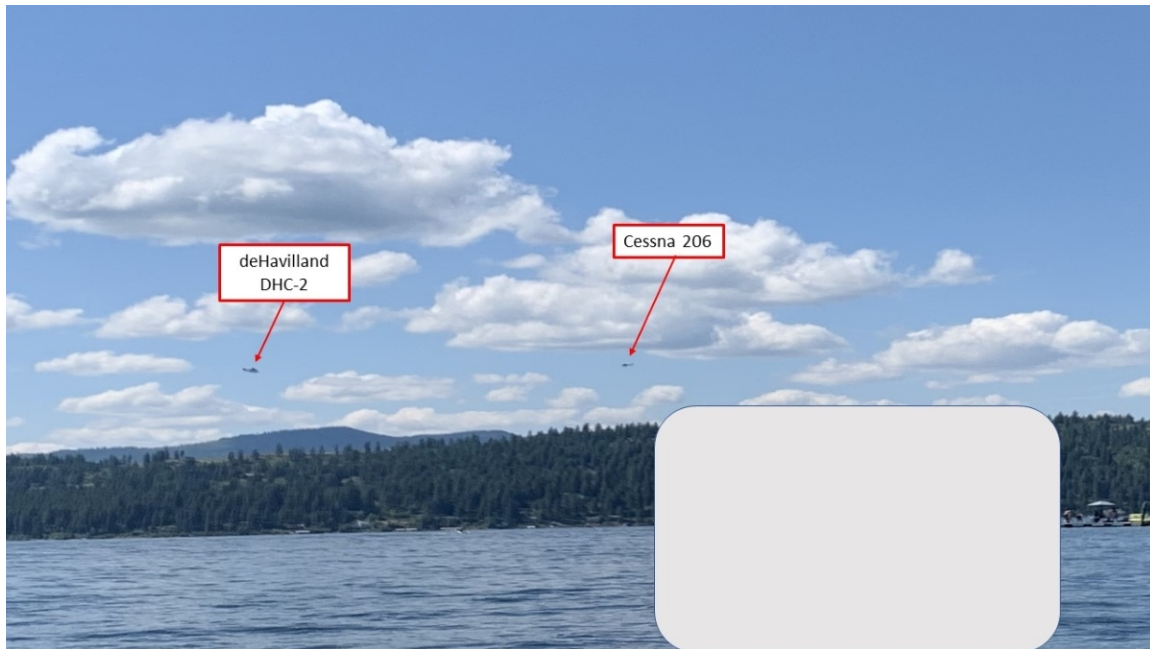
Witnesses located near the accident site reported that they observed the De Havilland flying on a northerly heading and the Cessna on a southerly heading, as shown in figure 1. The witnesses reported that both airplanes appeared to be about 700 to 800 ft above the water surface when they collided over the lake. Two witnesses located along the western side of the lake reported that the Cessna was at a lower altitude and that it had begun to climb before the collision. After the collision, witnesses observed a fireball as both airplanes descended into the water.

**Figure 1.** Still image from live capture of the Cessna and De Havilland airplanes before the collision. (Source: Kim Sprenger)

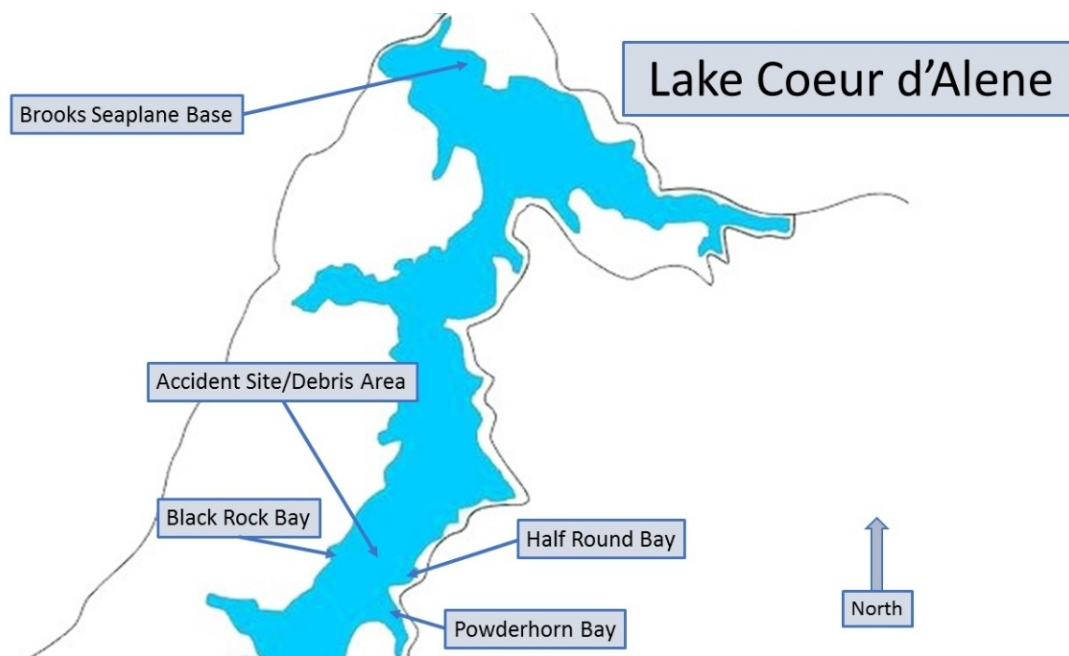
**Figure 2.** Accident site location.

The wreckage of both airplanes was submerged in about 130 ft of water near the center of the lake between Half Round Bay and Black Rock Bay, as indicated in figure 2. The underwater debris path was about 900 ft in length.
