Aviation Investigation Final Report

Location:	Coeur d'Alene, Idaho	Accident Number:	WPR20FA206
Date & Time:	July 5, 2020, 14:22 Local	Registration:	N6373U (A1); N2106K (A2)
Aircraft:	Cessna TU206 (A1); De Havilland DHC-2 (A2)	Aircraft Damage:	Destroyed (A1); Destroyed (A2)
Defining Event:	Midair collision	Injuries:	2 Fatal (A1); 6 Fatal (A2)
Flight Conducted Under:	Part 91: General aviation - Personal (A1); Part 91: General aviation - Aerial observation (A2)

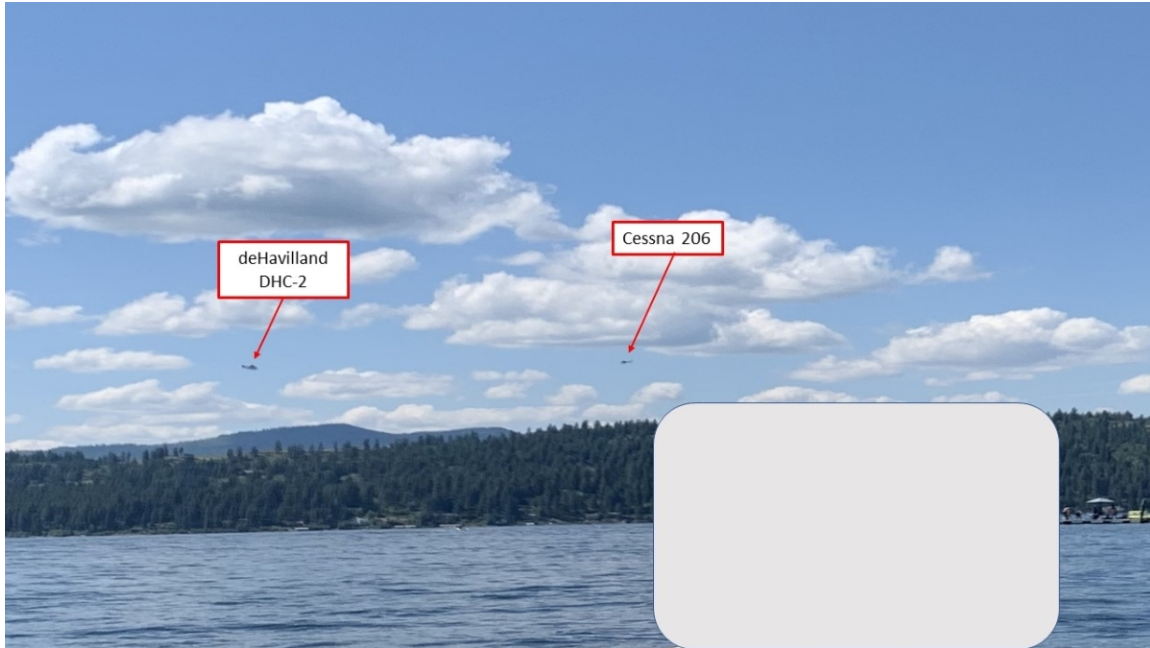
The float-equipped De Havilland DHC-2 was on a tour flight, and the Cessna 206 was on a personal flight. The airplanes collided in midair over a lake during day visual meteorological conditions. No radar or automatic dependent surveillance-broadcast data were available for either airplane. Witnesses reported that the airplanes were flying directly toward each other before they collided about 700 to 800 ft above the water. Other witnesses reported that the Cessna was at a lower altitude and had initiated a climb before the collision. Review of 2 seconds of video captured as part of a witness' "live" photo showed that both airplanes appeared to be in level flight before the collision.

Witnesses located near the accident site reported that they observed the De Havilland flying on a northerly heading and the Cessna on a southerly heading, as shown in figure 1. The witnesses reported that both airplanes appeared to be about 700 to 800 ft above the water surface when they collided over the lake. Two witnesses located along the western side of the lake reported that the Cessna was at a lower altitude and that it had begun to climb before the collision. After the collision, witnesses observed a fireball as both airplanes descended into the water.

Figure 1. Still image from live capture of the Cessna and De Havilland airplanes before the collision. (Source: Kim Sprenger)
