Aviation Investigation Final Report

Location:	Anchorage, Alaska	Accident Number:	ANC20LA065
Date & Time:	July 5, 2020, 11:15 Local	Registration:	N9185T
Aircraft:	Cessna 180	Aircraft Damage:	Substantial
Defining Event:	Loss of control on ground	Injuries:	2 None
Flight Conducted Under:	Part 91: General aviation - Personal

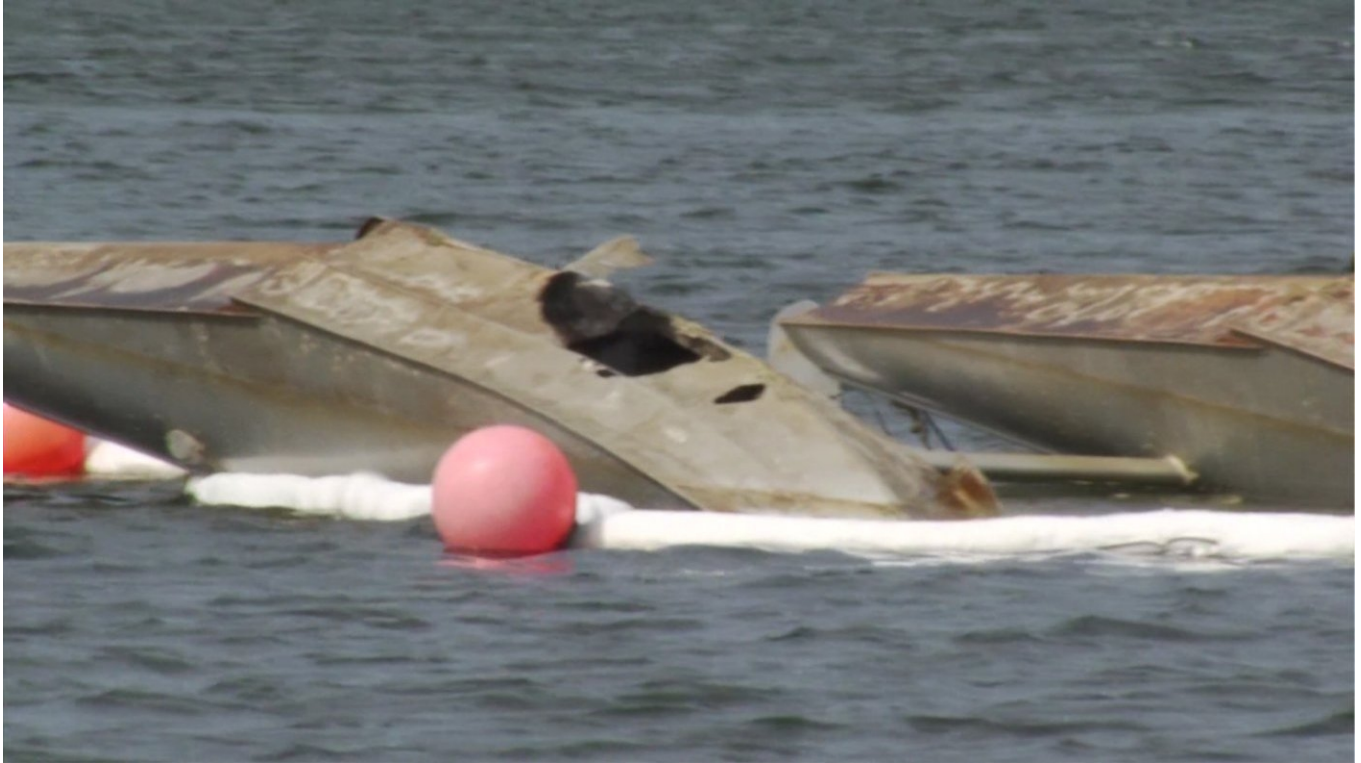
A postaccident examination revealed a large hole in the bottom of the left float just forward of the step. Corrosion was present around the hole and no impact signatures were present on the bottom of the float. The circumstances of the accident are consistent with a loss of control during the water landing due to the failure of the left float due to corrosion.

The failure of the left float bottom due to corrosion, which resulted in a loss of control during the water landing.

A postaccident examination of the left float revealed a large hole in the bottom of the float just forward of the step. (See Figure 1.) Corrosion was present around the hole and no impact signatures were present on the bottom of the float.

Figure 1 - Accident airplane at accident site, hole visible in left float. Photo courtesy of KTVA.
