# Aviation Investigation Final Report

<b>Location:</b>	Payson, Arizona	<b>Accident Number:</b>	WPR20LA211
<b>Date &amp; Time:</b>	July 7, 2020, 12:13 Local	<b>Registration:</b>	N623PB
<b>Aircraft:</b>	Bell UH1H	<b>Aircraft Damage:</b>	Destroyed
<b>Defining Event:</b>	Loss of control in flight	<b>Injuries:</b>	1 Fatal
<b>Flight Conducted Under:</b>	Part 133: Rotorcraft ext. load

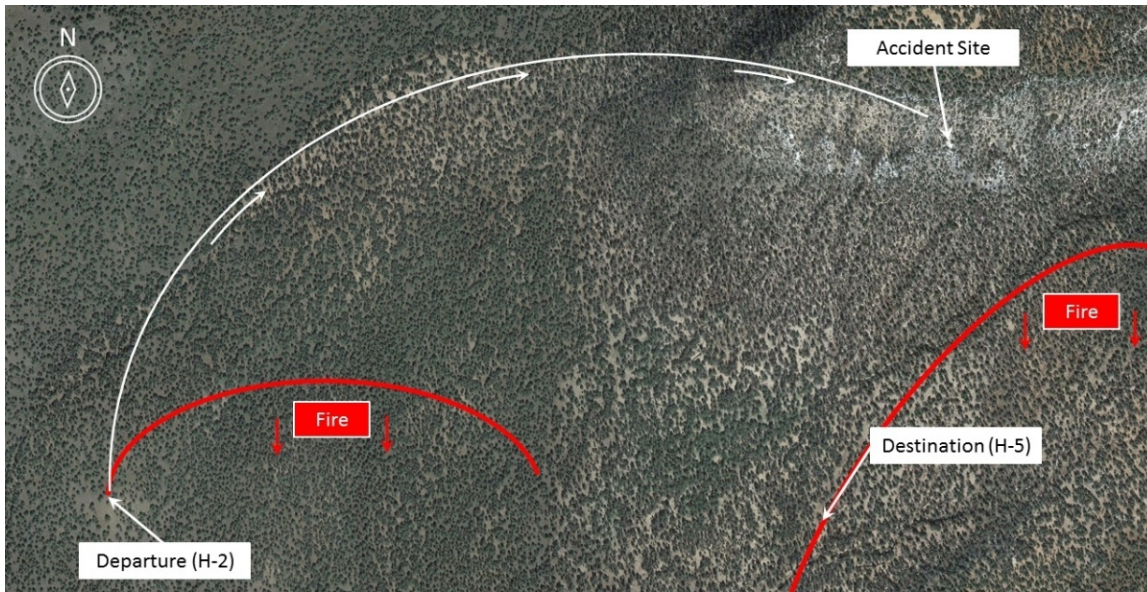
Figure 1: Depiction of helicopter flight path based on witness statements

According to witnesses, the helicopter was transporting supplies externally using a 100-ft-long line and cargo nets for a USFS hotshot firefighting crew that was repositioning on the ground. The pilot transported three loads from site H2 to site H5 uneventfully before the accident and was using an indirect route to the north to avoid a fire area. (See Figure 1.) While transporting the fourth load, witnesses observed the helicopter begin to fly erratically when it reached a plateau while enroute to its destination. During this time, a witness stated that he observed the helicopter enter a high nose-up pitch attitude, and the external payload began to swing. The helicopter then displayed irregular movements for several seconds before the external payload settled and the helicopter appeared to stabilize. However, after about 3 seconds, multiple witnesses observed the helicopter wobble and bank erratically before it entered a steep nose-up attitude and then descended rapidly to ground impact. Two witnesses reported that the helicopter started to twist to the right as it descended. The witnesses did not observe the helicopter on fire during the accident flight nor did the pilot report any anomalies over the assigned air-to-ground radio frequency, Air Guard, or any other assigned frequencies for the fire.
