Aviation Investigation Final Report

Location:	Payson, Arizona	Accident Number:	WPR20LA211
Date & Time:	July 7, 2020, 12:13 Local	Registration:	N623PB
Aircraft:	Bell UH1H	Aircraft Damage:	Destroyed
Defining Event:	Loss of control in flight	Injuries:	1 Fatal
Flight Conducted Under:	Part 133: Rotorcraft ext. load

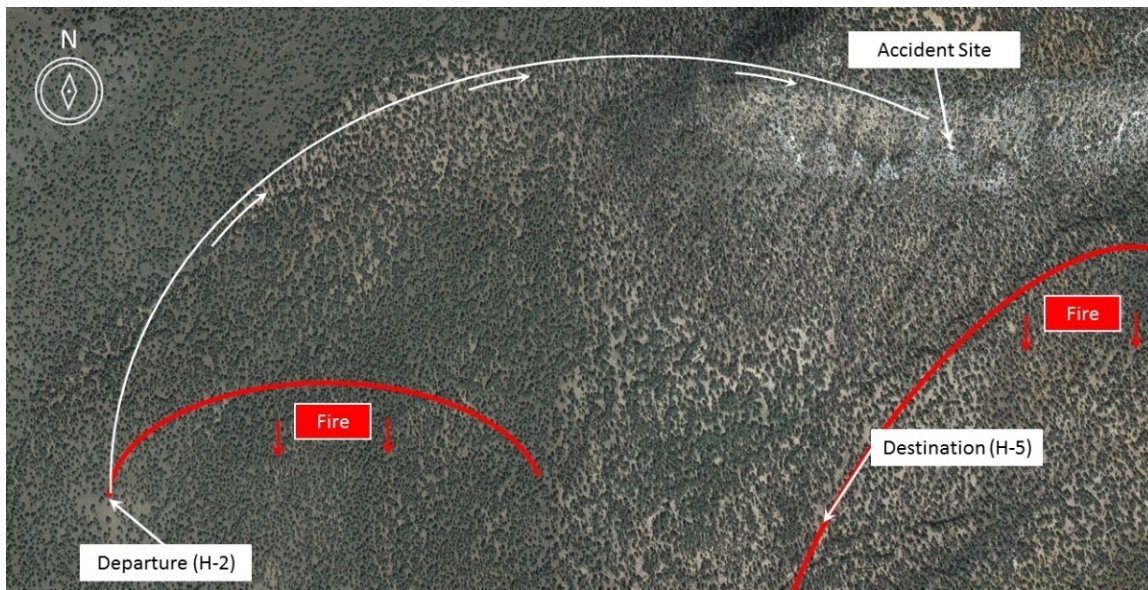
According to witnesses, the helicopter was transporting supplies externally using a 100-ft-long line and cargo nets for a USFS hotshot firefighting crew that was repositioning on the ground. The pilot transported three loads from site H2 to site H5 uneventfully before the accident and was using an indirect route to the north to avoid a fire area. (See Figure 1.) While transporting the fourth load, witnesses observed the helicopter begin to fly erratically when it reached a plateau while enroute to its destination. During this time, a witness stated that he observed the helicopter enter a high nose-up pitch attitude, and the external payload began to swing. The helicopter then displayed irregular movements for several seconds before the external payload settled and the helicopter appeared to stabilize. However, after about 3 seconds, multiple witnesses observed the helicopter wobble and bank erratically before it entered a steep nose-up attitude and then descended rapidly to ground impact. Two witnesses reported that the helicopter started to twist to the right as it descended. The witnesses did not observe the helicopter on fire during the accident flight nor did the pilot report any anomalies over the assigned air-to-ground radio frequency, Air Guard, or any other assigned frequencies for the fire.

Figure 1: Depiction of helicopter flight path based on witness statements
