# Aviation Investigation Final Report

<b>Location:</b>	Burns Flat, Oklahoma	<b>Accident Number:</b>	CEN20LA292
<b>Date &amp; Time:</b>	July 18, 2020, 22:45 Local	<b>Registration:</b>	N3412C
<b>Aircraft:</b>	Beech A23-24	<b>Aircraft Damage:</b>	Substantial
<b>Defining Event:</b>	Loss of engine power (partial)	<b>Injuries:</b>	4 None
<b>Flight Conducted Under:</b>	Part 91: General aviation - Personal

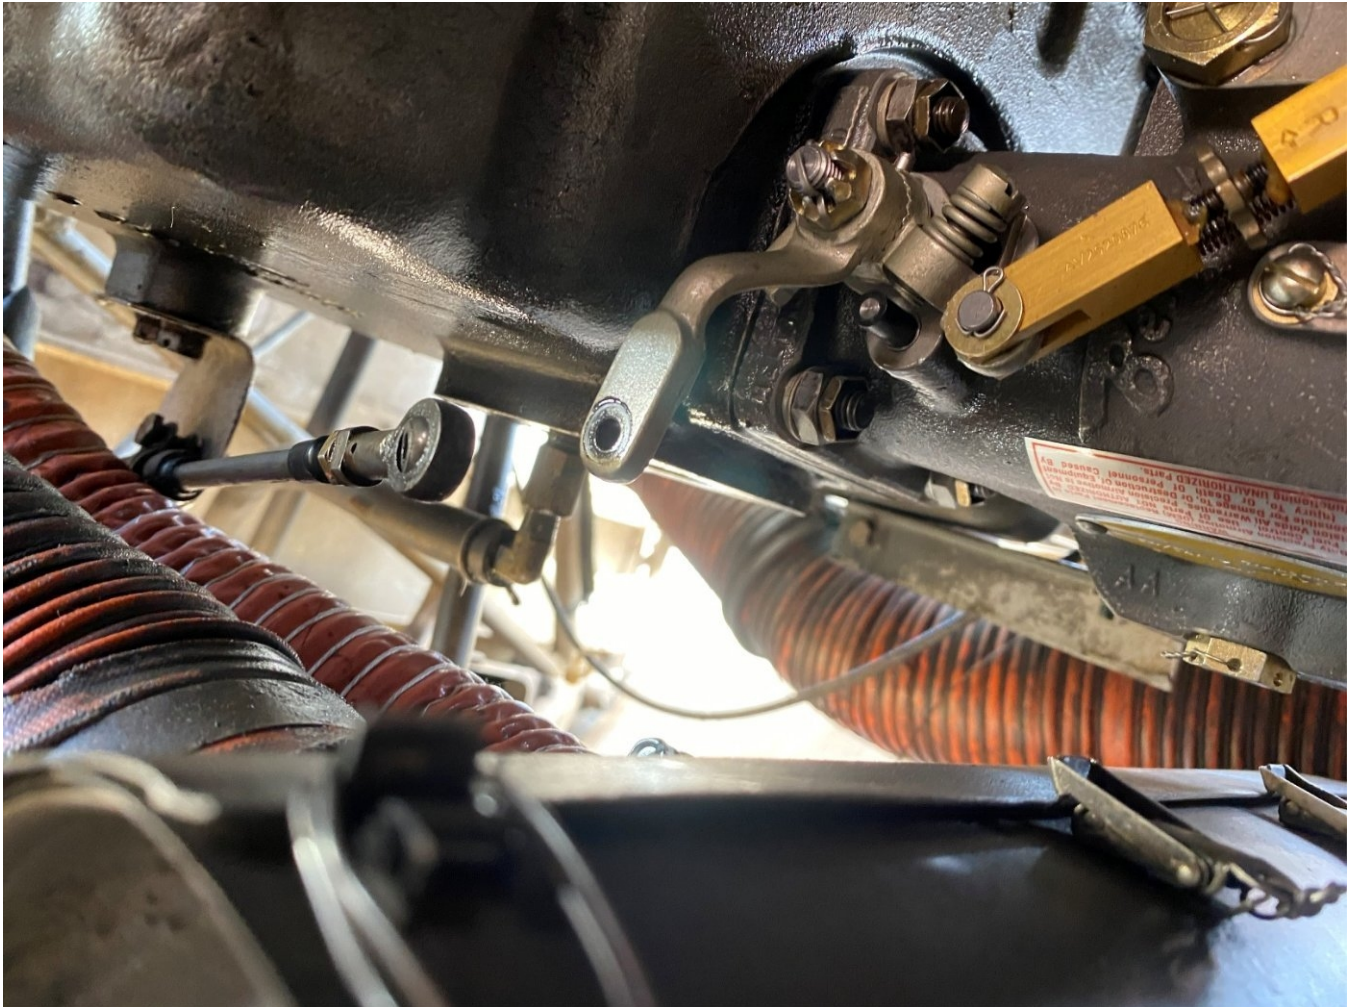
A postaccident examination revealed that the throttle control rod-end was not connected to the fuel servo throttle linkage. Additionally, the required retaining bolt, washer, and self-locking nut were not located during the investigation. The airplane had accumulated 8.72 flight hours since the last annual inspection, during which the fuel servo had been removed from the engine and overhauled. It is likely that the mechanic who reinstalled the fuel servo did not adequately torque the self-locking nut that secured the retaining bolt, which allowed the self-locking nut to back-off the retaining bolt. The airplane had a partial loss of engine power when the throttle control rod-end disconnected from the unsecured retaining bolt. The pilot did not have the ability to control engine power after the throttle control rod-end disconnected from the fuel servo throttle linkage.

The mechanic's improper maintenance when he reinstalled the fuel servo during the last annual inspection, which resulted in a loss of engine power during cruise flight when the throttle control rod-end disconnected from the fuel servo throttle linkage.

The airplane was examined at the accident site by a Federal Aviation Administration airworthiness inspector. Both wing fuel tanks contained about 25 gallons of 100 low-lead aviation fuel. The throttle control was very loose when moved by hand in the cockpit. A visual examination revealed that the throttle control rod-end was not connected to the fuel servo throttle linkage. (Figure 1) The required retaining bolt, washer, and self-locking nut were not located during the investigation.

Figure 1. Throttle control rod-end found disconnected from the fuel servo throttle linkage.

The airplane had accumulated 8.72 flight hours since the last annual inspection that was completed on October 22, 2019. The inspection authorized (IA) mechanic who had completed the annual inspection stated that the fuel servo had been removed from the engine and overhauled in conjunction with the annual inspection. The IA mechanic stated that he personally reinstalled the overhauled fuel servo on the engine, while another individual moved the throttle and mixture controls in the cockpit. The IA mechanic stated that it is his standard practice to connect both the throttle and mixture controls to the fuel servo at the same time. The IA mechanic stated that he likely reused the bolt and washer to connect the throttle control rod-end to the fuel servo throttle linkage, and that it is also possible that he reused the self-locking nut. However, he would not have reused the self-locking nut if it had fully engaged the bolt threads by hand. The IA mechanic stated that he used two wrenches to secure the self-locking nut and that he did not use a torque wrench. A review of the Beech A23-24 Maintenance Manual revealed no specific assembly instructions on how to physically connect the throttle control rod-end to the fuel servo throttle linkage. The Beech A23-24 Illustrated Parts Catalog specified that the throttle control rod-end be attached to the fuel servo throttle linkage with a 169-910021 bolt, AN960-10 washer, and MS20365-1032 self-locking nut.
