Aviation Investigation Final Report

Location:	San Andreas, California	Accident Number:	WPR20LA228
Date & Time:	July 20, 2020, 09:38 Local	Registration:	N745BW
Aircraft:	Md Helicopter 600	Aircraft Damage:	Destroyed
Defining Event:	Fire/smoke (non-impact)	Injuries:	3 None
Flight Conducted Under:	Part 91: General aviation - Aerial observation

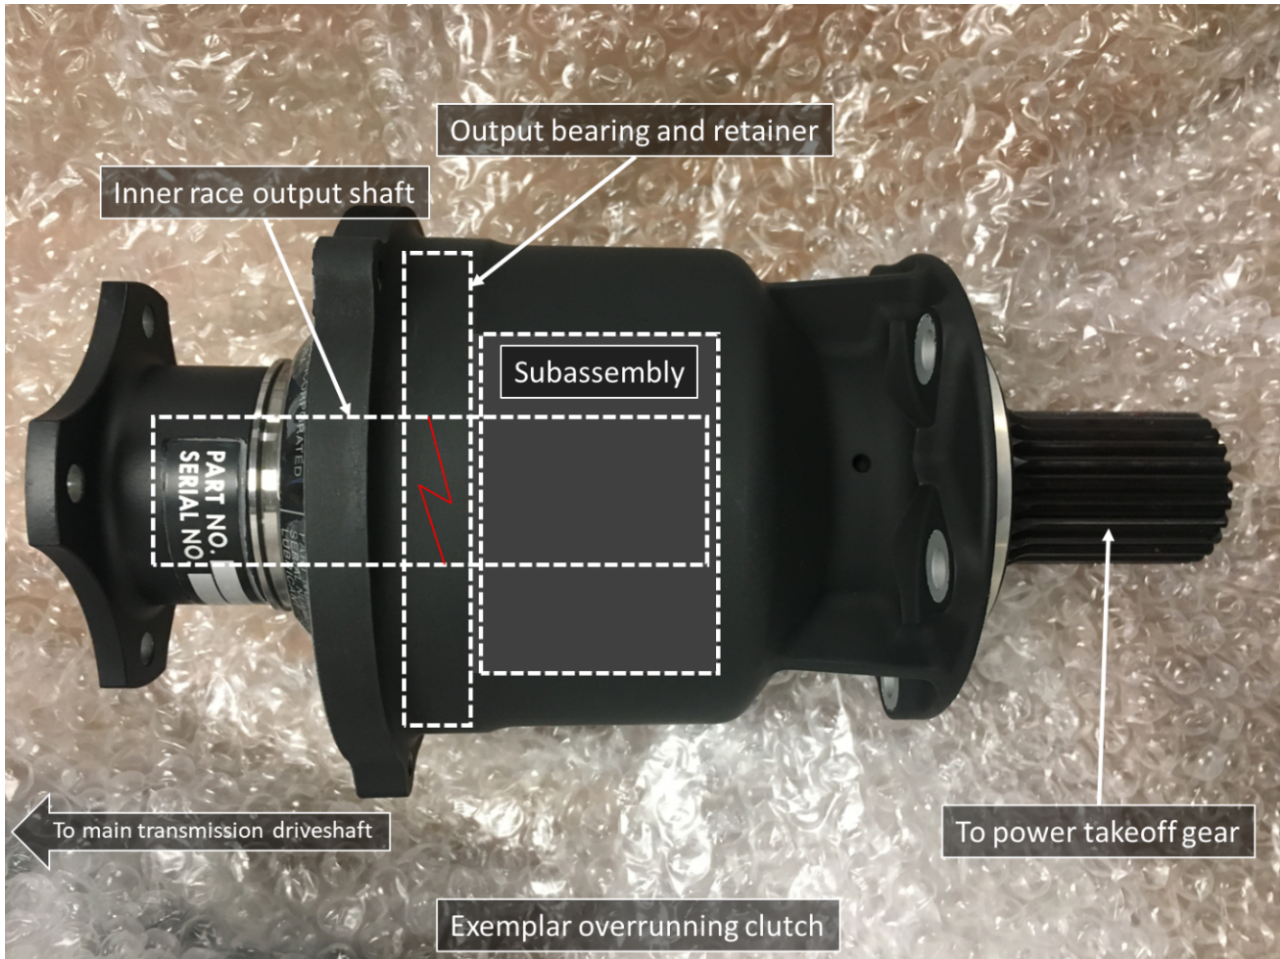
Figure 1. Exemplar overrunning clutch (Source: MD Helicopters).

Note: The output bearing, and retainer, subassembly, and inner race output shaft are internal and thus not visible in this figure. The red line indicates the location of the fracture in the accident overrunning clutch.

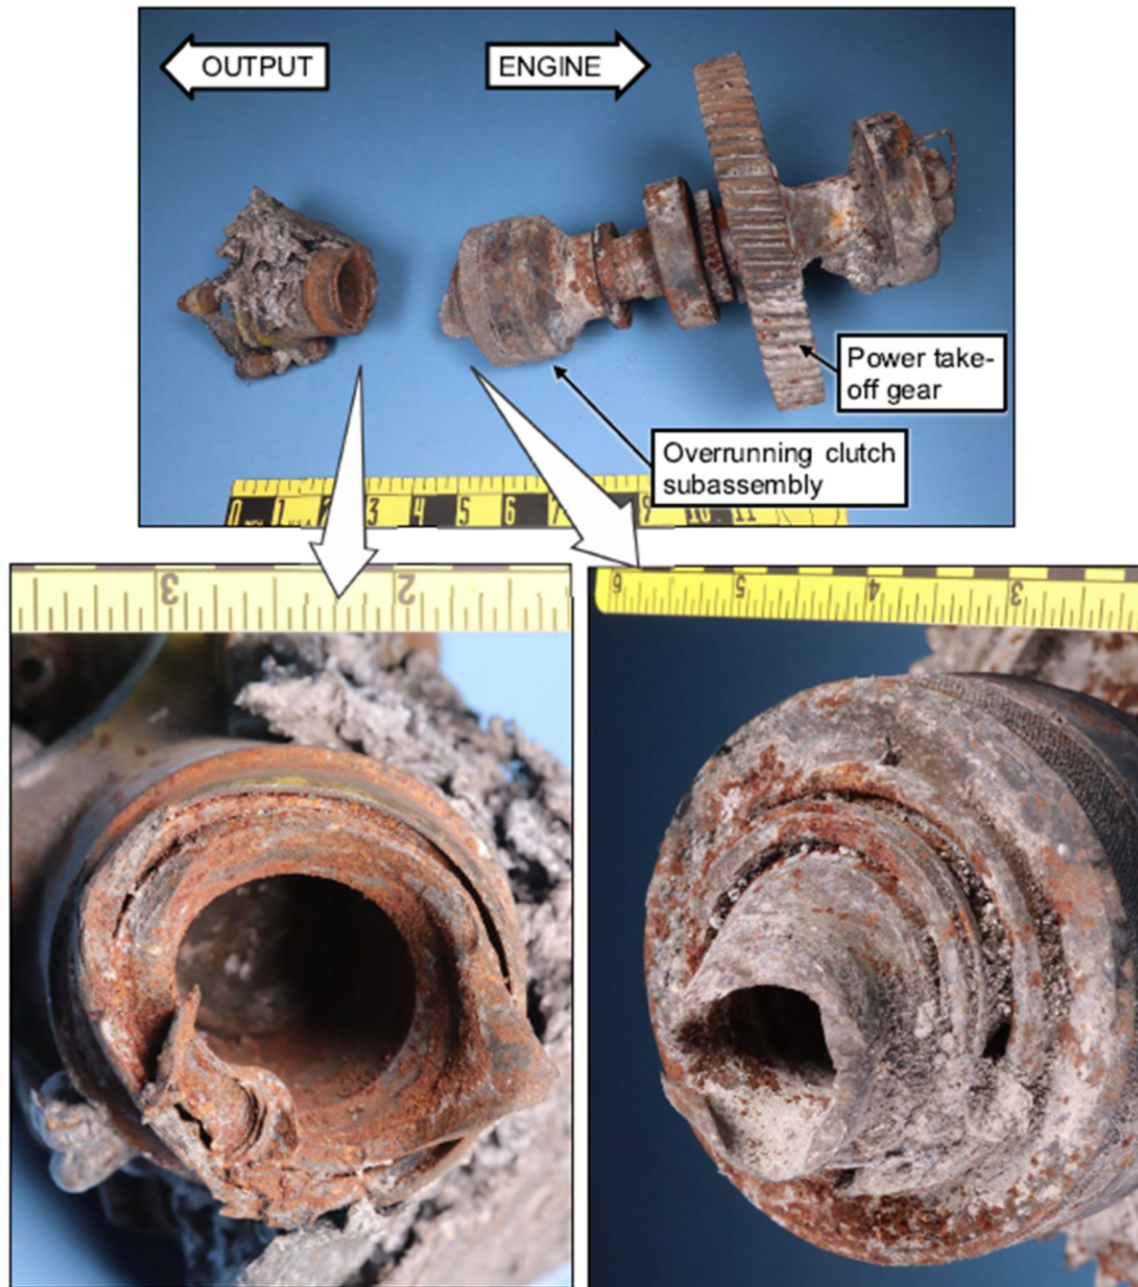
Figure 3. Separation of the inner race output shaft of the overrunning clutch subassembly.

The output shaft deformed and fractured due to high-temperature overstress at the output bearing. The highest heat, which was localized to the area around the output bearing inner race, was not from the postaccident fire because the overall pattern of heating, scoring, and deformation was consistent with frictional heating from a failure of the output bearing. That

The overrunning clutch subassembly, output bearing, and retainer were sent to the National Transportation Safety Board Materials Laboratory. Examination revealed that the overrunning clutch inner race was fractured near its output shaft, as shown in figure 3. Circumferential scoring and metal deposits were observed on the external surface of the overrunning clutch inner race. The area of scoring and metal deposits corresponded to the installed location of the clutch output bearing on the clutch inner race.

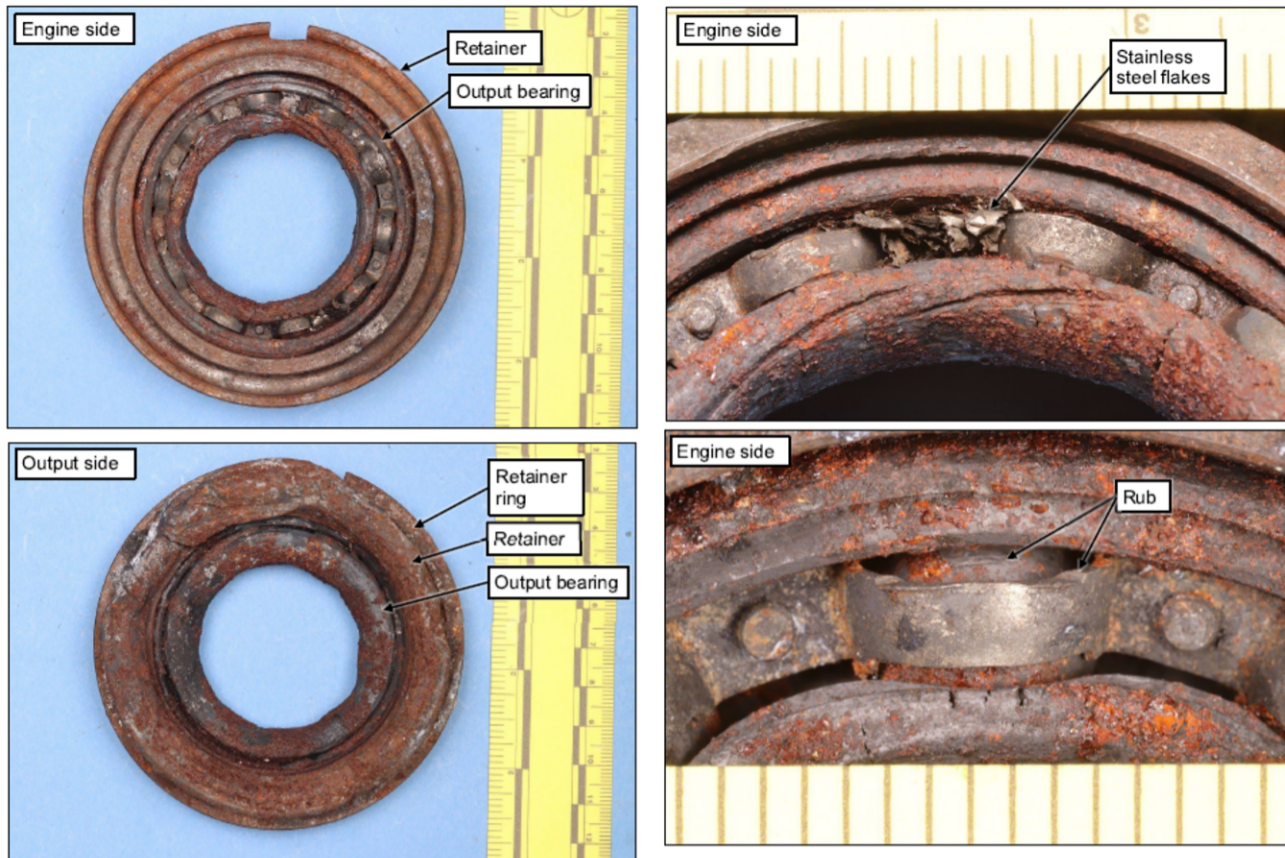
Figure 4. Output bearing and retainer damage to the inner race.

failure caused the output bearing to seize and spin on the clutch inner race. The flakes of stainless steel found between the balls, cage, and outer race were likely remnants of the stainless-steel insert that was part of the grease seal, and the accumulation of the flakes between the balls indicated the seal failed before the bearing seized.

Examination of the output bearing revealed that the inner race was substantially deformed radially outward, wrapping around the balls such that the inner diameter had a U-shaped profile. The output end of the retainer was also deformed radially outward, as shown in figure 4. Stainless steel flakes were observed in between the balls, cage, and outer race. A sample of the flakes was analyzed and found to be consistent with the stainless steel used on the grease seal.
