# Aviation Investigation Final Report

<b>Location:</b>	West Jordan, Utah	<b>Accident Number:</b>	WPR20LA238
<b>Date &amp; Time:</b>	July 25, 2020, 13:38 Local	<b>Registration:</b>	N7677C
<b>Aircraft:</b>	Piper PA32R	<b>Aircraft Damage:</b>	Substantial
<b>Defining Event:</b>	Aerodynamic stall/spin	<b>Injuries:</b>	4 Fatal, 2 Serious, 1 Minor
<b>Flight Conducted Under:</b>	Part 91: General aviation - Personal

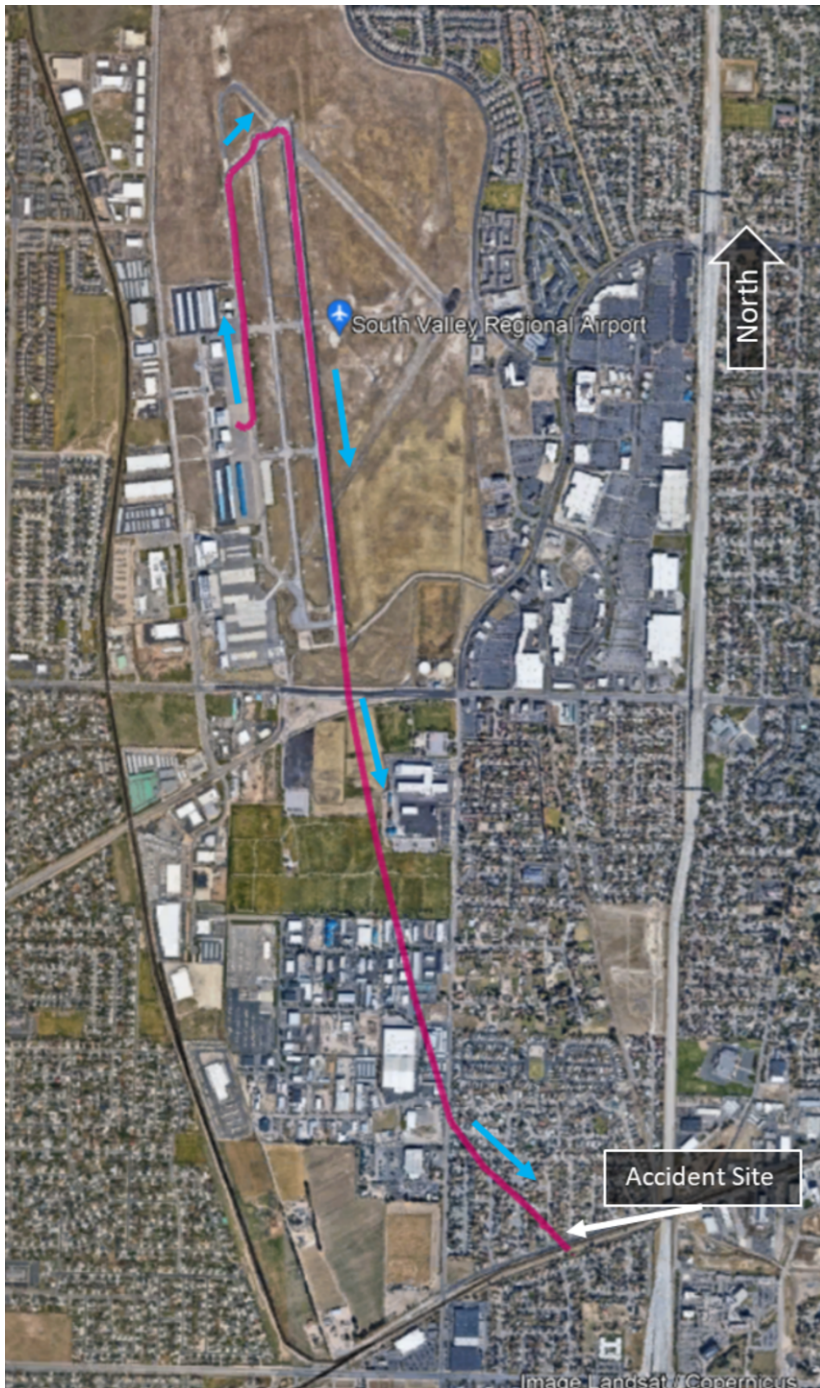
Downloaded data from the airplane’s onboard GPS unit revealed that the airplane departed U42 about 1336 and traveled southeast on a magnetic heading of 165° for about 1.3 miles and then turned left to a magnetic heading of about 136° for 0.2 miles. The airplane climbed to an altitude of 4,720 ft mean sea level (msl)/about 120 ft above ground level (agl) and accelerated to a groundspeed of about 82 knots. The last GPS point, at 1338:24, recorded the airplane near the accident site at an altitude of 4603 ft msl/about 10 ft agl and a groundspeed of about 1 knot, as shown in figure 1.

Figure 1. GPS flightpath (magenta line) and the airplane’s direction of travel (blue arrows).

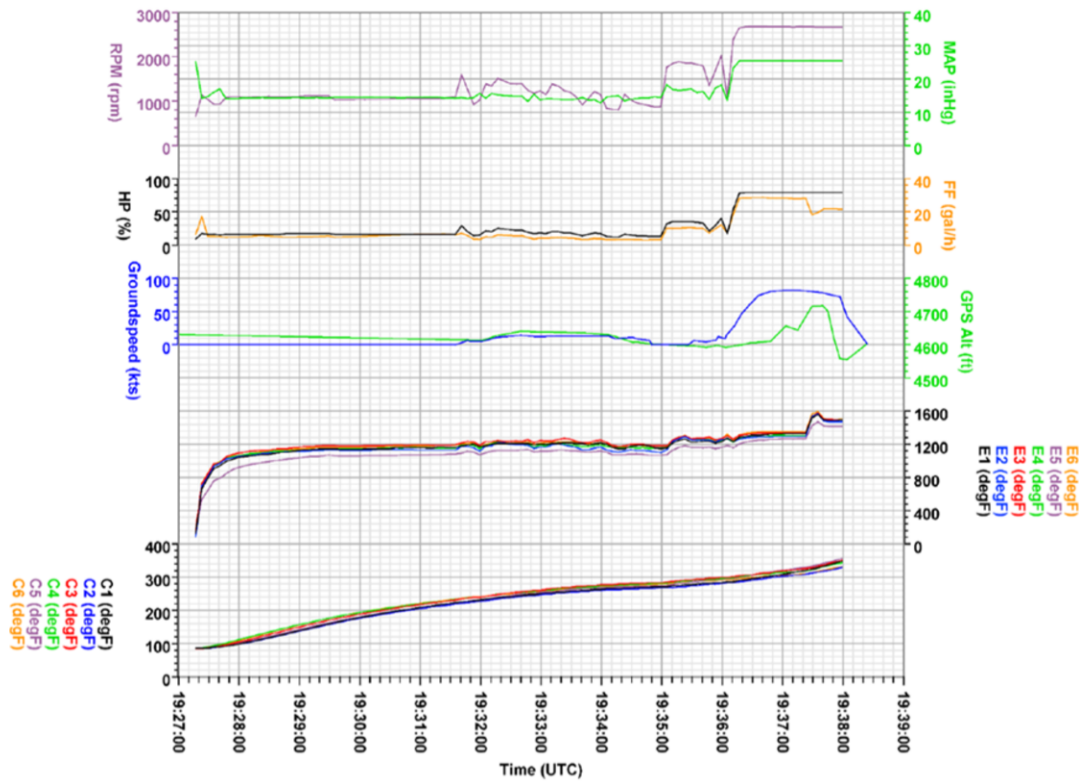
Recorded engine data revealed consistent operation of the engine throughout the flight until about 15 seconds before the loss of data, when the exhaust gas temperatures and the fuel flow fluctuated likely because the pilot was adjusting the mixture lever. No mechanical malfunctions or failures with the airplane were found that would have precluded normal operations.

Data recovered from an engine data monitor (EDM) revealed engine performance parameters for the accident flight, as shown in figure 2. The data revealed consistent engine operation for the first 10 minutes of operation. About 1337, the exhaust gas temperature (EGT) of all cylinders increased rapidly from about 1,280°F to a maximum of about 1,600°F, and the fuel flow decreased from about 28 to 19 gallons per hour. About 5 seconds later the EGTs for all cylinders decreased to about 1,500°F, and the fuel flow increased to about 22 gallons per hour, consistent with adjustments being made to the mixture control. The EDM data stopped recording about 1338.

Figure 2. Engine performance and GPS data from the accident flight.
