Aviation Investigation Final Report

Location:	West Jordan, Utah	Accident Number:	WPR20LA238
Date & Time:	July 25, 2020, 13:38 Local	Registration:	N7677C
Aircraft:	Piper PA32R	Aircraft Damage:	Substantial
Defining Event:	Aerodynamic stall/spin	Injuries:	4 Fatal, 2 Serious, 1 Minor
Flight Conducted Under:	Part 91: General aviation - Personal

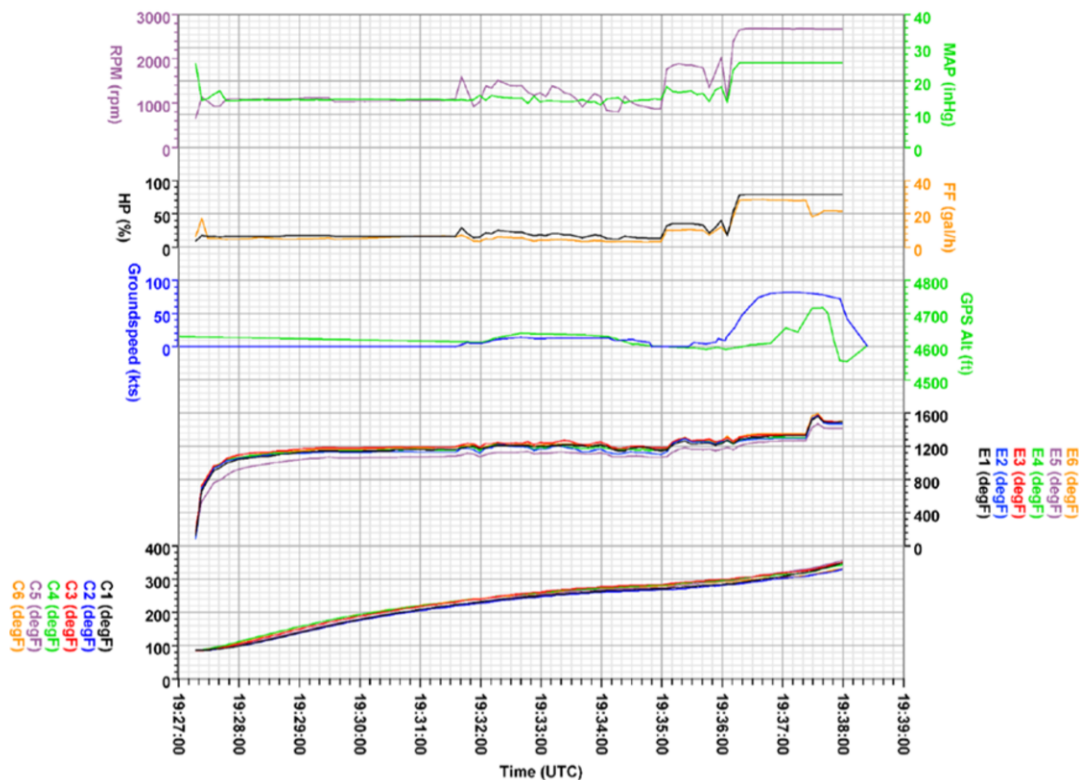
Data recovered from an engine data monitor (EDM) revealed engine performance parameters for the accident flight, as shown in figure 2. The data revealed consistent engine operation for the first 10 minutes of operation. About 1337, the exhaust gas temperature (EGT) of all cylinders increased rapidly from about 1,280°F to a maximum of about 1,600°F, and the fuel flow decreased from about 28 to 19 gallons per hour. About 5 seconds later the EGTs for all cylinders decreased to about 1,500°F, and the fuel flow increased to about 22 gallons per hour, consistent with adjustments being made to the mixture control. The EDM data stopped recording about 1338.

Figure 2. Engine performance and GPS data from the accident flight.
