Aviation Investigation Final Report

Location:	Henefer, Utah	Accident Number:	WPR20LA239
Date & Time:	July 26, 2020, 11:10 Local	Registration:	N514BS
Aircraft:	Vans RV7	Aircraft Damage:	Substantial
Defining Event:	Loss of engine power (total)	Injuries:	1 Minor
Flight Conducted Under:	Part 91: General aviation - Personal

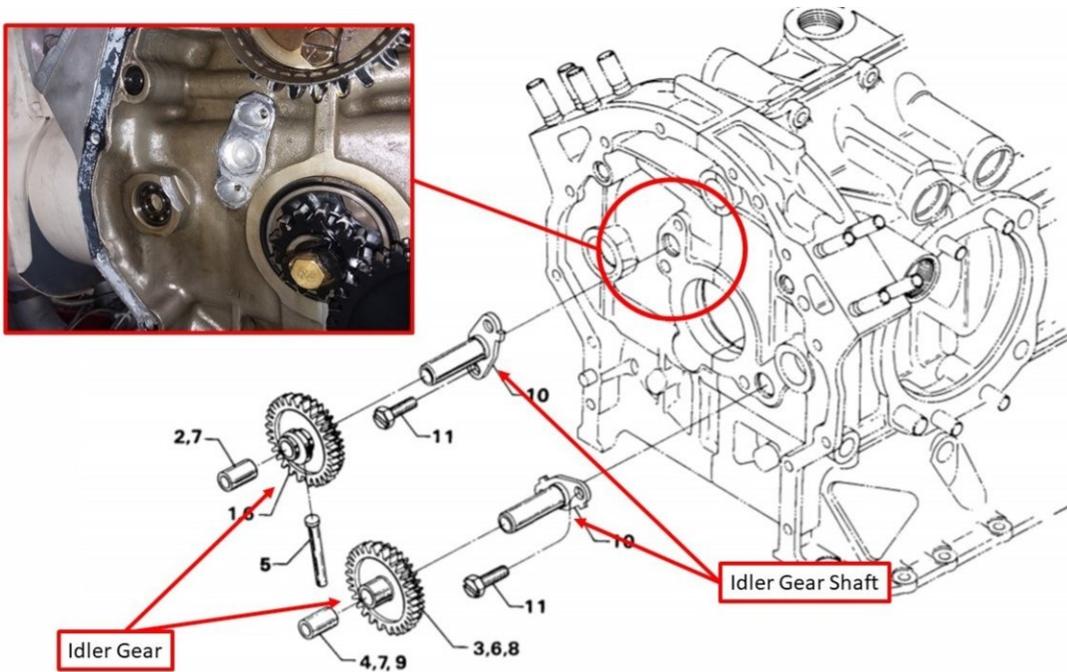
Postaccident examination of the engine revealed that the crankshaft idler gear shaft was separated from its mount and the idler gear was disengaged from the crankshaft and camshaft. Fretting was observed within the area of the idler gear shaft mount. The idler gear shaft bolts were separated. No evidence of a locking plate or safety wire was observed. It's likely that idler gear bolts had become loose due to improper installation, which allowed the idler gear shaft to shift and the idler gear to become disengaged from the crankshaft and camshaft, which would result in a loss of engine power.

The total loss of engine power due to the separation of the idler gear shaft bolts as a result of improper installation, which allowed for the idler gear to become disengaged.

Examination of the Lycoming IO-540-C4B5 engine by a Federal Aviation Administration inspector revealed that the crankshaft idler gear shaft was separated from its mount and the idler gear was disengaged from the crankshaft and camshaft. The idler gear shaft bolts were separated with no locking tabs or safety wire present. Photos supplied by the inspector showed that both the left idler gear shaft bolt holes were elongated, and the entire mounting area was severely worn and exhibited areas of fretting. The left idler gear interconnects the crankshaft, camshaft, left magneto, and fuel pump drive gears. (See figure 1)

Figure 1: View of the idler gear and idler gear shaft assembly.
