Aviation Investigation Final Report

Location:	Pioche, Nevada	Accident Number:	WPR20LA244
Date & Time:	July 29, 2020, 10:00 Local	Registration:	N755AE
Aircraft:	AMERICAN EUROCOPTER AS350	Aircraft Damage:	Destroyed
Defining Event:	External load event (Rotorcraft)	Injuries:	2 Fatal
Flight Conducted Under:	Part 91: General aviation

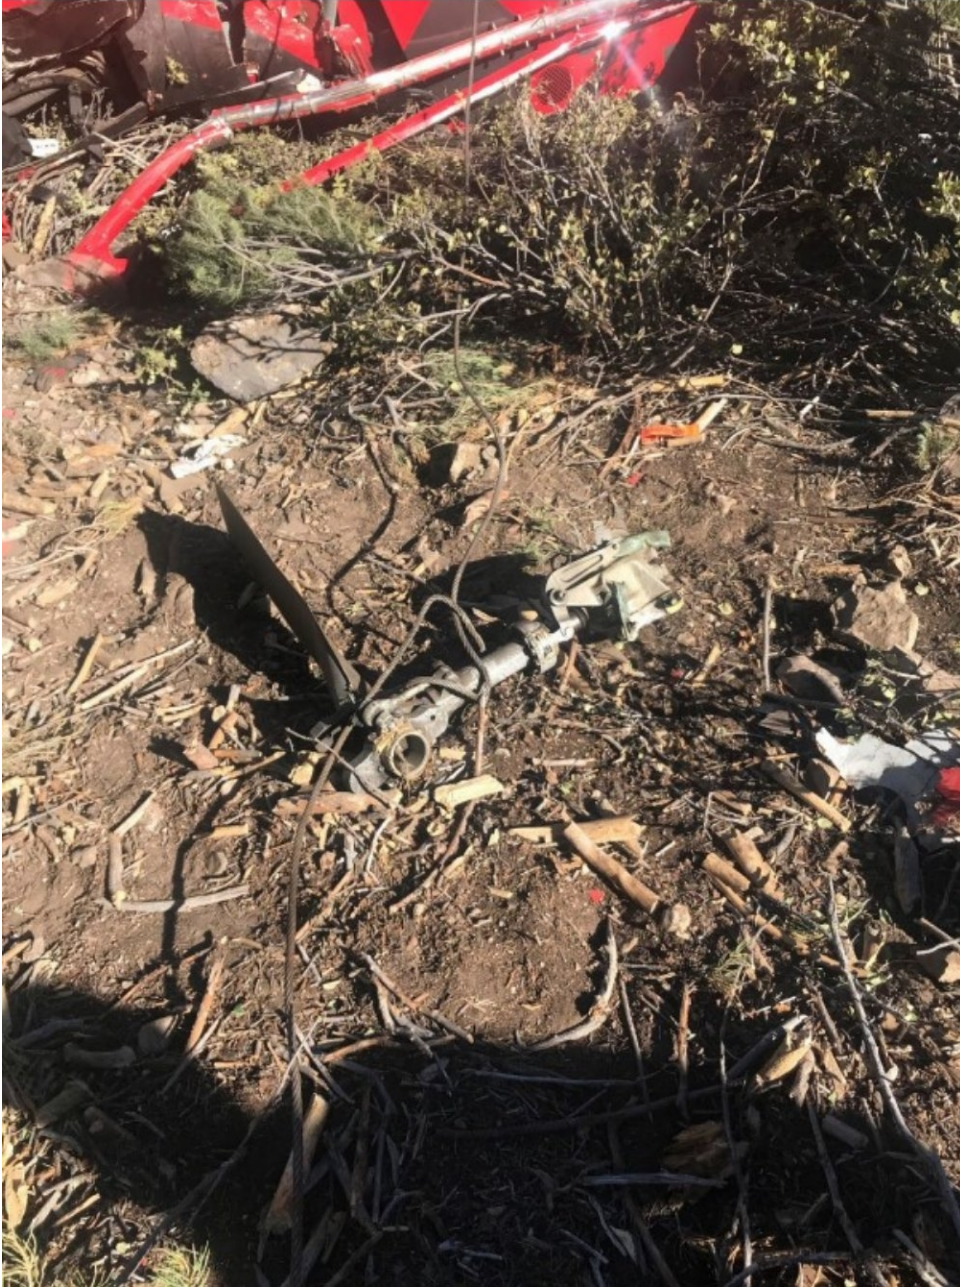
Examination of the helicopter revealed that the long line was entangled with the tail rotor, which had separated from the helicopter. The tail cone/vertical fin assembly was found about 365 ft from the main wreckage and exhibited evidence of cable abrasion. Examination of the flight controls and engine, as well as review of recorded engine data, revealed no evidence of mechanical anomalies that would have precluded normal operation.

Based on the available information, it is likely that the pilot failed to achieve adequate clearance between the long line and terrain before descending downhill toward the fuel truck, which resulted in the helicopter's long line, becoming entangled with the tail rotor, and a subsequent loss of helicopter control.

The helicopter came to rest in heavily treed terrain on its right side. There was no evidence of a postimpact fire. The helicopter was equipped with a long line cargo hook system. About 21 ft of steel long line cable impacted the main rotor blades and was found entangled in the separated tail rotor. (see Figure 1.) The separated cable end exhibited a broomstrawed appearance and evidence of red paint transfer.

Figure 1. Photo of tail rotor wrapped with cable

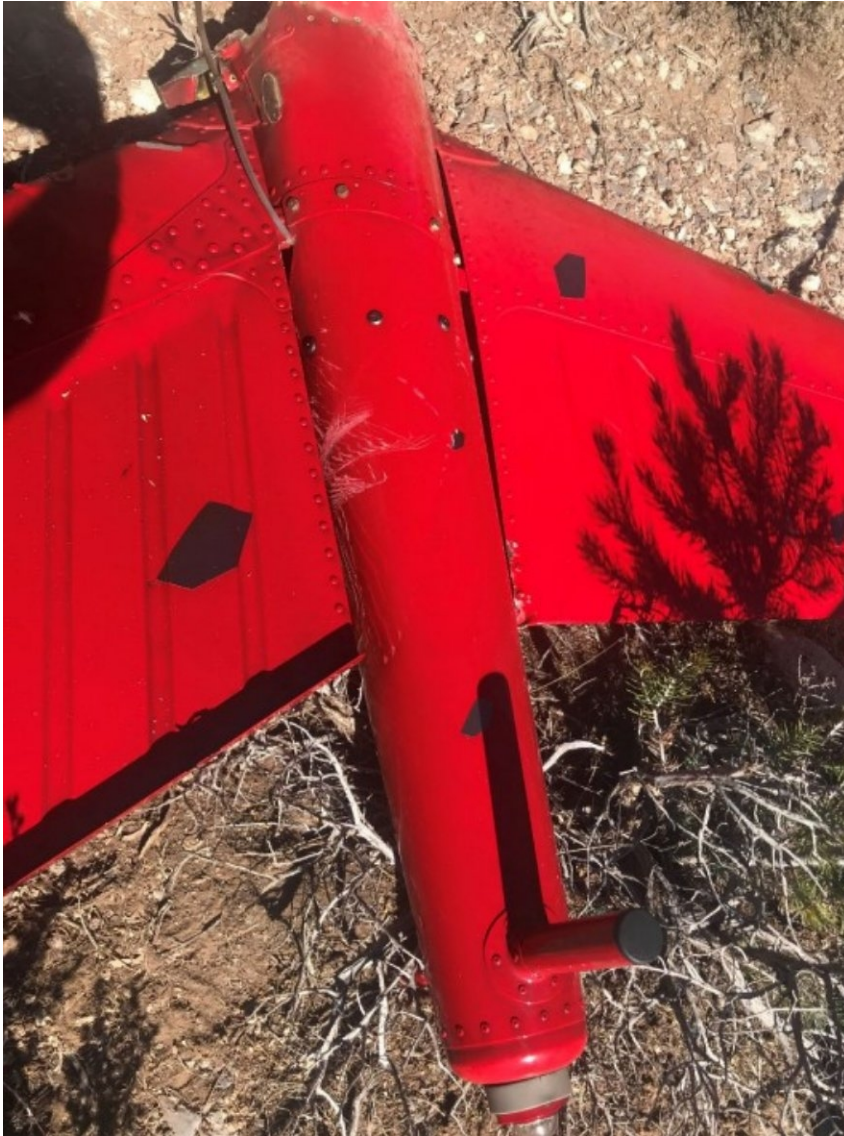
The aft tail cone was separated just forward of the vertical fin; the vertical fin remained attached. The assembly was found about 365 ft from the main wreckage. The tail cone and vertical fin trailing edge exhibited abrasions consistent with cable contact. (see Figure 2.)

Figure 2. Tail cone and vertical fin displaying cable abrasions
