Aviation Investigation Final Report

Location:	Glenwood Springs, Colorado	Accident Number:	CEN20LA345
Date & Time:	August 12, 2020, 08:00 Local	Registration:	N9726K
Aircraft:	Stinson 108	Aircraft Damage:	Substantial
Defining Event:	Loss of control on ground	Injuries:	2 None
Flight Conducted Under:	Part 91: General aviation - Personal

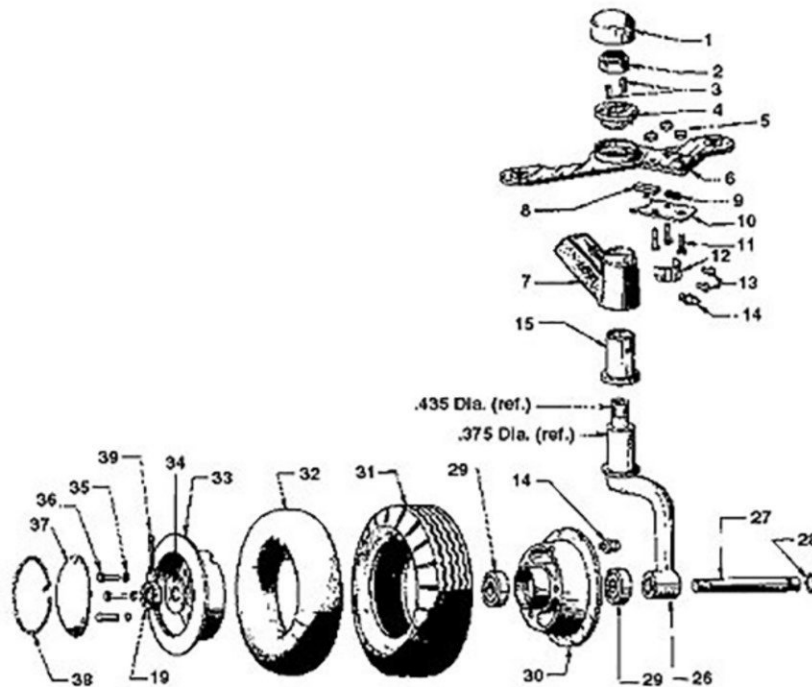
Figure 1: Maule Tailwheel Schematic

A post-accident examination revealed that the tailwheel locking pin was sheared, which allowed the tailwheel to rotate freely more than 90°. When the pin is not engaged, the fork would have the ability to rotate and pivot independently of the steering arm and rudder input, a condition known as free-castoring.

The pilot’s loss of directional control upon landing due to a sheared tailwheel locking pin.

A postaccident examination revealed that the tailwheel locking pin (item #8 in figure 1 below) was sheared, which allowed the tailwheel to rotate freely more than 90°. The locking pin, when properly functioning, locks the steering arm to the tailwheel fork assembly. When the pin is not engaged, the fork has the ability to rotate and pivot independently of the steering arm and rudder input, a condition known as free-castoring.
