Aviation Investigation Final Report

Location:	Ninilchik, Alaska	Accident Number:	ANC20LA083
Date & Time:	August 25, 2020, 07:00 Local	Registration:	N160SH
Aircraft:	Eurocopter AS350	Aircraft Damage:	Substantial
Defining Event:	Unknown or undetermined	Injuries:	1 Minor
Flight Conducted Under:	Part 135: Air taxi & commuter - Non-scheduled

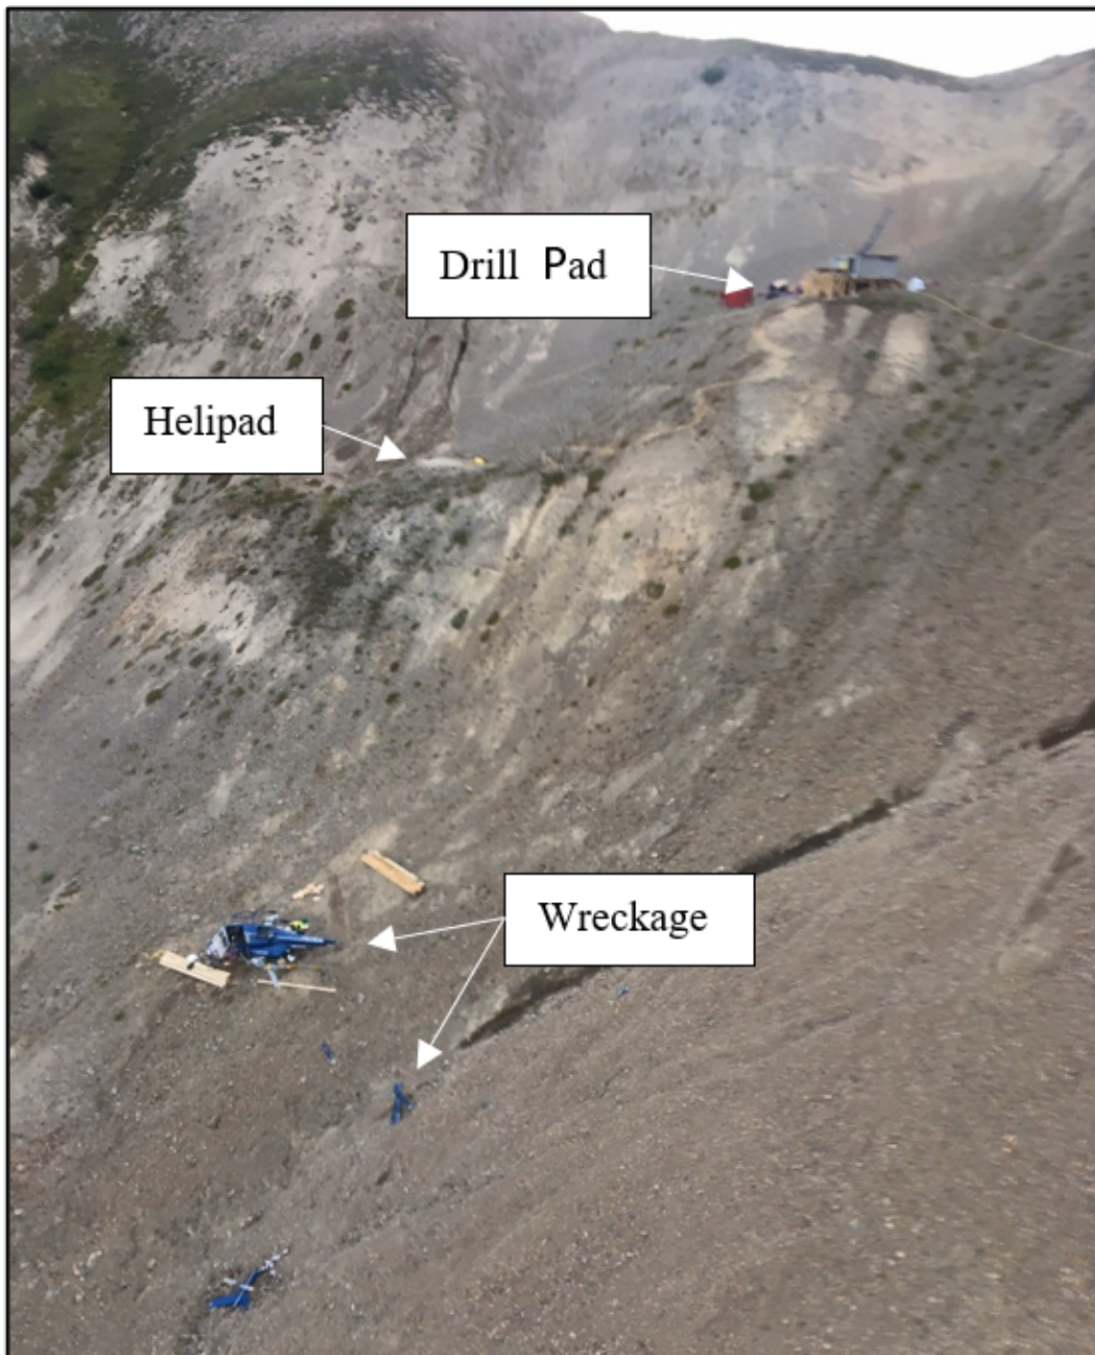
On the morning of the accident, the pilot departed the main camp about 0655 with 4 passengers and disembarked 2 of them at a low-elevation drill pad, and then he flew to a high mountainside helipad, which was located about 2,750 ft msl cut into a rocky steep slope and disembarked the other 2 passengers. He flew the helicopter to a nearby site and waited a short time for the off going workers to be ready for pick up. He departed and made another approach to the helipad. The pilot stated that when the helicopter was about 25 ft from the landing site, at very slow forward airspeed, the engine "flamed out" and the helicopter yawed right. Witnesses reported seeing a puff of smoke and hearing loud alarms when the engine lost power. The pilot continued the right turn, lowered the collective and attempted to autorotate to a level area about 600 ft below the helipad. When the pilot realized that the helicopter could not make the intended site, he slowed down by applying some aft cyclic and increasing collective to cushion the touchdown. The helicopter landed on the skids facing down the mountain and continued to slide. The left skid impacted a rock and the helicopter rolled over and continued down the mountain, resulting in the tail boom separating. The helicopter came to rest on a drill pad under construction about 200 ft below the helipad, on its left side. Refer to figure 1. The tail section, fuselage and main rotor blades sustained substantial damage. The mining workers at the helipad called for assistance, hiked down to the site, and assisted the pilot.

Figure 1. The accident site and wreckage. (Courtesy of Soloy Helicopters.)
