Aviation Investigation Final Report

Location:	Los Angeles, California	Accident Number:	DCA20LA138
Date & Time:	August 19, 2020, 04:47 Local	Registration:	N146FE
Aircraft:	Boeing 767	Aircraft Damage:	Substantial
Defining Event:	Sys/Comp malf/fail (non-power)	Injuries:	1 Serious, 1 None
Flight Conducted Under:	Part 121: Air carrier - Non-scheduled

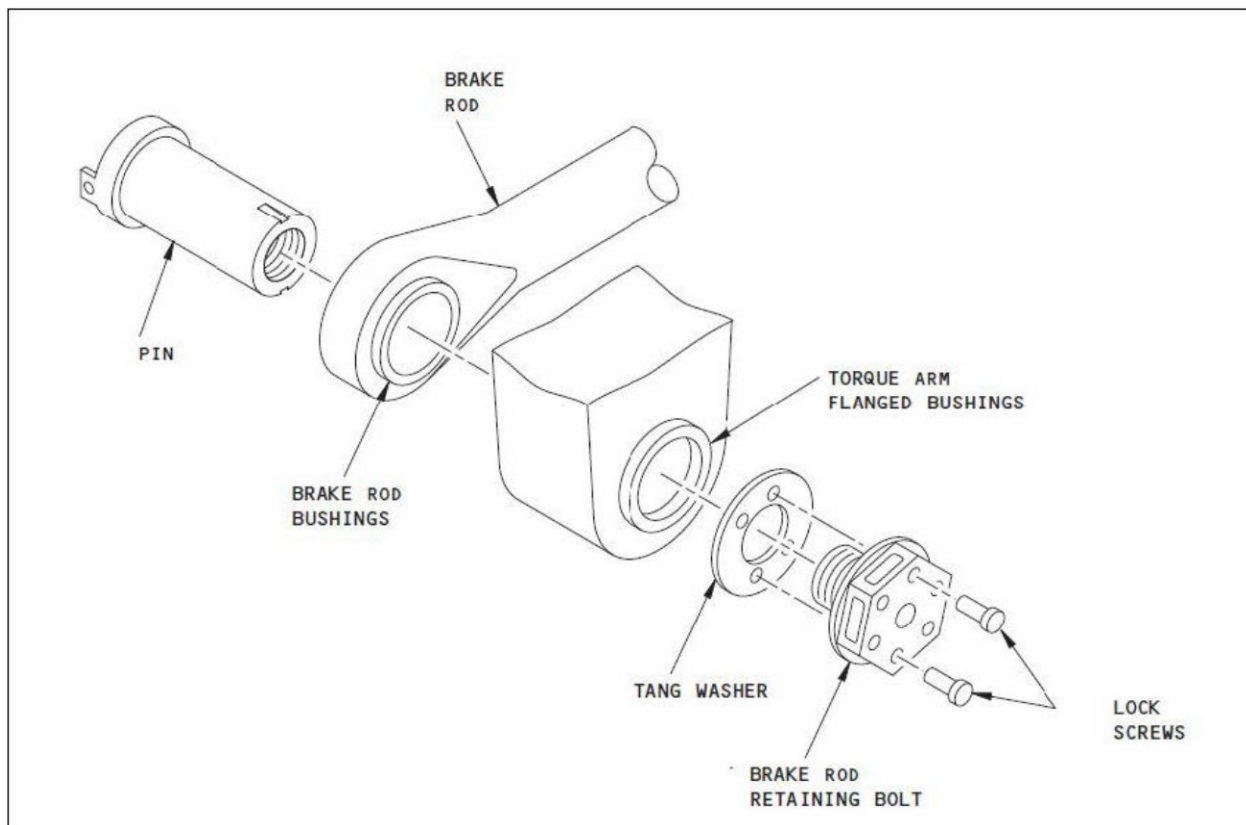
A brake rod, which is installed between each brake assembly housing and the shock strut, transfers the torque generated by the brake to the MLG. The brake rod is connected to the torque arm on the brake assembly housing using a pin, a tang washer, a retaining bolt, and two lock screws secured by safety wire, as shown in figure 1.

Figure 1. Brake rod attaching hardware. (Copyright © Boeing. Reproduced with permission.)

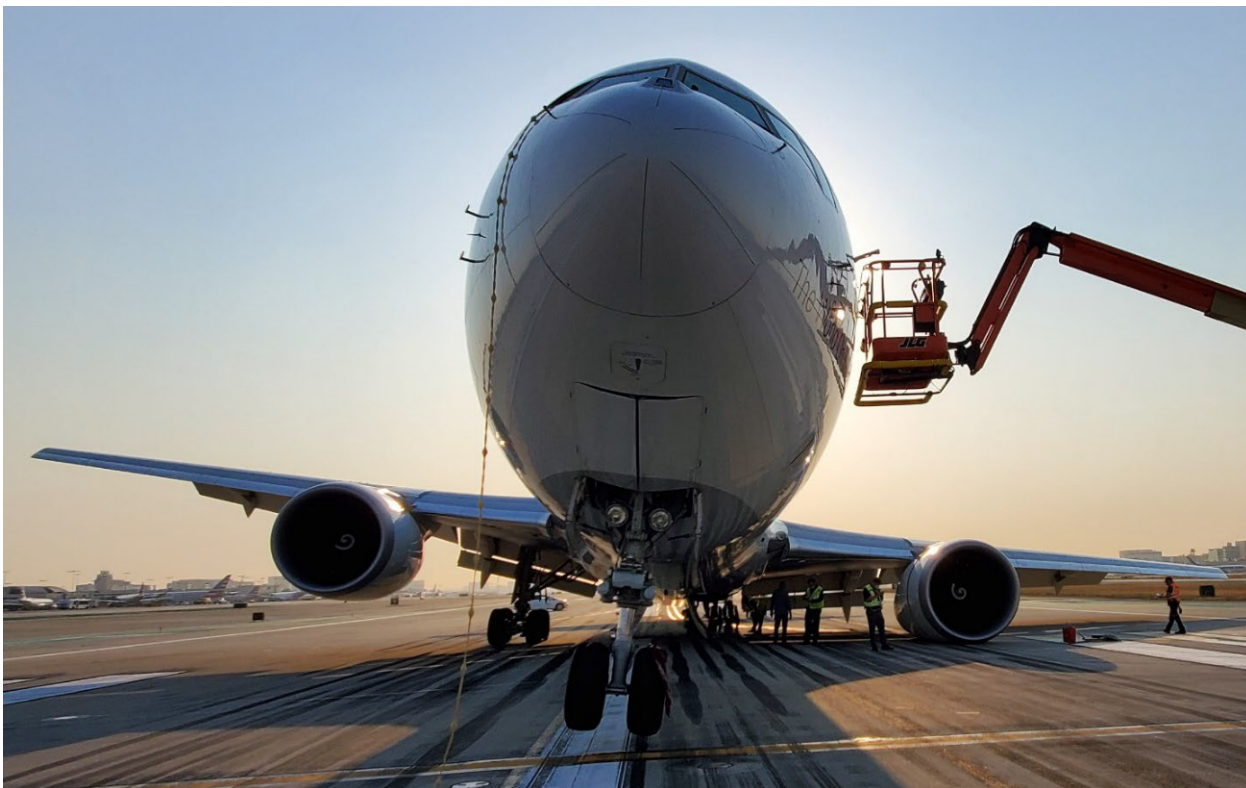
The airplane was found resting on the left engine nacelle and the right MLG (see figure 2), and the nose gear and tail were found suspended in the air. The left MLG door was open, but the left gear had not deployed.

Figure 2. Airplane after accident landing. (Copyright © Boeing. Reproduced with permission.)

The left engine cowlings and left MLG door were damaged from contact with the runway during the landing. Further examination revealed deformation of and cracking on the left engine pylon structure.

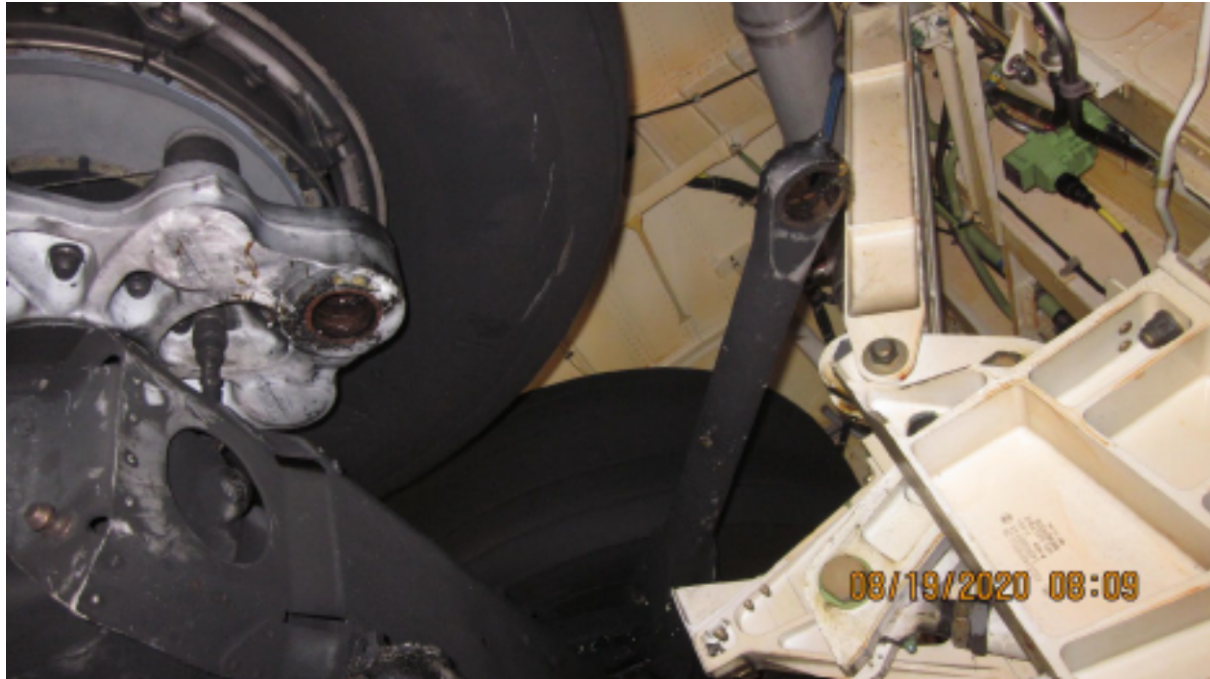
Examination of the left MLG assembly revealed that the No. 6 brake rod remained connected to the lugs on the shock strut but was not connected to the torque arm on the No. 6 brake assembly housing. All attaching hardware was missing. The brake rod was found “hung up” on the landing

gear upstop (see figure 3), which is inside the left landing gear bay. No damage was found on the brake assembly or the associated hydraulic line. EWR and LAX airport operations personnel performed a search of the departure and landing runways, respectively, and no brake rod attaching hardware components were found.

Figure 3. Location of brake rod during postaccident examination (Source: FedEx).

The No. 6 brake rod was examined by Boeing's Equipment Quality Analysis Laboratory. Visual examination of the No. 6 brake rod revealed shallow gouges and chipped paint on the forked end, consistent with the brake rod contacting and becoming hung up on the landing gear upstop. No evidence (scrape marks or gouging) indicated that the brake rod had previously contacted a runway during a takeoff or landing. All measurements of the brake rod end bores were found to be within specification drawing limits.

The damaged left MLG door was disabled, and the brake rod was secured to the brake assembly housing torque arm. Normal gear extensions and retractions and alternate gear extensions were then performed; no anomalies were identified.
