# Aviation Investigation Final Report

<b>Location:</b>	Ray, Michigan	<b>Accident Number:</b>	CEN20LA372
<b>Date &amp; Time:</b>	August 30, 2020, 12:00 Local	<b>Registration:</b>	N698D
<b>Aircraft:</b>	Cessna 414	<b>Aircraft Damage:</b>	Substantial
<b>Defining Event:</b>	Loss of control on ground	<b>Injuries:</b>	1 Minor
<b>Flight Conducted Under:</b>	Part 91: General aviation - Personal

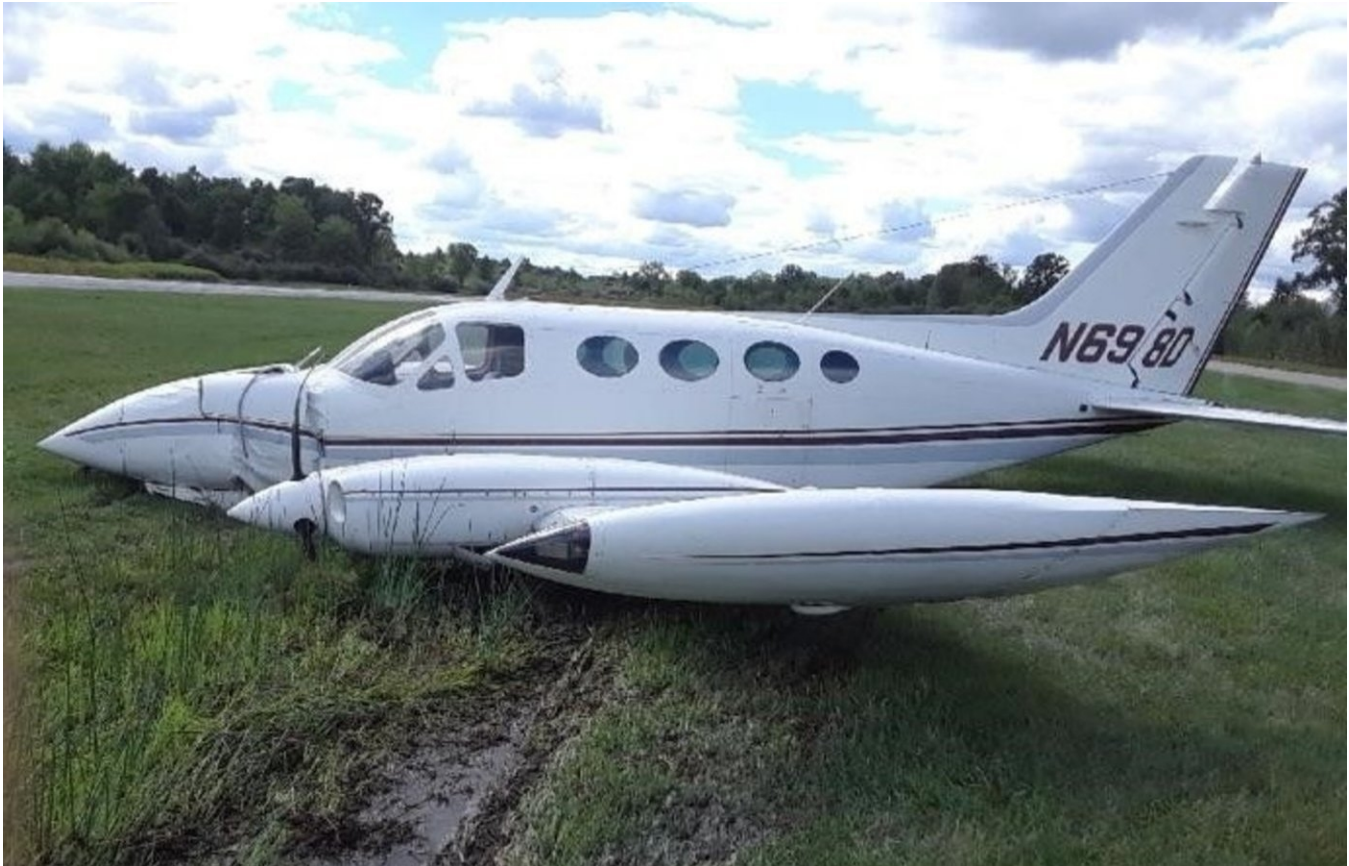
The airplane sustained substantial damage including crush damage to its forward fuselage and separation of the nose landing gear. A comprehensive determination of the airplane’s mechanical integrity prior to the accident could not be determined due to the damage to the damage to the forward fuselage and nose landing gear; however, no apparent pre-impact defects were noted.
