# Aviation Investigation Final Report

<b>Location:</b>	Weston, Florida	<b>Accident Number:</b>	ERA20LA327
<b>Date &amp; Time:</b>	September 9, 2020, 09:35 Local	<b>Registration:</b>	N120GX
<b>Aircraft:</b>	Mooney M20R	<b>Aircraft Damage:</b>	Substantial
<b>Defining Event:</b>	Loss of engine power (total)	<b>Injuries:</b>	2 None
<b>Flight Conducted Under:</b>	Part 91: General aviation - Personal

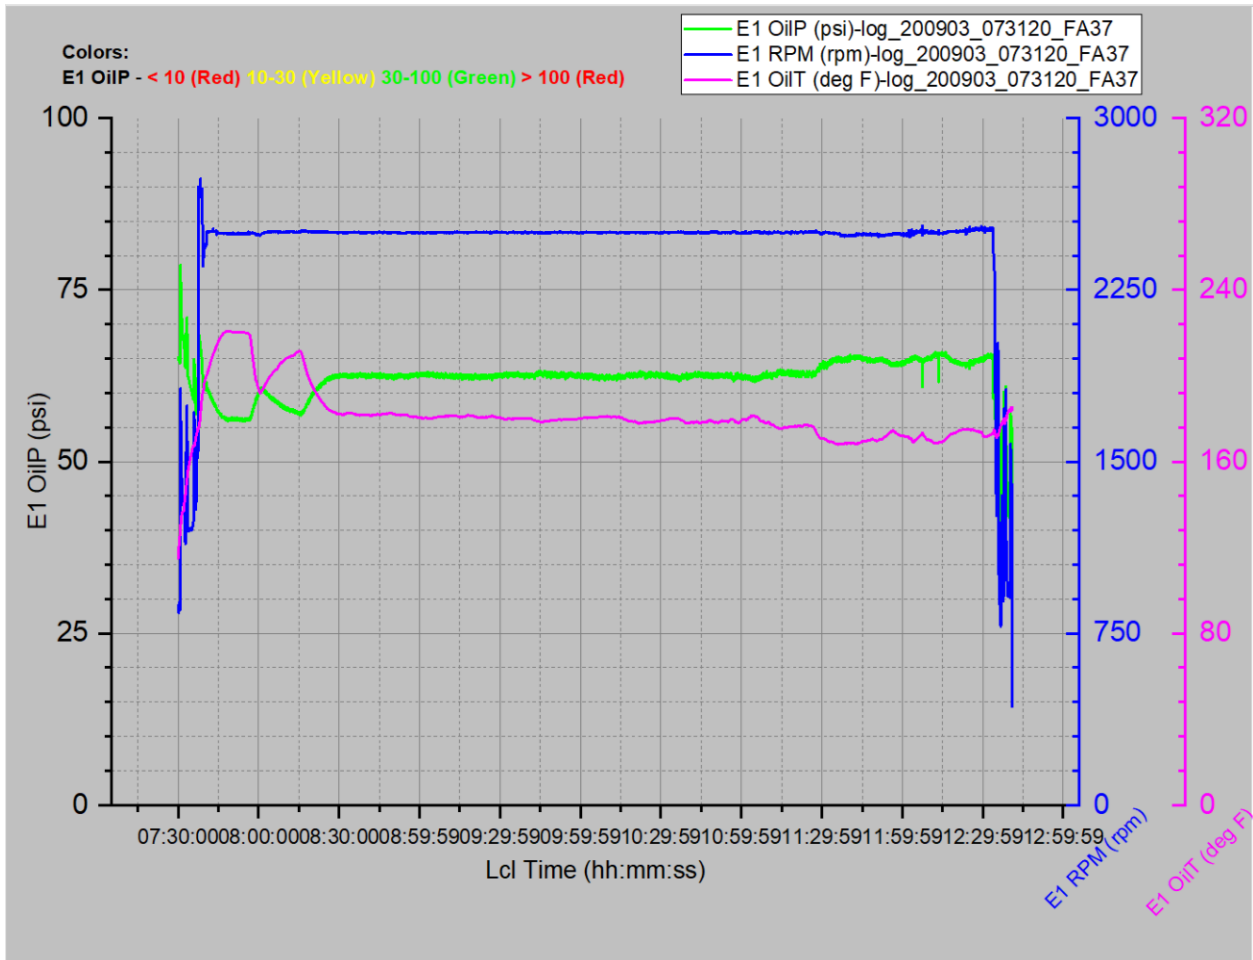
Figure 1 - Engine Oil Pressure - Typical Flight

The airplane was equipped with electronic primary and multifunction displays, which recorded flight data to an on-board memory card. A review of the data from 34 previous flights revealed that during cruise flight, the engine oil pressure was typically between 60 and 65 psi, and consistent. Any fluctuations in cruise flight were normally concurrent with a change in engine rpm or oil temperature. Figure 1 shows the engine rpm, oil pressure and temperature for a typical flight.

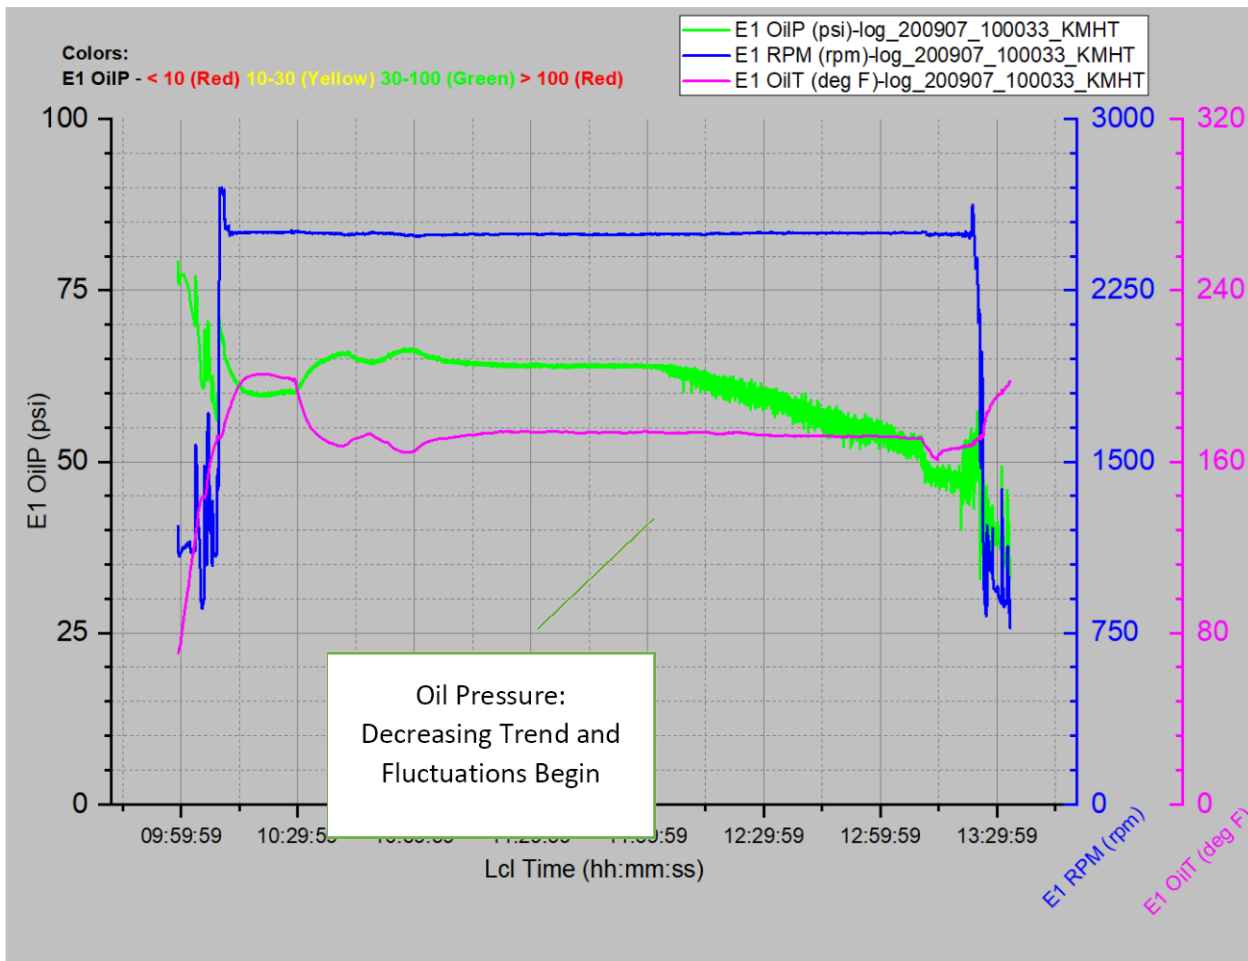
Figure 2 – Engine Oil Pressure - Data from 2nd Previous Flight Prior to Accident Flight

A review of data recorded by the airplane’s avionics system revealed that during two previous legs of the cross-country trip the oil pressure began to gradually decrease and fluctuate about midway through each flight. During the last leg, the oil pressure decreased continuously throughout the entire flight. During the accident flight, the oil pressure remained in the green range until just prior to the loss of engine power.

Beginning with the 3<sup>rd</sup> previous flight (which occurred 6 days prior to the accident), the recorded data for engine oil pressure deviated from the preceding typical trends. During the 3<sup>rd</sup> and 2<sup>nd</sup> previous flights, the oil pressure began to decrease about halfway through the flight, without an accompanying change in oil temperature or engine rpm. Additionally, during the decreasing trend, the oil pressure data became “noisy”, exhibited by high frequency fluctuations in the recorded pressure. These trends continued for the remainder of both these flights. The decrease in pressure was gradual, dropping 15-20 psi over about 90 minutes, reaching about 45 psi by the end of the cruise. A review of the data from 31 flights prior to this time revealed that the oil pressure was not below 60 psi during the cruise phase. Figure 2 shows the data from the 2<sup>nd</sup> previous flight.

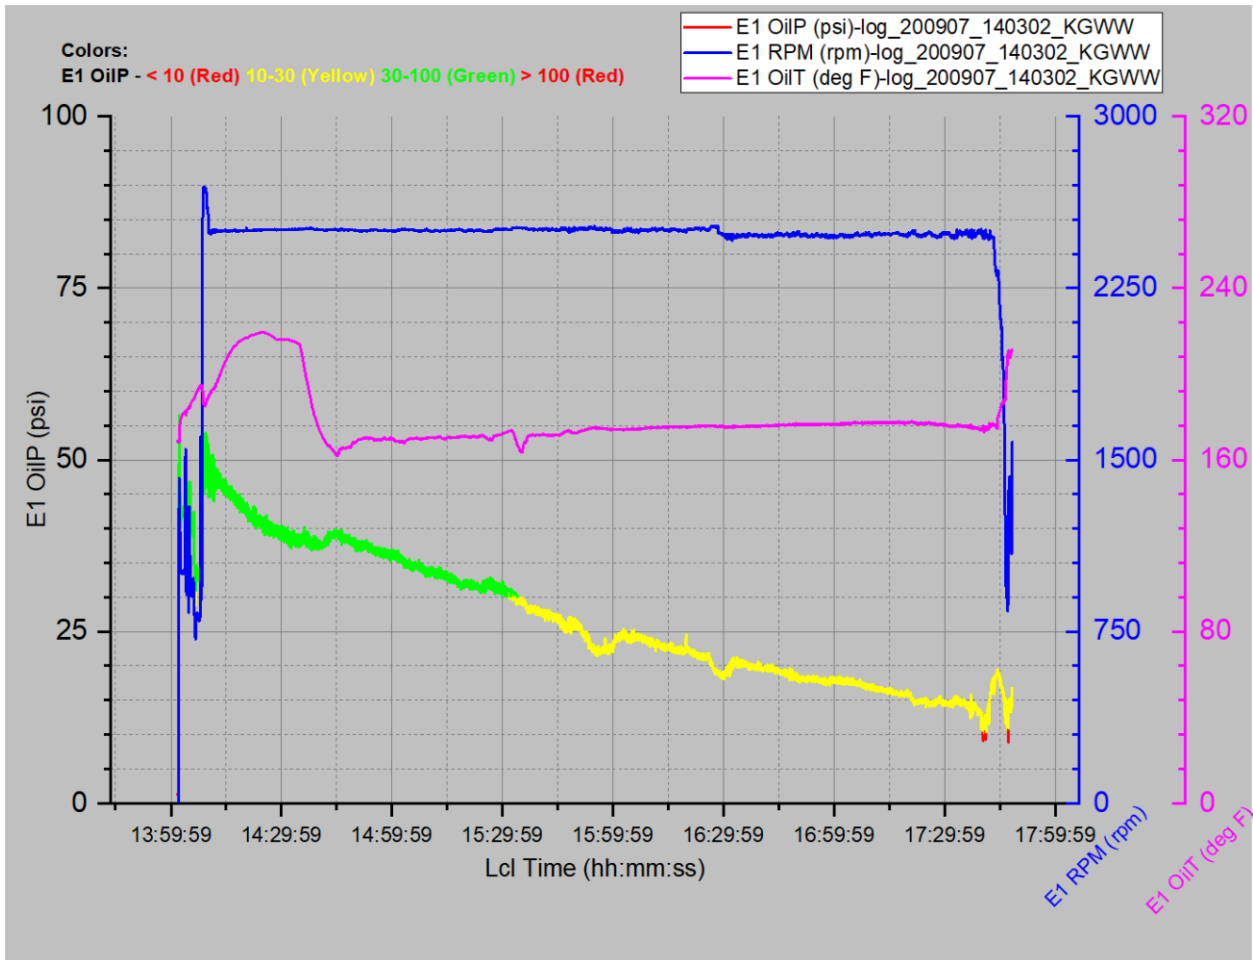
Figure 3 Engine Oil Pressure - Data from Flight Prior to Accident Flight

During the flight prior to the accident, the oil pressure did not reach the typical 60-65 psi during cruise, and it decreased throughout the entire flight. About 1/3 of the way through the flight, the pressure fell into the yellow range of the oil pressure gauge (10-30 psi). It continued to decrease until it briefly reached the lower red range (<10 psi) twice, near the end of the flight. Figure 3 shows the data from the previous flight.

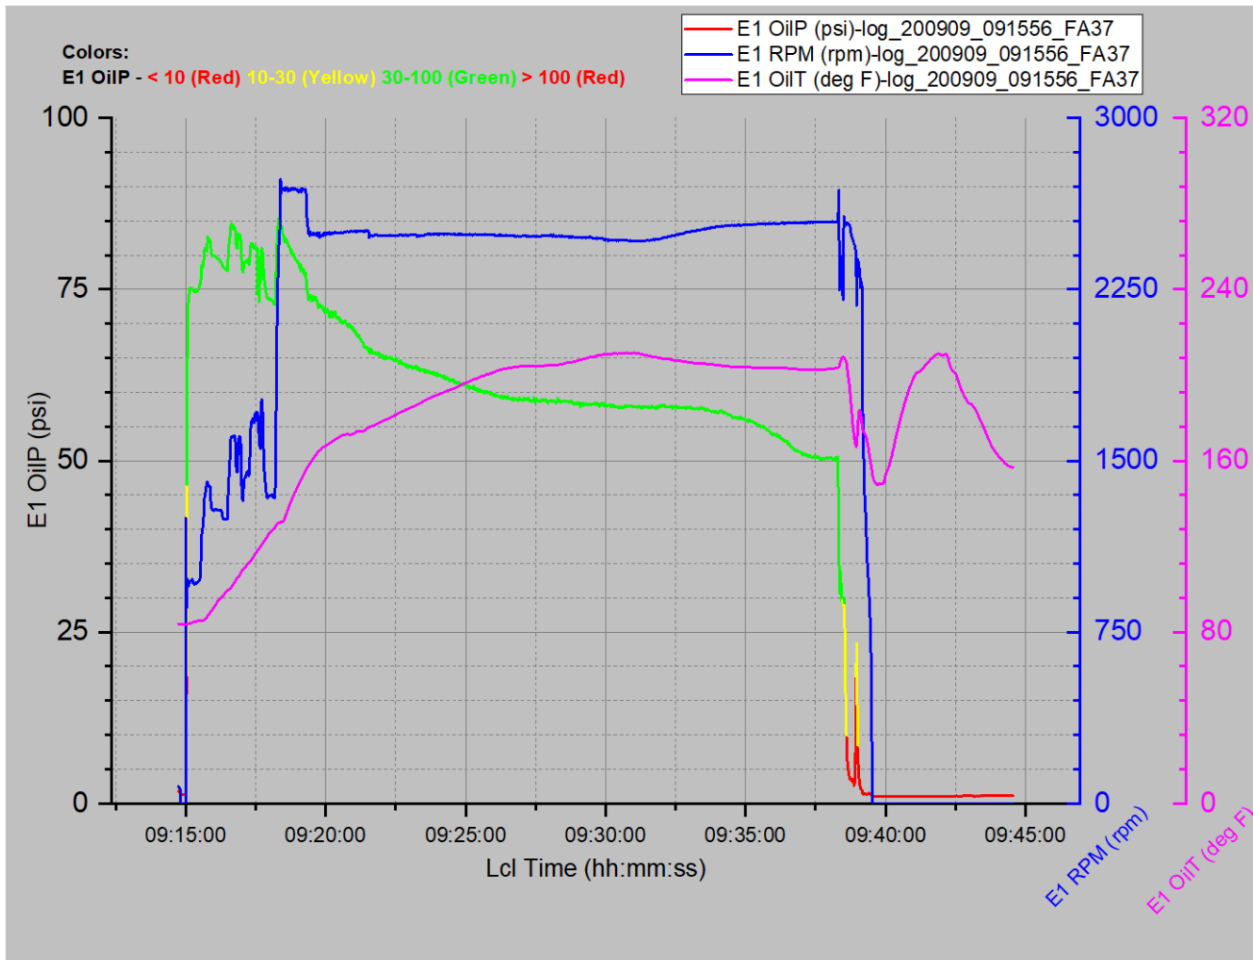
Figure 4 Engine Oil Pressure - Data from Accident Flight

A total loss of engine power because of the overheating and failure of the connecting rod bearings due to a lack of lubrication for reasons that could not be determined.

During the accident flight, the oil pressure was generally more consistent with a typical flight, with a decrease (about 7-8 psi) over the 3 minutes prior to the loss of engine power. Figure 4 shows the data from the accident flight.

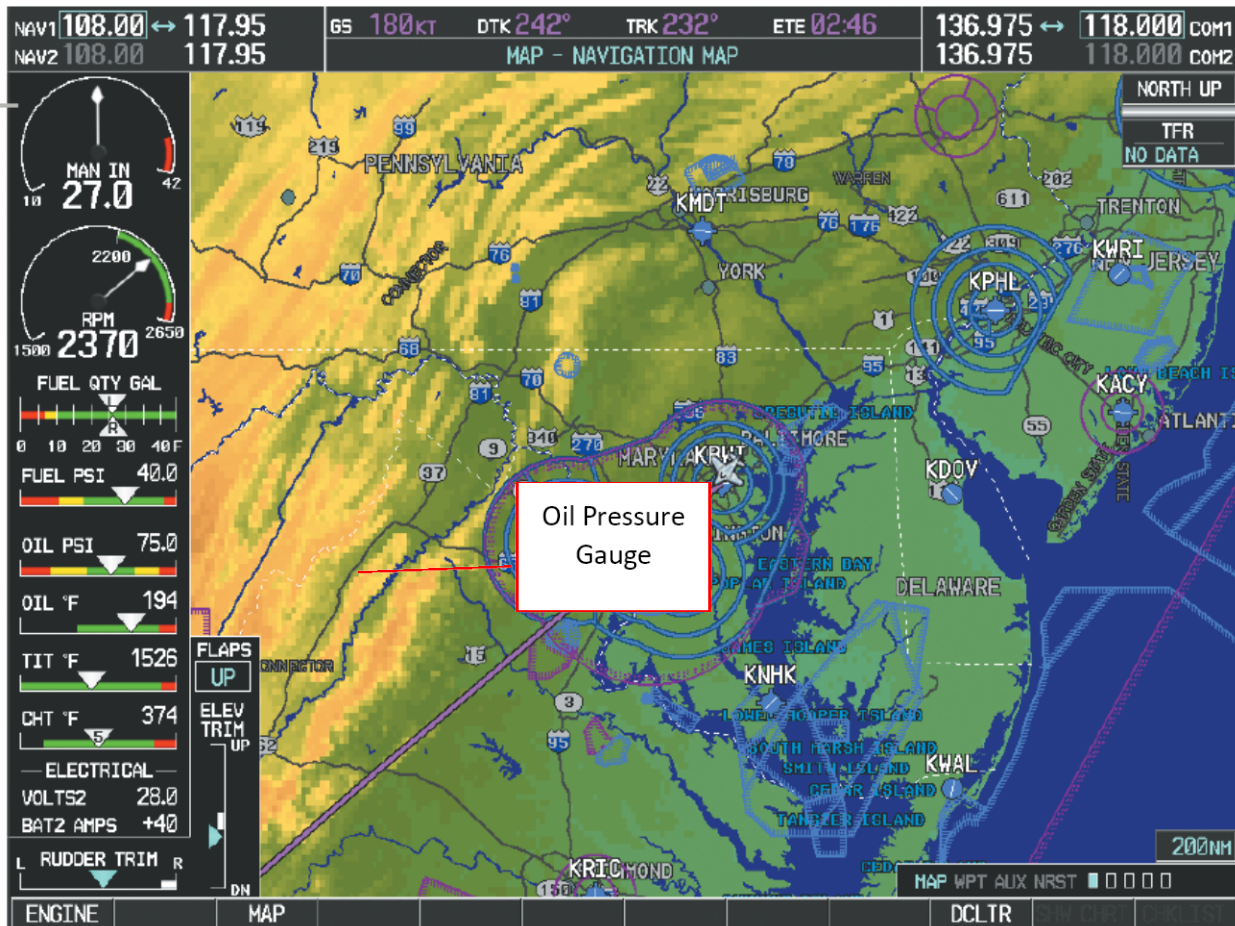
Figure 5 - Exemplar MFD Display (Mooney M20M)

Oil pressure and other engine indications are displayed on the airplane’s multifunction display (MFD). While this display is used for many different functions, engine data are typically depicted on the left side of the screen as shown in an exemplar image in figure 5. In some cases, such as when using the ‘lean’ function, the oil pressure gauge is not depicted. According to the MFD pilot’s guide:

The pilot’s guide did not specify whether the oil pressure indicator would flash if the oil pressure value fell within the yellow range.
