# Aviation Investigation Final Report

<b>Location:</b>	Centerville, Maryland	<b>Accident Number:</b>	ERA20LA341
<b>Date &amp; Time:</b>	September 28, 2020, 18:00 Local	<b>Registration:</b>	N562TU
<b>Aircraft:</b>	Tecnam P92	<b>Aircraft Damage:</b>	Substantial
<b>Defining Event:</b>	Loss of engine power (total)	<b>Injuries:</b>	2 None
<b>Flight Conducted Under:</b>	Part 91: General aviation - Instructional

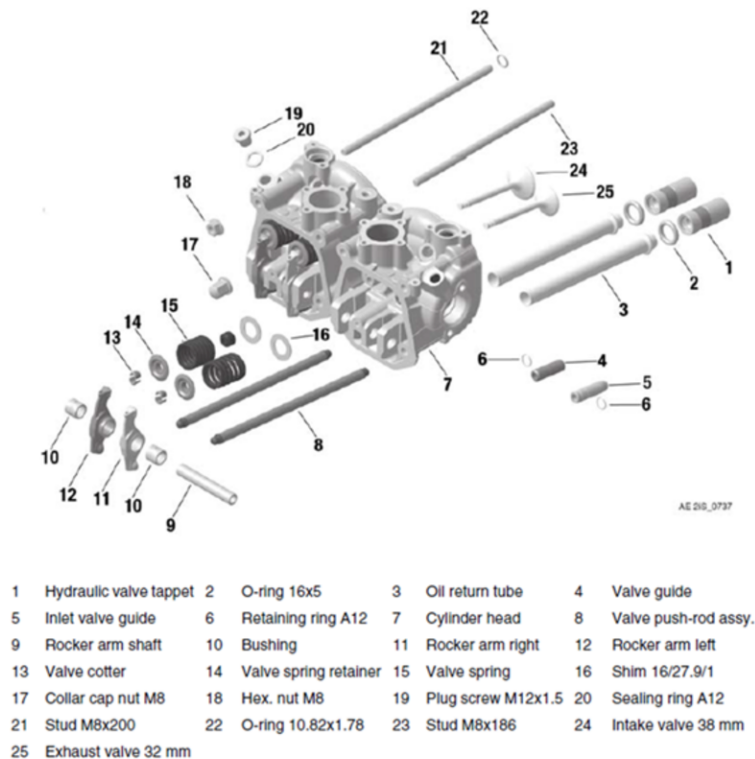
Review of the Rotax 912 Heavy Maintenance Manual 72-00-00, Edition 1, Revision 4, page 69, revealed that wear of "the valve spring support can indicate a malfunction of the valve train as a result of badly or insufficiently vented hydraulic valve tappets." Figure 1 shows the components of the engine valvetrain.

Figure 1. Illustration of components of the engine valvetrain.
