Aviation Investigation Final Report

Location:	Tok, Alaska	Accident Number:	ANC20LA100
Date & Time:	September 30, 2020, 19:40 Local	Registration:	N926LL
Aircraft:	Cessna 180	Aircraft Damage:	Substantial
Defining Event:	Loss of control on ground	Injuries:	1 None
Flight Conducted Under:	Part 91: General aviation - Personal

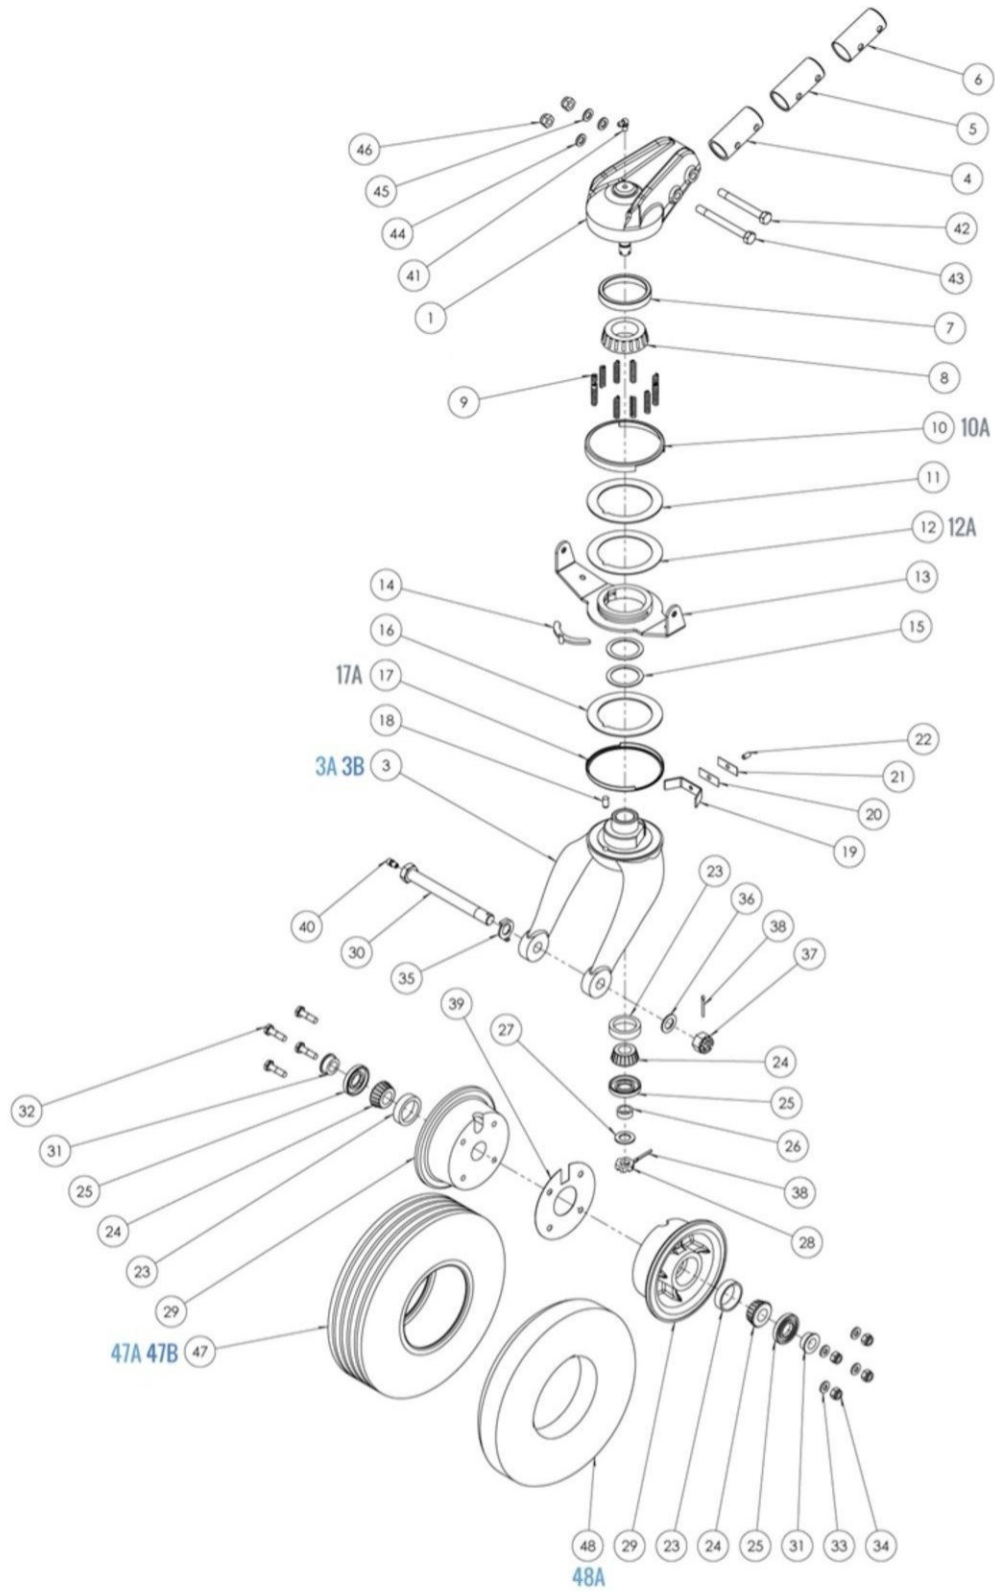
Figure 1 - Scott 3400 series tailwheel parts illustration.

A postaccident examination revealed excessive wear, damage, and a missing component inconsistent with proper tailwheel maintenance occurring the day before the accident.

The mechanic’s failure to properly repair the tailwheel, which resulted in a malfunction of the tailwheel and a loss of directional control.

A postaccident examination revealed that the tailwheel rotated freely to the right but was very stiff and difficult to rotate to the left. Disassembly of the tailwheel revealed that the steering arm inside radius (item #13 in figure 1 below) was heavily scored and worn. The compression spring (item #19 in figure 1 below) had sharp and damaged edges on the ends of the spring, and the spacer (item #20 or #21 in figure 1 below) was not present, which allowed for excessive movement of the spring in its assembly.
