Aviation Investigation Final Report

Location:	Woodbranch, Texas	Accident Number:	CEN21FA026
Date & Time:	October 25, 2020, 08:37 Local	Registration:	N26136
Aircraft:	Grumman AA5	Aircraft Damage:	Destroyed
Defining Event:	Loss of control in flight	Injuries:	2 Fatal
Flight Conducted Under:	Part 91: General aviation - Personal

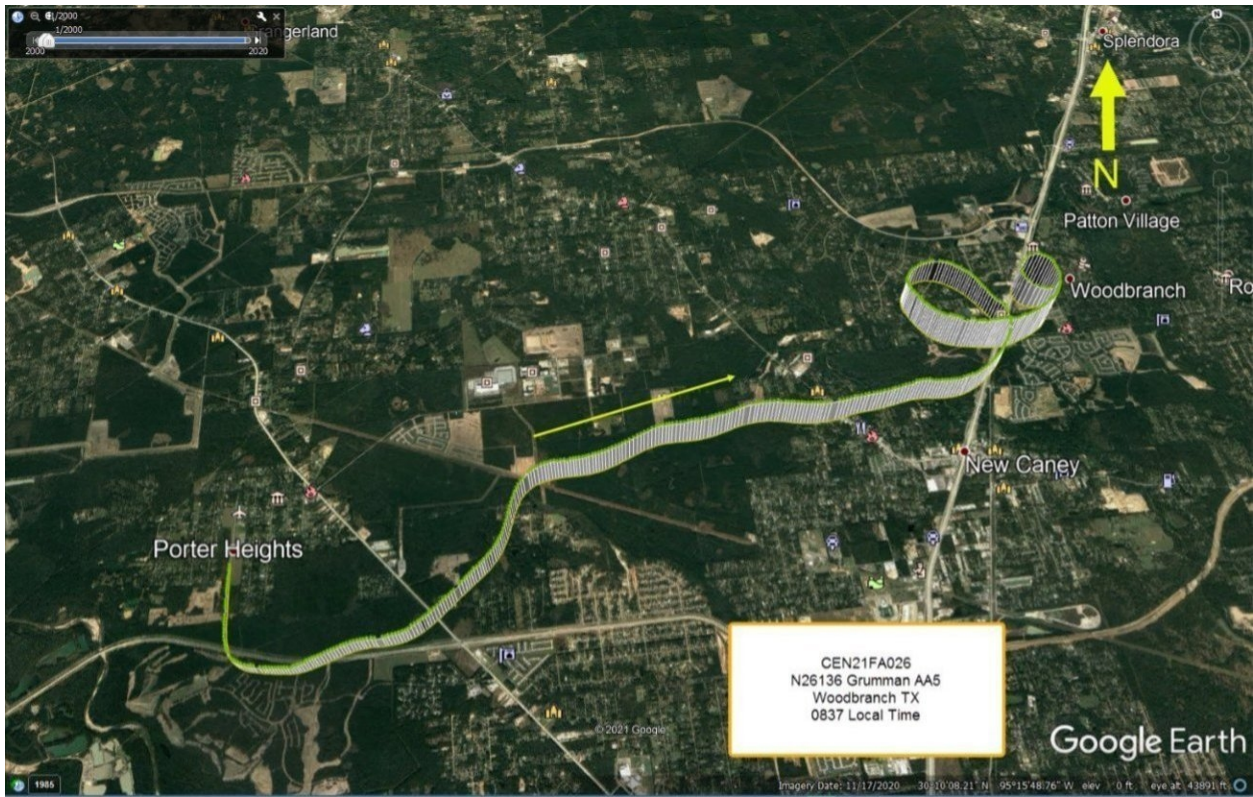
Figure 1. ADS-B Flight Track.

Simultaneous loss of radar and radio communications occurred with the airplane headed east. At 0837:54, the ATC controller advised the pilot that radar contact was lost. There were no radio distress calls heard from the pilot. The estimated flight path is depicted in Figures 1 and 2.

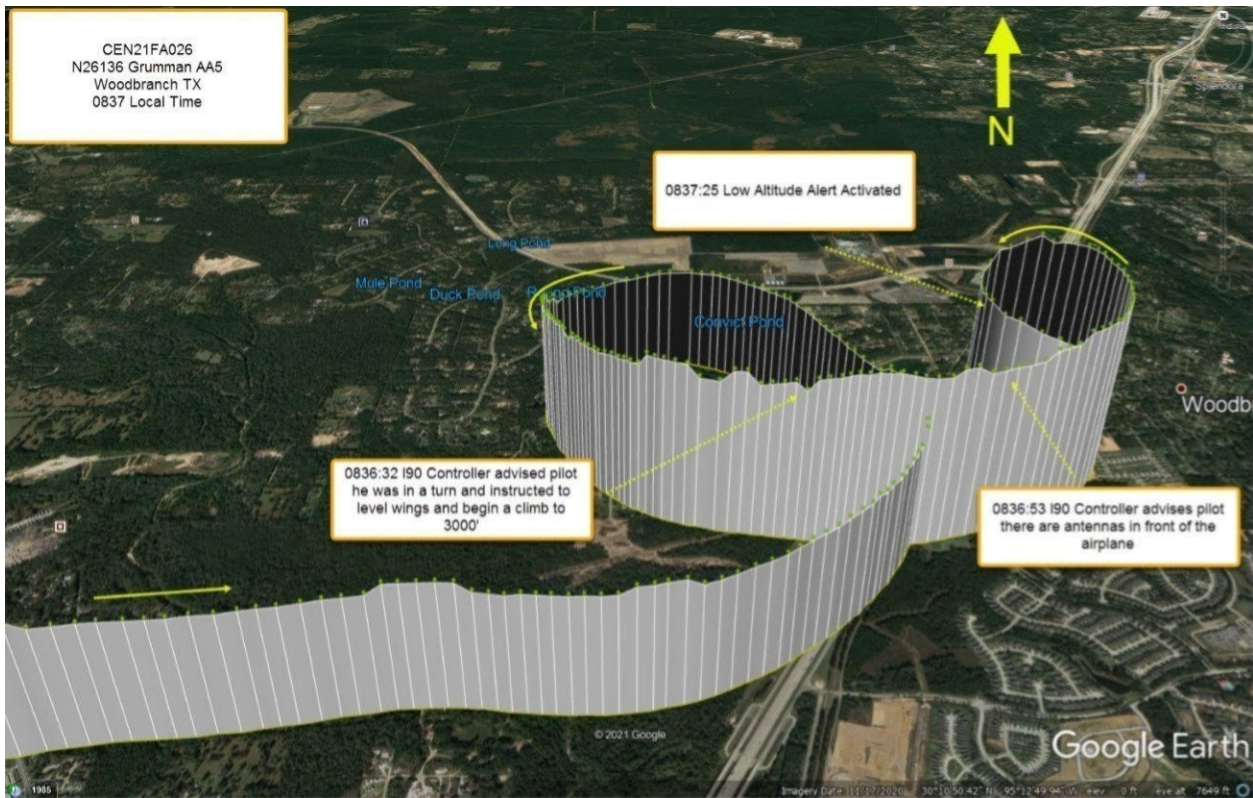
Figure 2. ADS-B Depiction of the End of the Flight Track.

The ATC controller cleared the airplane to T78 via radar vectors and instructed the pilot to climb to 3,000 ft and fly a heading of 270°. The airplane made a left turn to a northeast heading when the controller instructed them to stop their turn and climb to 3,000 ft. The airplane climbed through 2,200 ft when the ATC controller advised the pilot of antennas in front of them and again instructed him to climb to 3,000 ft. The airplane climbed to 2,400 ft, continued a turn left, and then descended rapidly. At 0836:53, the controller's Low Altitude Aural and Visual Alert activated as the airplane descended through 1,900 ft. The ATC controller informed the pilot of the alert, to check his altitude, and that he appeared to be in a spiraling left hand turn. He then instructed the pilot to level his wings and stop his descent.

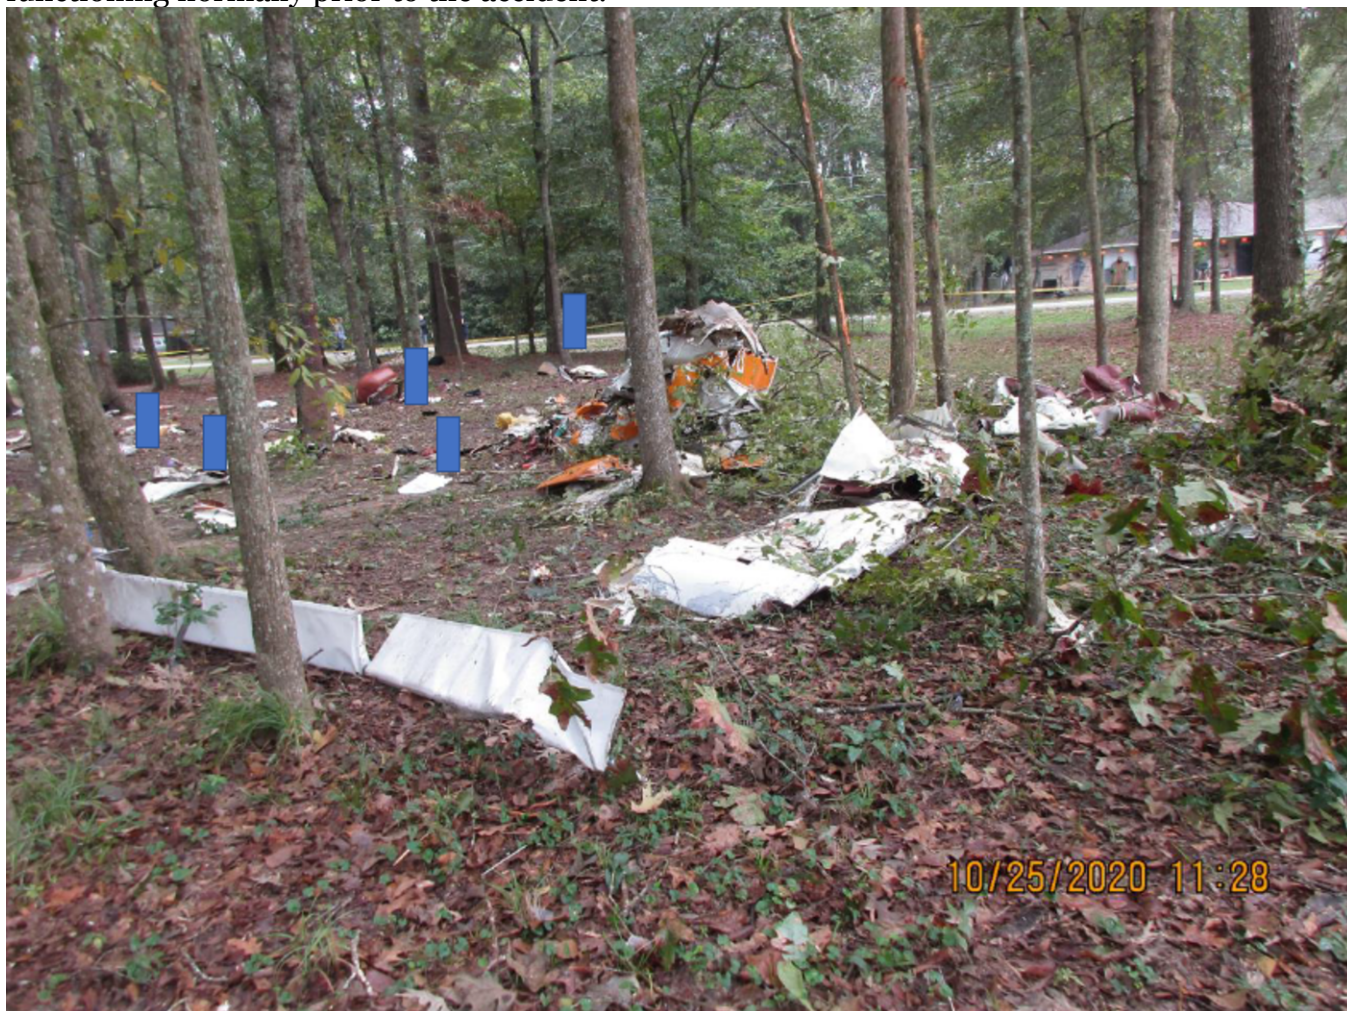
Figure 3. Accident Site. Boxes Shown Covers Sensitive Material

The accident site was located in a wooded area which bordered a residential neighborhood, about 8 miles east of 9X1. A photograph of the accident scene is at Figure 3. The elevation of the accident site was about 95 ft and the terrain was predominately flat. The airplane wreckage showed evidence of a nearly vertical impact. Several trees in the immediate vicinity of the airplane’s fuselage showed impact damage. One tree had a piece of airplane metal embedded in it. The airplane’s engine was embedded in the ground. The forward fuselage, cabin, baggage compartment, aft fuselage, and empennage were crushed aft and fragmented. Both wings were separated from the fuselage and broken in several sections. The broken wing sections showed aft crush impact damage spanning the leading edges. The propeller was fractured torsionally at the flange and both blades showed S-bending, leading edge gouges, and chordwise scratches. A postaccident examination of the airframe, engine, and vacuum system revealed no mechanical malfunctions or failures that would have precluded normal operation. Further examination of the

attitude and heading indicators and the turn coordinator showed these instruments were functioning normally prior to the accident.
