Aviation Investigation Final Report

Location:	Los Angeles, California	Accident Number:	WPR21LA039
Date & Time:	November 6, 2020, 15:00 Local	Registration:	N109EX
Aircraft:	Agusta A109	Aircraft Damage:	Substantial
Defining Event:	Flight control sys malf/fail	Injuries:	2 Serious, 1 Minor
Flight Conducted Under:	Part 135: Air taxi & commuter - Non-scheduled - Air Medical (Organ transport)

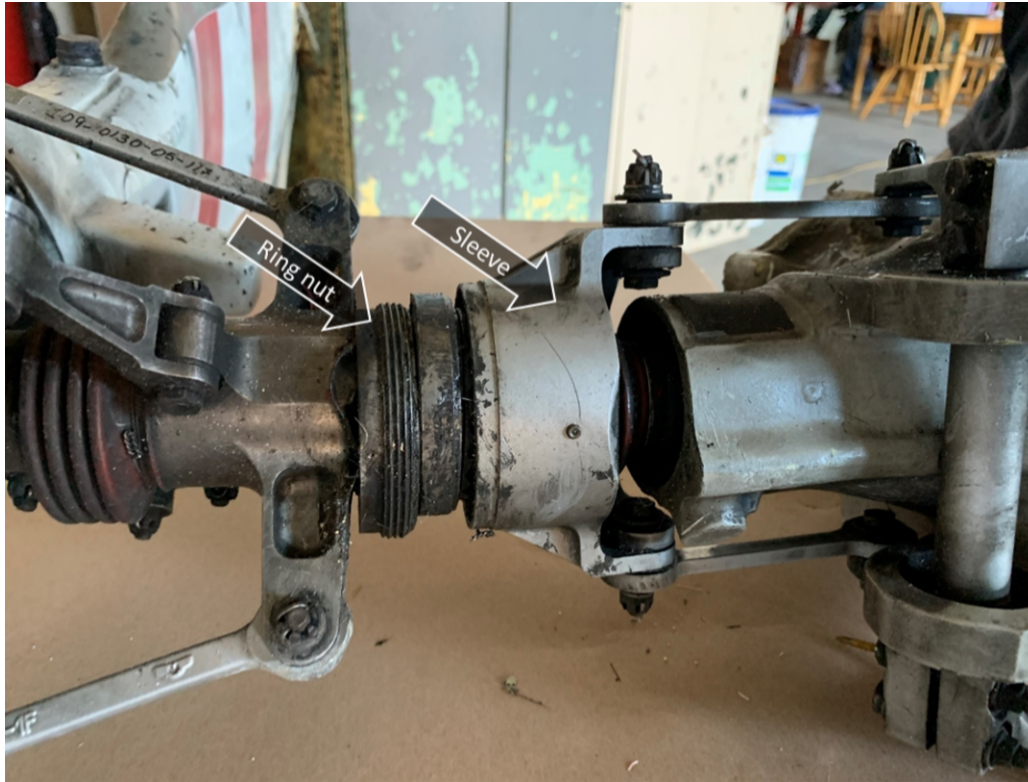
The loss of tail rotor control due to the separation of the tail rotor duplex bearing ring nut from the thrust sleeve, which resulted in the loss of helicopter control.

Examination of the tail rotor assembly rotating controls revealed that the ring nut was separated from the thrust sleeve assembly (figure 1.). No other mechanical malfunctions or failures were found with the helicopter that would have precluded normal operations.

Figure 1. Photo of the tail rotor rotating controls, showing the ring nut, and thrust sleeve. Photo courtesy of the Federal Aviation Administration (FAA).
