Aviation Investigation Final Report

| Location: | Los Angeles, California | Accident Number: | WPR21LA039 |
| Date & Time: | November 6, 2020, 15:00 Local | Registration: | N109EX |
| Aircraft: | Agusta A109 | Aircraft Damage: | Substantial |

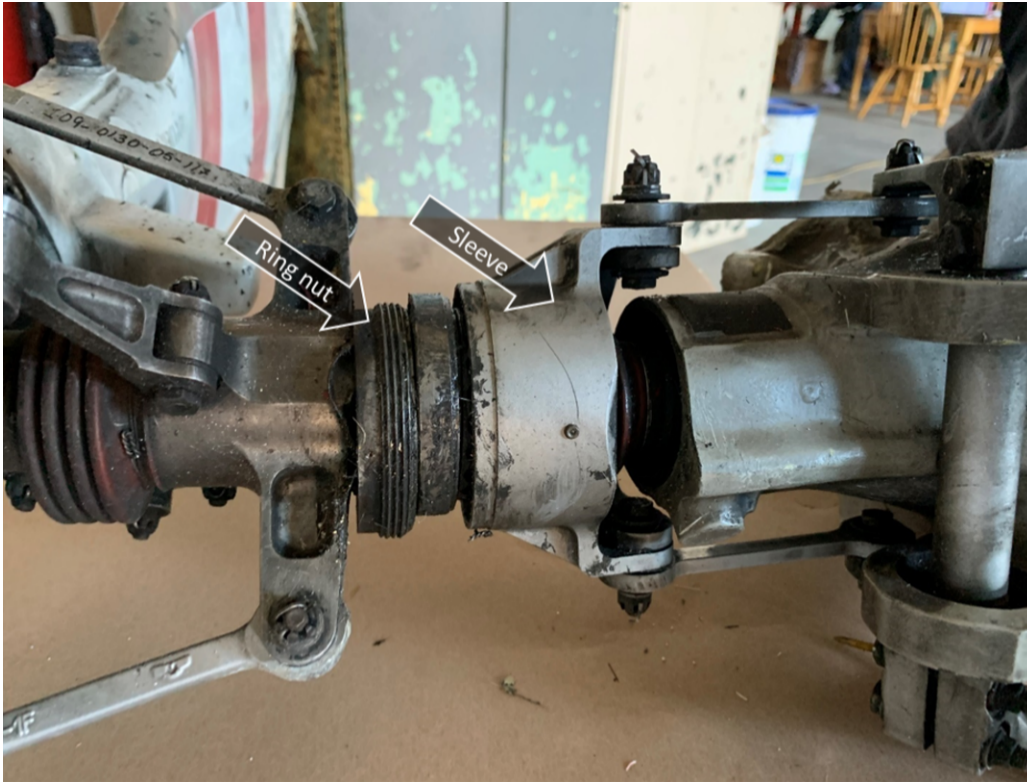
The loss of tail rotor control due to the separation of the tail rotor duplex bearing ring nut from the thrust sleeve, which resulted in the loss of helicopter control.

Examination of the tail rotor assembly rotating controls revealed that the ring nut was separated from the thrust sleeve assembly (figure 1.). No other mechanical malfunctions or failures were found with the helicopter that would have precluded normal operations.

Figure 1. Photo of the tail rotor rotating controls, showing the ring nut, and thrust sleeve. Photo courtesy of the Federal Aviation Administration (FAA).

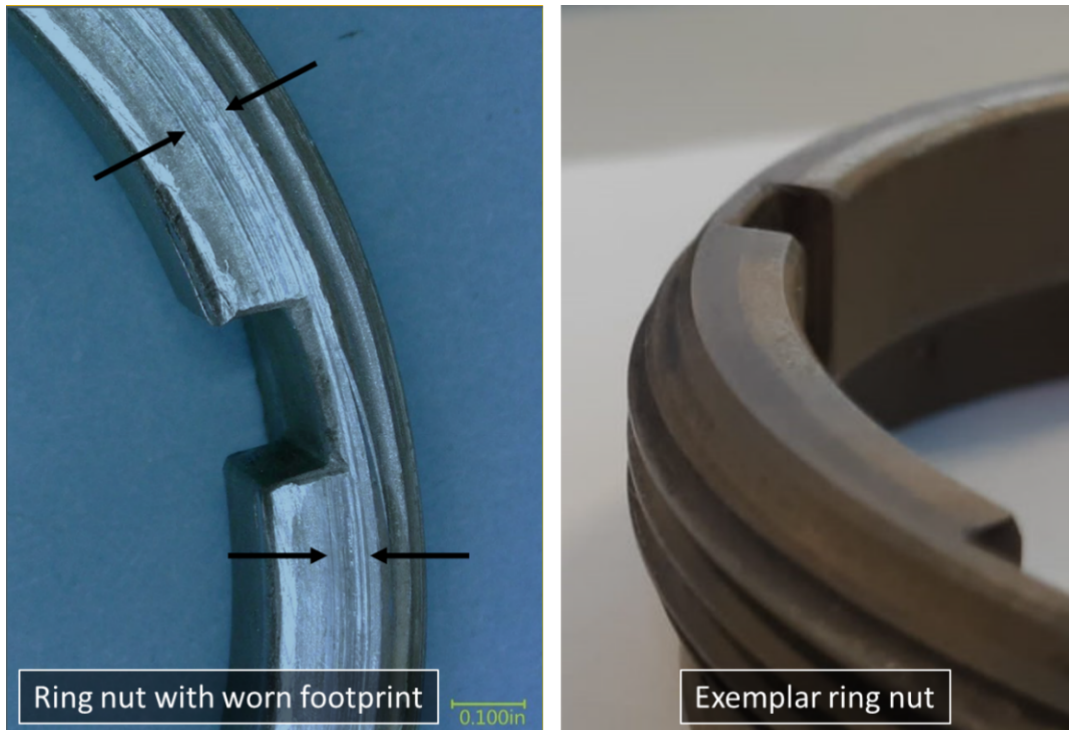
Examination of the tail rotor assembly and 90° gearbox by the National Transportation Safety Board (NTSB) Materials Laboratory revealed a step, or worn footprint, in the bottom surface of the ring nut at the outside diameter edge (figure 2). The threads of the outer diameter of the ring nut and the inner diameter of the thrust sleeve appeared intact. Examination of the grease for trace amounts of required locktite were inconclusive.

Figure 2. Image showing the step or worn footprint on the accident ring nut, and an exemplar ring nut. Photo of the exemplar ring nut courtesy of Leonardo Helicopters.

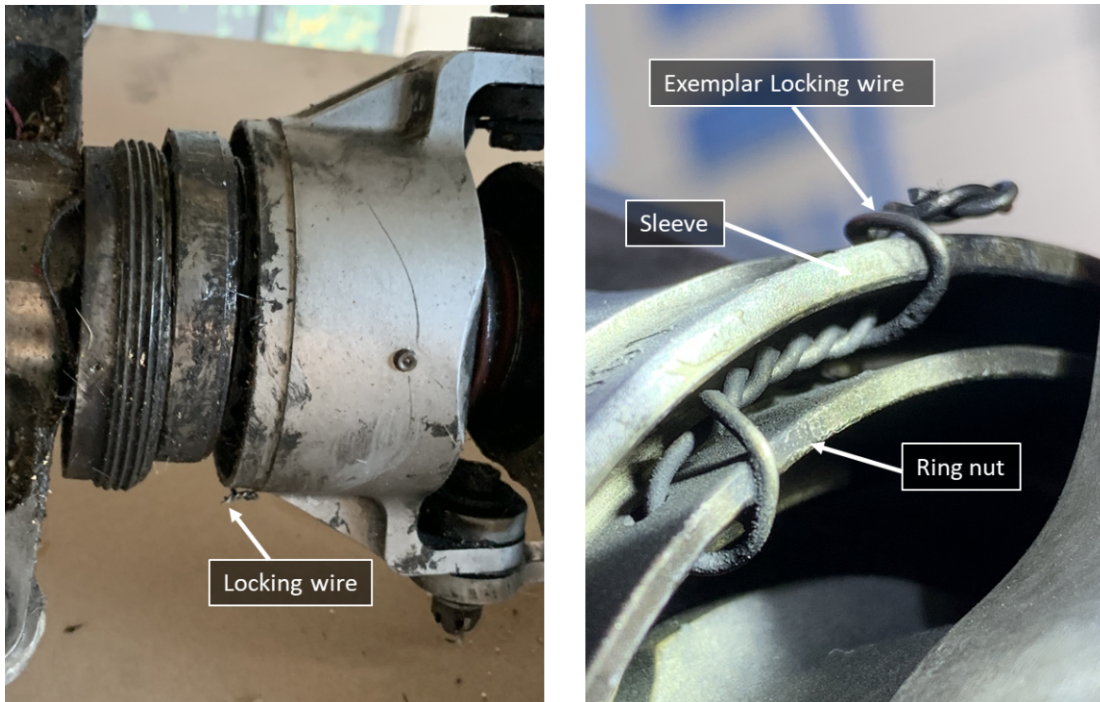
The accident pilot had signed off the tail rotor lockwire inspection on November 6, 2020, at 1120 hours. Prior to that, the previous pilot had signed off the tail rotor lockwire inspection on November 6, 2020, at 0400 hours. Postaccident photos show that part of one locking wire remained attached to the thrust sleeve (Figure 3).

Figure 3. The left photo shows part of one locking wire attached to the accident sleeve, and the right photo shows an exemplar locking wire from a different helicopter. (Photo of the accident ring and sleeve, courtesy of the FAA)

According to the manufacturer a new tail rotor dual lock duplex bearing support has been developed that incorporates a more robust locking system and is compatible with the current duplex bearing. The target for certification is the fourth quarter of 2022 and will be retrofit through service bulletins.
