Aviation Investigation Final Report

Location:	Atlanta, Georgia	Accident Number:	ERA21LA056
Date & Time:	November 25, 2020, 00:09 Local	Registration:	N8125U (A1); N777CM (A2)
Aircraft:	Cessna 172 (A1); Aero Commander 500 (A2)	Aircraft Damage:	Substantial (A1); Minor (A2)
Defining Event:	Collision during takeoff/land	Injuries:	1 None (A1); 1 None (A2)
Flight Conducted Under:	Part 91: General aviation - Personal (A1); Part 135: Air taxi & commuter - Non-scheduled (A2)

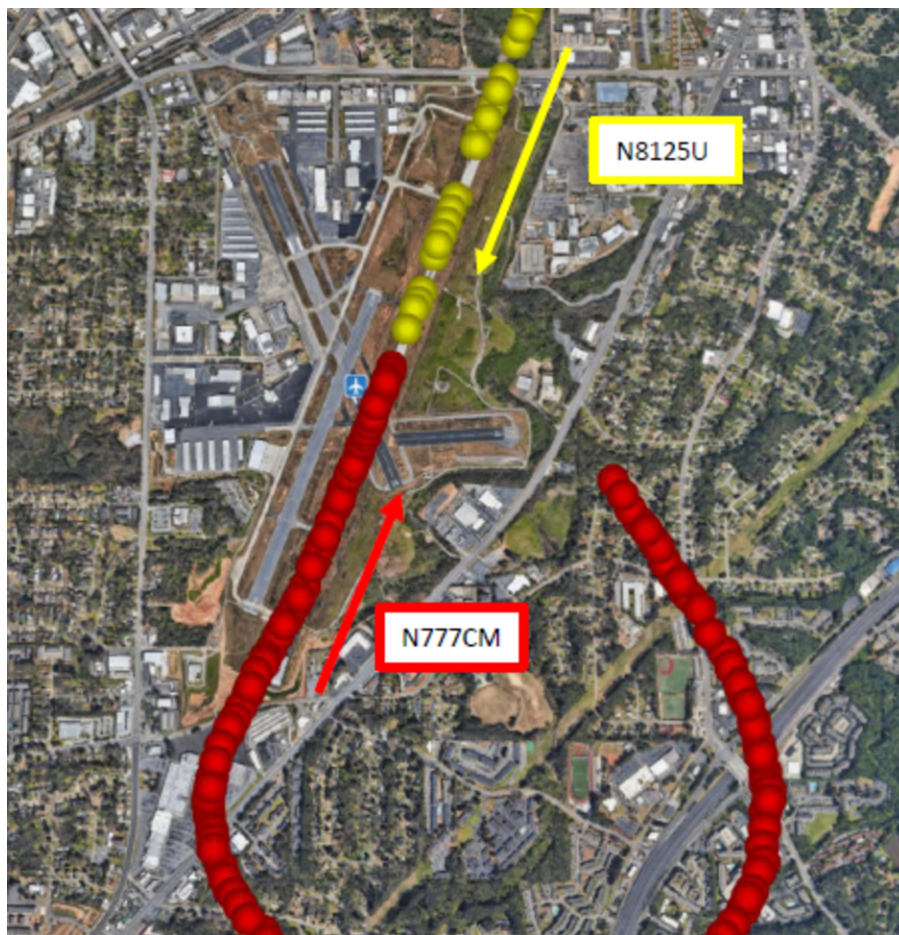
A review of Federal Aviation Administration (FAA) automatic dependent surveillance-broadcast (ADS-B) tracking data (see figure 1) revealed that the Cessna approached the airport from the northeast and flew a straight-in approach to runway 21L.

Figure 1 - ADS-B tracking data showing the ground track of the Cessna (yellow) and the Aero Commander (red).

FAA tracking data (see figure 1) showed that at the time the Aero Commander pilot advised that he had the helicopter in sight, the Cessna was on final, about 1/2 mile from the displaced threshold of runway 21L. The recording did not include any radio calls from the Cessna pilot.
