# Aviation Investigation Final Report

| <b>Location:</b> | Atlanta, Georgia | <b>Accident Number:</b> | ERA21LA056 |
| <b>Date &amp; Time:</b> | November 25, 2020, 00:09 Local | <b>Registration:</b> | N8125U (A1);<br>N777CM (A2) |
| <b>Aircraft:</b> | Cessna 172 (A1); Aero<br>Commander 500 (A2) | <b>Aircraft Damage:</b> | Substantial (A1);<br>Minor (A2) |

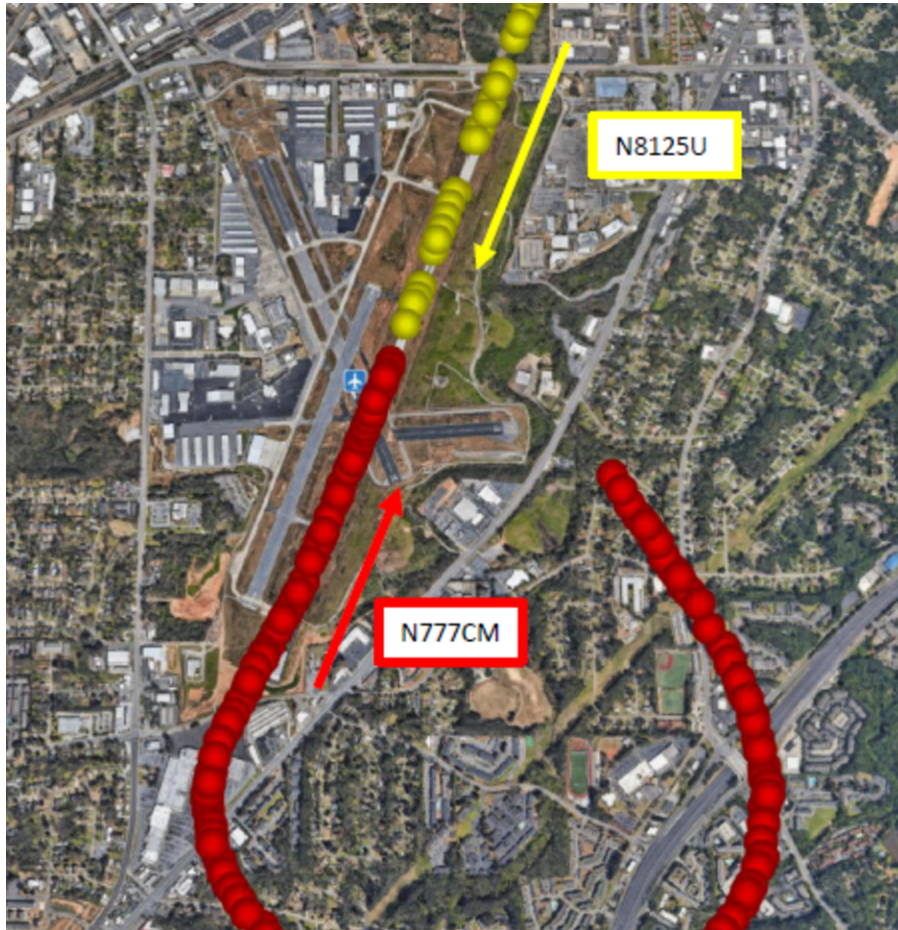
A review of Federal Aviation Administration (FAA) automatic dependent surveillance-broadcast (ADS-B) tracking data (see figure 1) revealed that the Cessna approached the airport from the northeast and flew a straight-in approach to runway 21L.

Figure 1 - ADS-B tracking data showing the ground track of the Cessna (yellow) and the Aero Commander (red).

FAA tracking data (see figure 1) showed that at the time the Aero Commander pilot advised that he had the helicopter in sight, the Cessna was on final, about 1/2 mile from the displaced threshold of runway 21L. The recording did not include any radio calls from the Cessna pilot.
