Aviation Investigation Final Report

Location:	Leesburg, Virginia	Incident Number:	ERA21LA065
Date & Time:	December 6, 2020, 19:10 UTC	Registration:	N282ST
Aircraft:	Piper PA46	Aircraft Damage:	Minor
Defining Event:	Loss of control on ground	Injuries:	1 None
Flight Conducted Under:	Part 91: General aviation - Personal

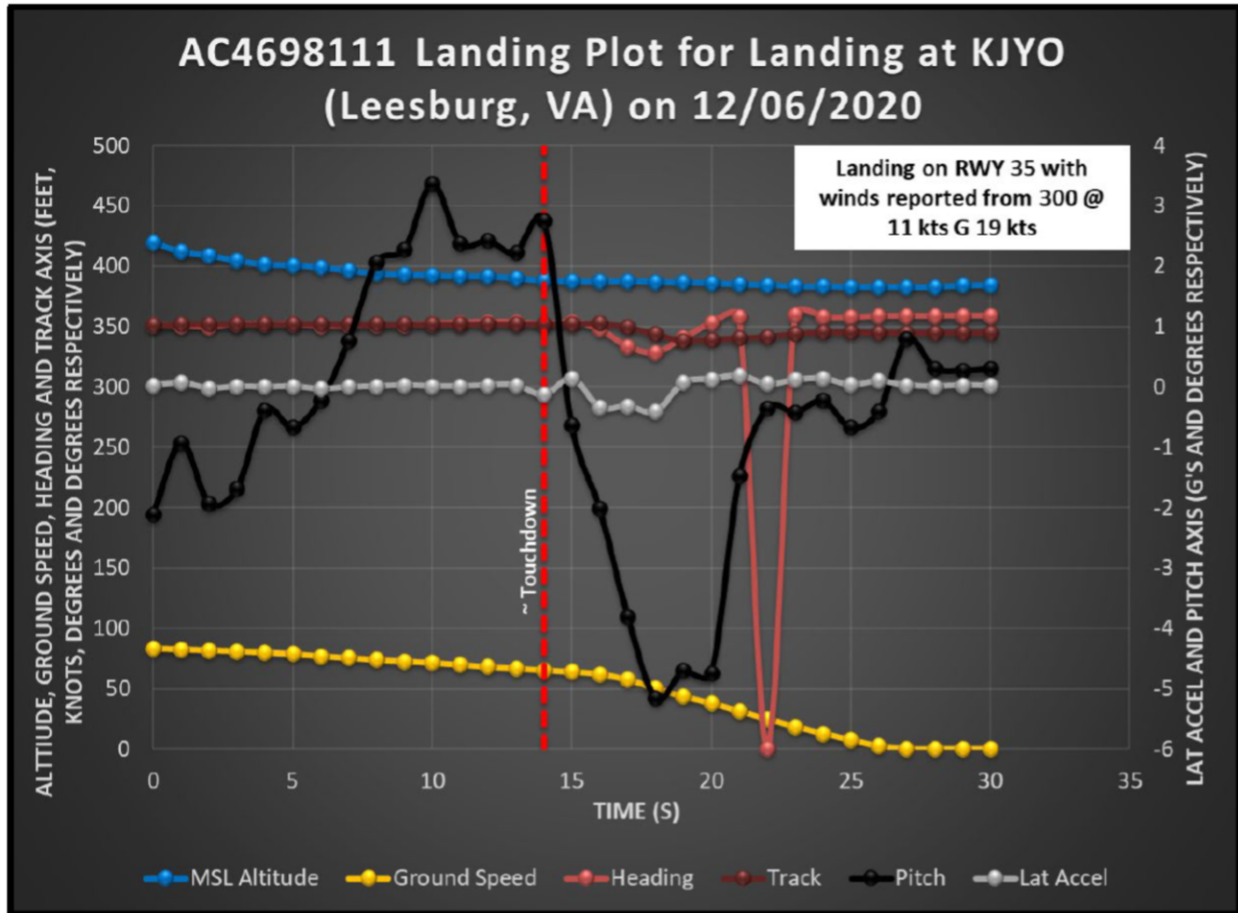
Figure 3. Plot of data from N282ST incident landing.

Data downloaded from the airplane’s Garmin G3000 Integrated Avionics System revealed a rightward lateral acceleration following touchdown immediately followed by a significant lateral acceleration to the left and a corresponding decrease in heading and track consistent with the airplane sliding.

The Garmin G3000 Integrated Avionics System on the airplane recorded certain flight parameters. Data downloaded and plotted by the manufacturer revealed the altitude, groundspeed, heading, track, pitch, and lateral acceleration data for the incident landing, shown in Figure 3. The airplane experienced an initial slight lateral acceleration to the right after the MLG touched down, followed by a more significant left lateral acceleration when the NLG touched down about 2 seconds later. The heading began to diverge left of the track when the NLG touched down. About 5 seconds after touchdown, the heading and lateral acceleration transition to the right, even though the airplane was still tracking toward the left side of the runway.
