# Aviation Investigation Final Report

| <b>Location:</b> | Aledo, Texas | <b>Accident Number:</b> | CEN21LA091 |
| <b>Date &amp; Time:</b> | December 17, 2020, 16:29 Local | <b>Registration:</b> | N102JK |
| <b>Aircraft:</b> | EXTRA FLUGZEUGPRODUKTIONS-<br>UND EA 300/L | <b>Aircraft Damage:</b> | Substantial |

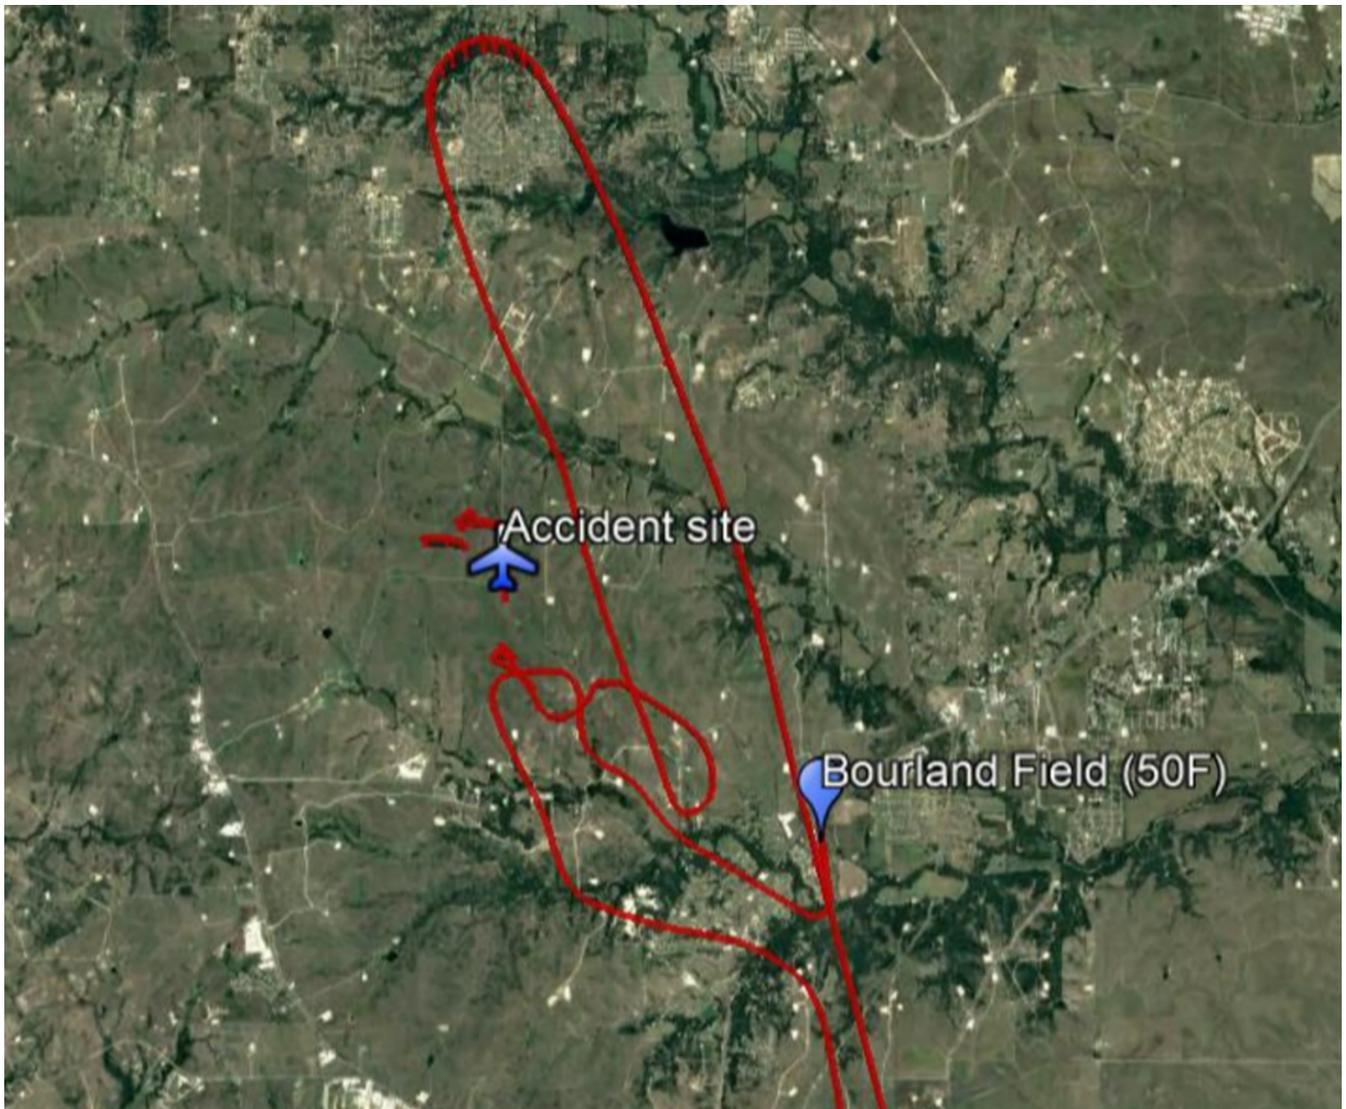
Figure 1 – Accident Airplane’s Flightpath Information (Courtesy of FAA)

The RV4 pilot descended to land at 50F, and the accident pilot climbed to about 5,300 ft msl, which was about 4,200 ft above ground level (agl), to practice aerobatic maneuvers. Flight track data from the onboard device showed the airplane performing maneuvers consistent with aerobatics between about 1625 and 1628. At 1628:16, the last onboard data showed the airplane over the accident site at 4,641 ft msl. At 1628:20, the last Mode S transponder data received showed the airplane had descended through 4,300 ft msl, which was about 3,200 ft agl. The airplane impacted terrain near this location, about 3.5 miles northwest of 50F at an elevation 1,086 ft msl (see figure 1).

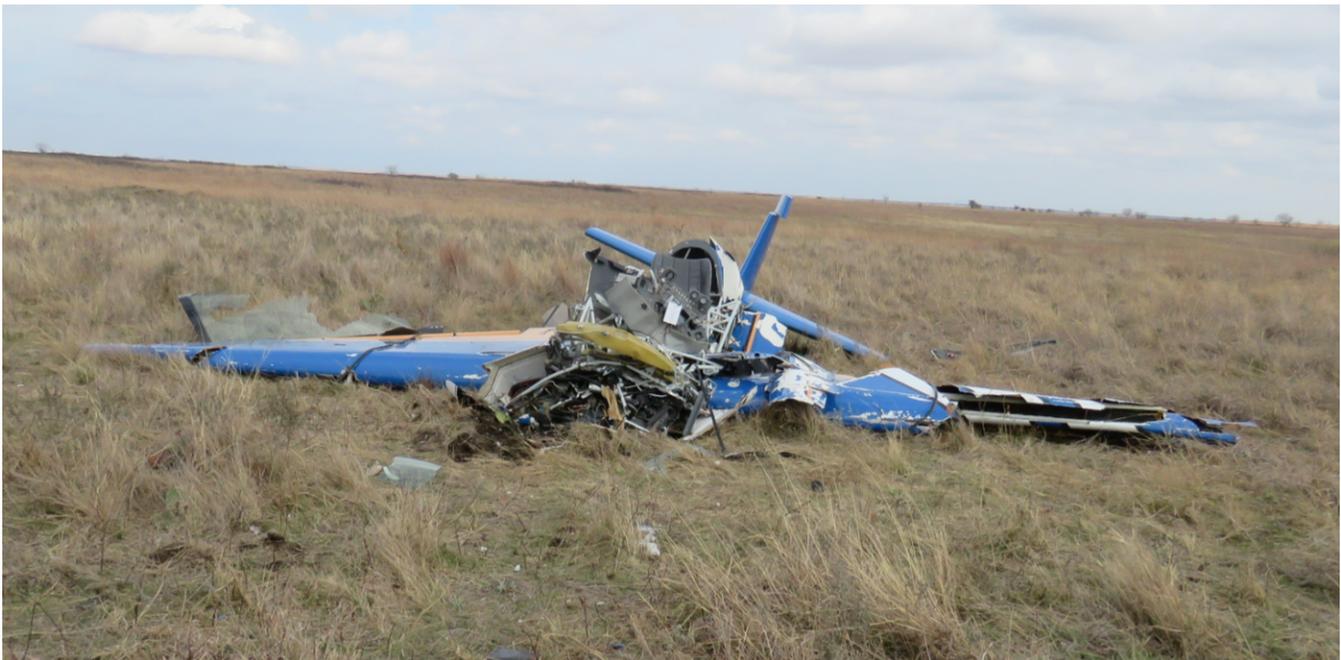
Figure 2 – Airplane at Accident Site (Courtesy of FAA)

The airplane impacted a rural, grassy field, and the wreckage distribution and damage to the airplane were consistent with a nose-down attitude and minimal forward momentum at impact. Both wings and the fuselage were crushed downward, and the tail section was twisted to the left of the fuselage (see figure 2).
