# Aviation Investigation Final Report

| <b>Location:</b> | Warm Springs, Oregon | <b>Accident Number:</b> | WPR21LA082 |
| <b>Date &amp; Time:</b> | January 9, 2021, 13:37 Local | <b>Registration:</b> | N3RB |
| <b>Aircraft:</b> | Cessna 560 | <b>Aircraft Damage:</b> | Destroyed |

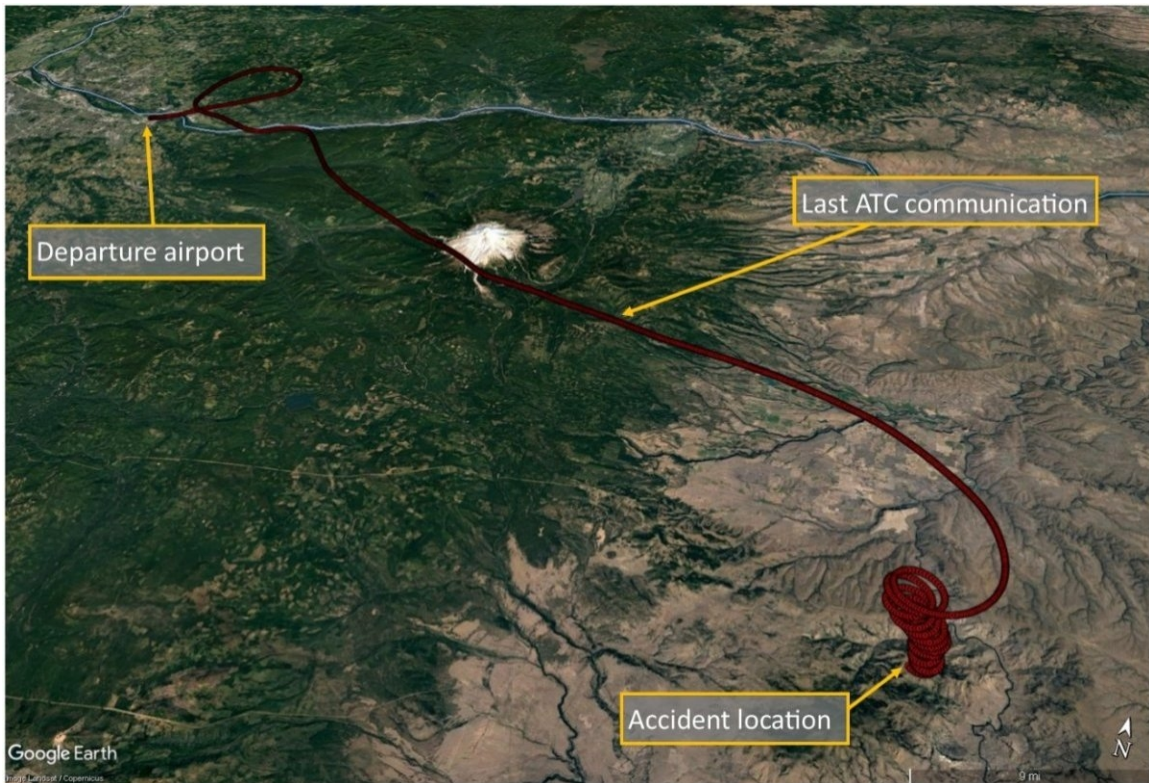
Figure 1 – Flight track

At 1327, the airplane had reached an altitude of 27,000 ft when it began to deviate to the right while continuing to climb. The controller alerted the pilot that he was about 30° right of course, but the pilot did not respond. The airplane continued to climb until 1328:45, when it reached its highest altitude of 31,000 ft. The airplane began to descend and remained for the next eight

minutes in a spiraling and descending 1-mile radius right turn. (see Figure 1.) The last ADS-B target was recorded at 1336:27, with the airplane on a northwest heading at an altitude of 3,800 ft.

Interpolation of the ADS-B data during the spiraling descent indicated a right bank angle of between 60° and 70° and a descent rate of between -2,500 to -5,000 ft/min to impact.

The data also revealed 50- to 100-knot oscillations in groundspeed during the descent. The data was compared to flight test data for the Citation 560 series airplane, specifically the data used to simulate the longitudinal, open-loop, long period (or phugoid) response of the airplane after a pitch disturbance.
