Aviation Investigation Final Report

Location:	Warm Springs, Oregon	Accident Number:	WPR21LA082
Date & Time:	January 9, 2021, 13:37 Local	Registration:	N3RB
Aircraft:	Cessna 560	Aircraft Damage:	Destroyed
Defining Event:	Medical event	Injuries:	1 Fatal
Flight Conducted Under:	Part 91: General aviation - Personal

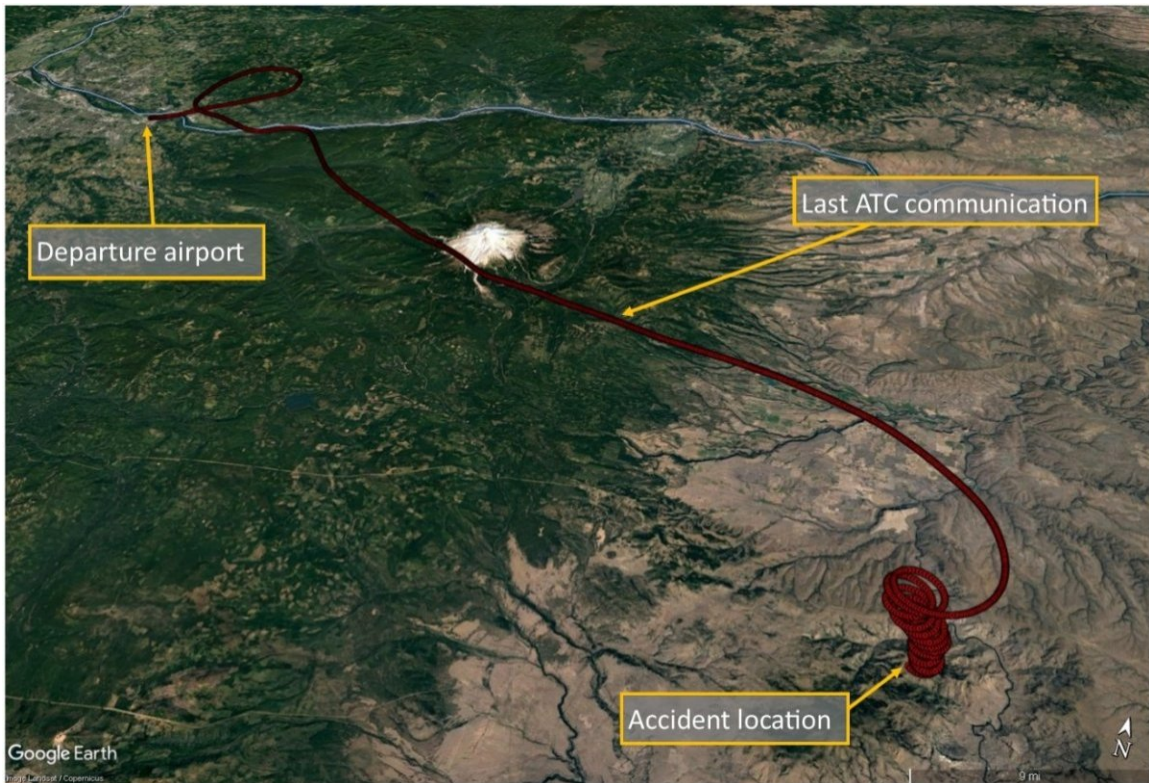
Figure 1 – Flight track

minutes in a spiraling and descending 1-mile radius right turn. (see Figure 1.) The last ADS-B target was recorded at 1336:27, with the airplane on a northwest heading at an altitude of 3,800 ft.

Interpolation of the ADS-B data during the spiraling descent indicated a right bank angle of between 60° and 70° and a descent rate of between -2,500 to -5,000 ft/min to impact.

The data also revealed 50- to 100-knot oscillations in groundspeed during the descent. The data was compared to flight test data for the Citation 560 series airplane, specifically the data used to simulate the longitudinal, open-loop, long period (or phugoid) response of the airplane after a pitch disturbance.

The data for the accident airplane displayed longitudinal dynamic characteristics that were similar to the flight test data for over a period of oscillation, or approximately 90 seconds.
