# Aviation Investigation Final Report

<b>Location:</b>	Columbia, South Carolina	<b>Accident Number:</b>	ERA21LA101
<b>Date &amp; Time:</b>	January 13, 2021, 10:33 Local	<b>Registration:</b>	N266DC
<b>Aircraft:</b>	Beech F33	<b>Aircraft Damage:</b>	Destroyed
<b>Defining Event:</b>	Collision with terr/obj (non-CFIT)	<b>Injuries:</b>	1 Fatal
<b>Flight Conducted Under:</b>	Part 91: General aviation - Personal

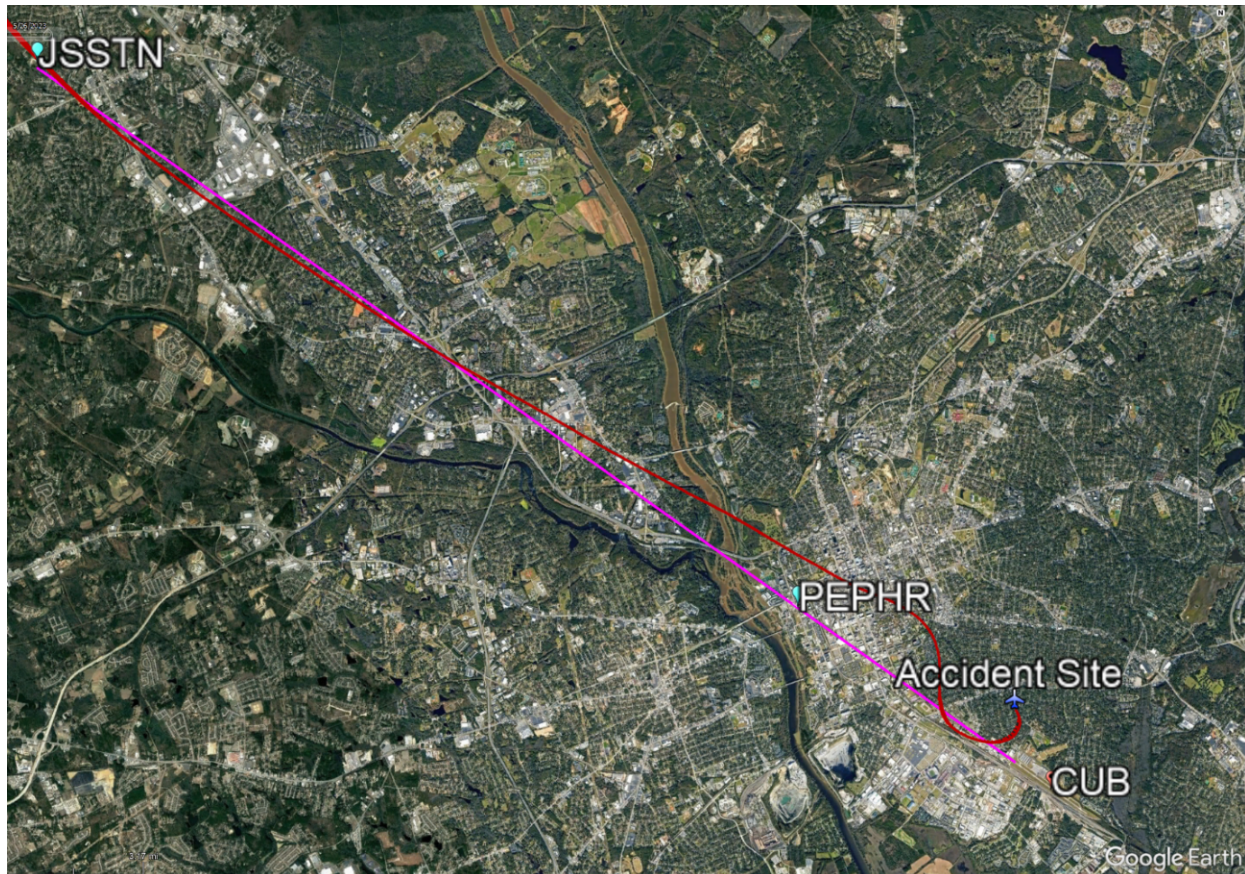
Review of ADS-B data showed that during the instrument approach, the airplane remained about 3/4-mile left of course until the airplane was about 1 1/4 miles from the approach end of the runway. At that time, the airplane made a right turn, descended to 325 ft msl, and made a climbing left turn to 800 ft msl before descending into a residential neighborhood (see figures 1 and 2).

Figure 1. Airplane flight track during the approach (in red) and extended runway centerline at CUB (in magenta). Note: JSSTN is the initial approach fix for the RNAV runway 13 approach, and PEPHR is the final approach fix for the approach.

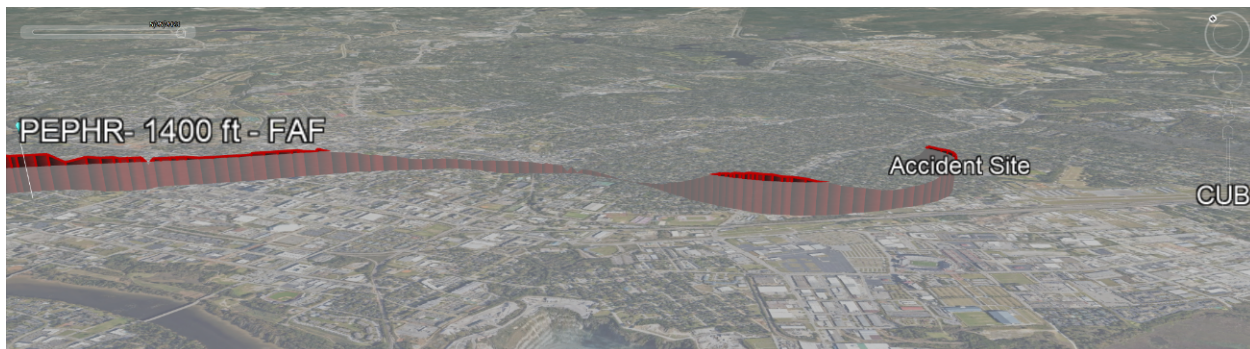
Figure 2. Three-dimensional view of the airplane's flight track (in red) with the minimum descent altitude overlay of the flight track (semi-transparent gray layer). Note: The lowest minimum descent altitude for the RNAV runway 13 approach was 780 ft mean sea level. The airplane descended below the MDA three times before the accident occurred.
