# Aviation Investigation Final Report

<b>Location:</b>	Columbia, South Carolina	<b>Accident Number:</b>	ERA21LA101
<b>Date &amp; Time:</b>	January 13, 2021, 10:33 Local	<b>Registration:</b>	N266DC
<b>Aircraft:</b>	Beech F33	<b>Aircraft Damage:</b>	Destroyed
<b>Defining Event:</b>	Collision with terr/obj (non-CFIT)	<b>Injuries:</b>	1 Fatal
<b>Flight Conducted Under:</b>	Part 91: General aviation - Personal

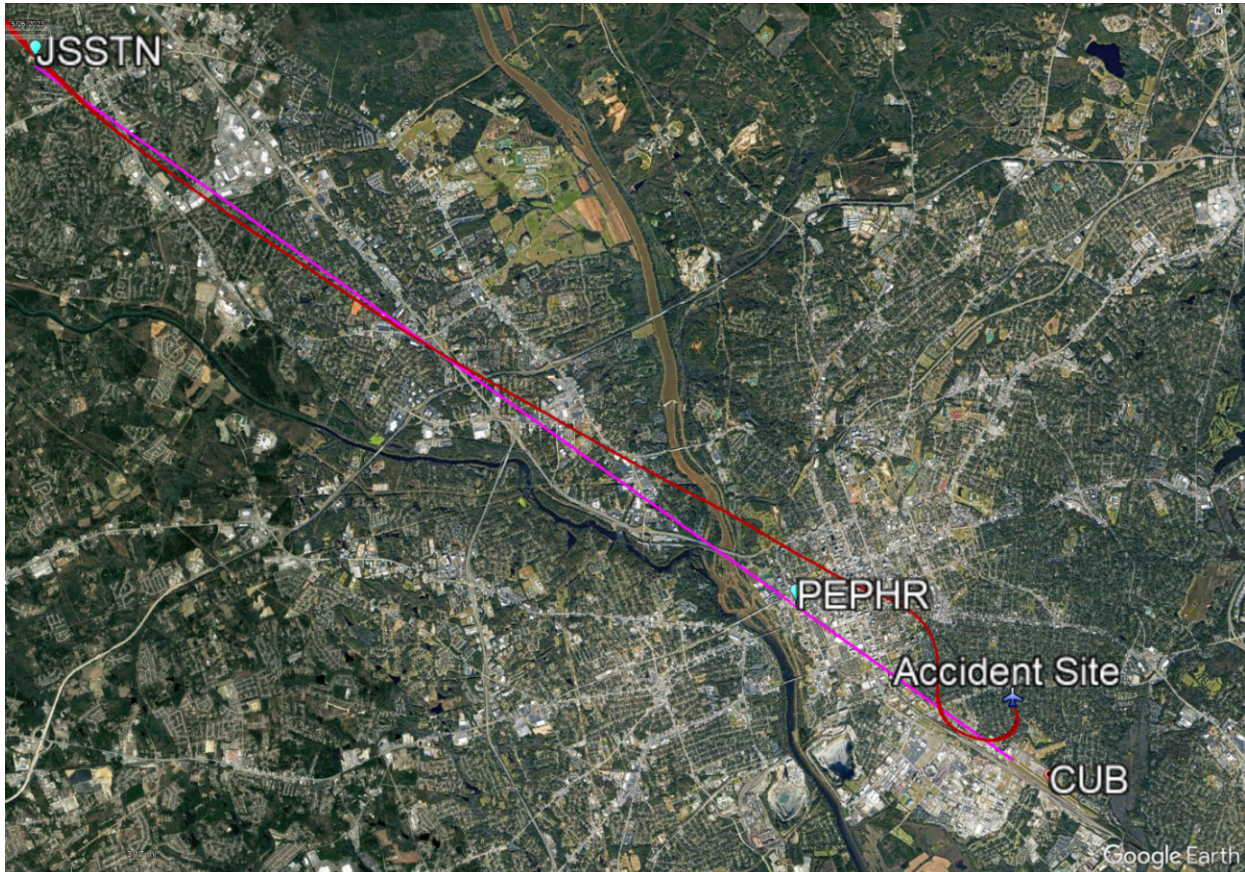
Review of ADS-B data showed that during the instrument approach, the airplane remained about 3/4-mile left of course until the airplane was about 1 1/4 miles from the approach end of the runway. At that time, the airplane made a right turn, descended to 325 ft msl, and made a climbing left turn to 800 ft msl before descending into a residential neighborhood (see figures 1 and 2).

Figure 1. Airplane flight track during the approach (in red) and extended runway centerline at CUB (in magenta). Note: JSSTN is the initial approach fix for the RNAV runway 13 approach, and PEPHR is the final approach fix for the approach.

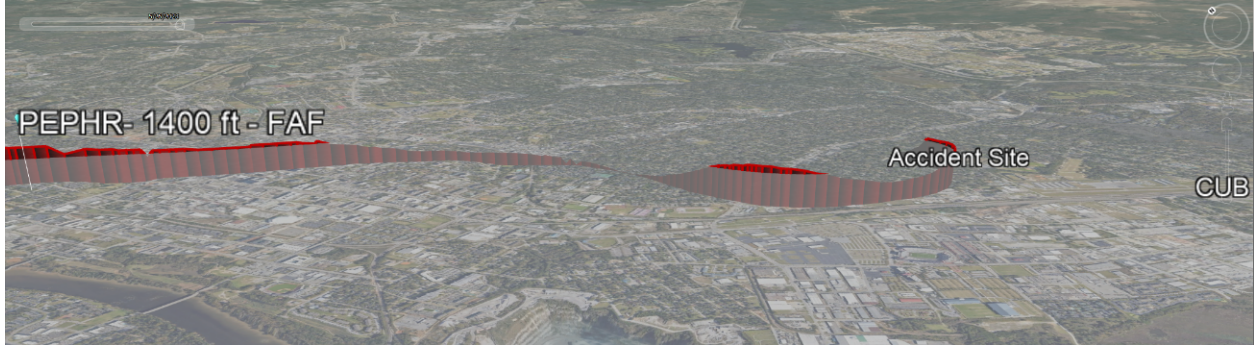
Given the instrument meteorological conditions at the time of the accident, which included restricted visibility, and the pilot's maneuvering off of the instrument approach course both laterally and vertically, it is likely that the pilot became spatially disoriented during the approach, which led to a loss of airplane control and a subsequent spiraling descent.

Figure 2. Three-dimensional view of the airplane’s flight track (in red) with the minimum descent altitude overlay of the flight track (semi-transparent gray layer). Note: The lowest minimum descent altitude for the RNAV runway 13 approach was 780 ft mean sea level. The airplane descended below the MDA three times before the accident occurred.
