Aviation Investigation Final Report

Location:	Port Angeles, Washington	Accident Number:	WPR21LA097
Date & Time:	January 26, 2021, 16:40 Local	Registration:	N9114A
Aircraft:	Cessna 170A	Aircraft Damage:	Substantial
Defining Event:	Fuel exhaustion	Injuries:	1 Fatal
Flight Conducted Under:	Part 91: General aviation - Personal

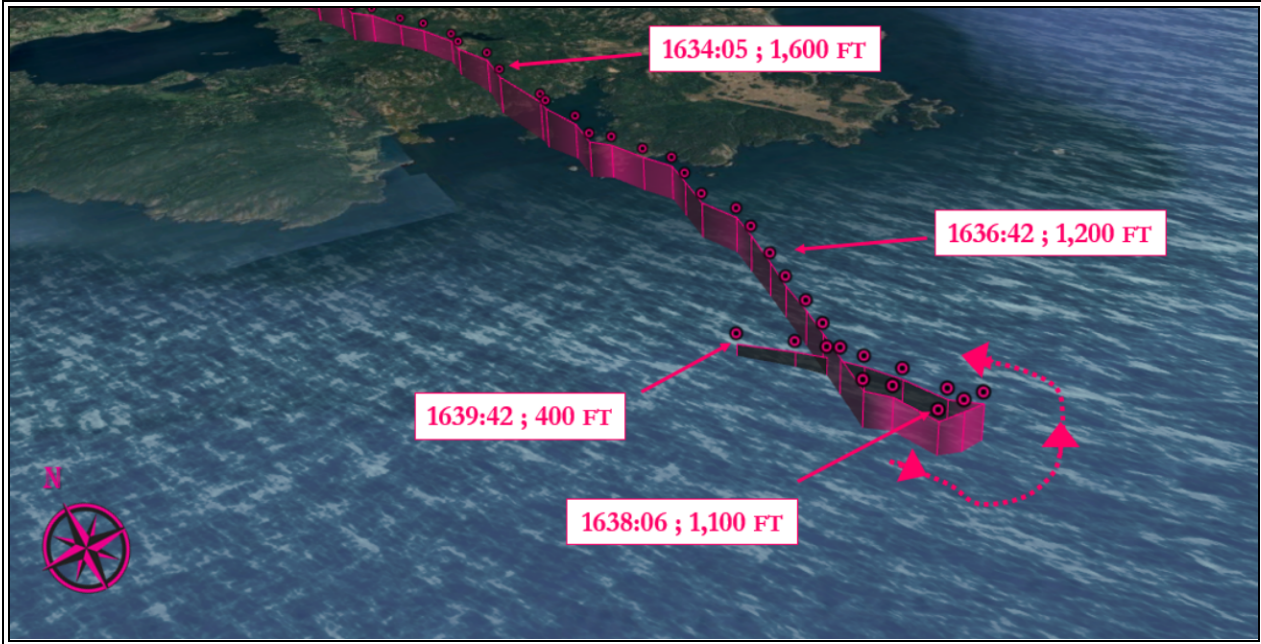
Figure 1: Last Radar Returns

A review of the radar data revealed that the airplane was on a southerly track, reaching the edge of the northern land mass at 1634. The radar data continued south for about 5.4 nautical miles (nm) at an altitude of about 1,200 ft. At 1638:06 the data deviated from the southerly direction and were consistent with the airplane reversing course and heading north-northeast. The data from the turn to the last data point indicated a decreasing airspeed and a gradual decent from 1,200 to 400 ft (see figure 1).

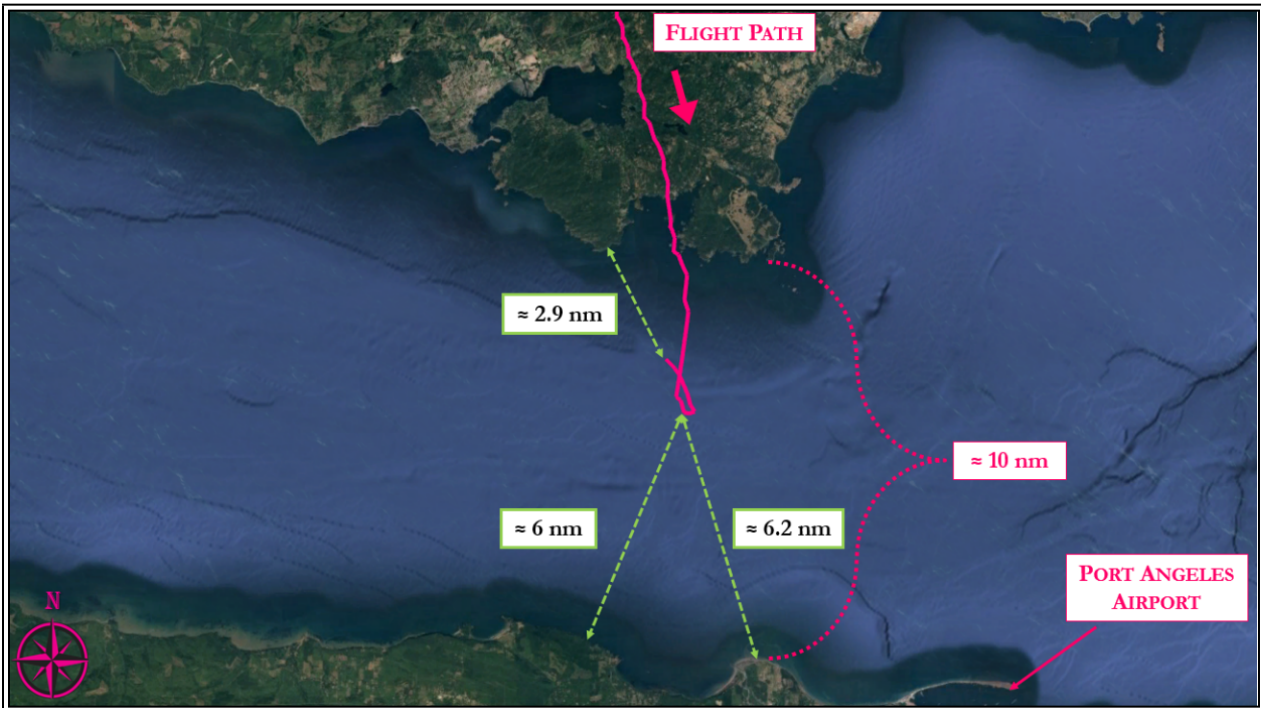
Figure 2: Radar Track in Reference to Land.

The radar data the furthest south were about 6 nm from land to the south and 4 nm from land to the north. The last radar return was 2.9 nm from the closet land (see figure 2). The pilot sent a picture to his mother about 1637 that showed a marine vessel towing a barge in the water below his location. The pilot broadcast a mayday call over the Port Angeles UNICOM frequency at 1638:47. He stated that he was out in the middle of the water and was ditching by a boat that was towing a barge.
