Aviation Investigation Final Report

Location:	Horseshoe Bend, Idaho	Accident Number:	WPR21LA107
Date & Time:	February 5, 2021, 14:00 Local	Registration:	N6639R
Aircraft:	Hughes OH-6A	Aircraft Damage:	Substantial
Defining Event:	Loss of engine power (partial)	Injuries:	1 Serious, 1 Minor
Flight Conducted Under:	Public aircraft

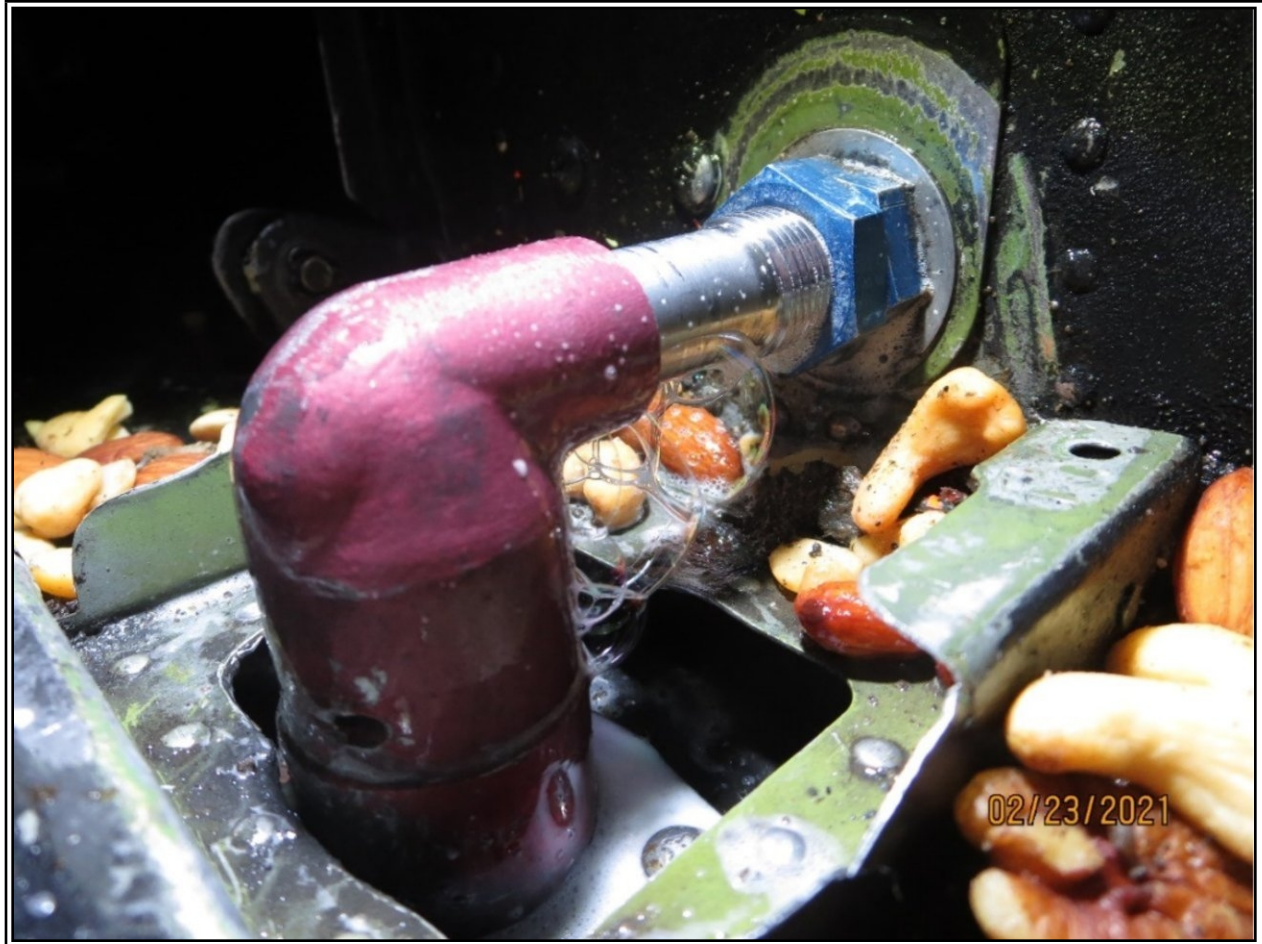
Postaccident examinations of the helicopter revealed substantial damage to the fuselage and tail boom, as well as an air leak at the fuel cell outlet valve that connected the fuel supply line from the fuel shutoff valve and the frangible in-line fuel valve on the self-sealing engine fuel inlet hose located at the firewall. (see Figure 1.) The fuel cell outlet valve along with the engine fuel inlet hose were shipped to the NTSB (NTSB) Materials Laboratory for further examination.

Figure 1: view of fuel line leak (photo provided by MD Helicopters)

According to the engine manufacturer, the accident helicopter had a non-pressure-boosted fuel system that was utilized for normal operation. The engine fuel pump generated a vacuum at its inlet to draw the fuel from the tank to the engine fuel delivery system. A leak in the fuel delivery system prior to the engine can produce air entrainment in the fuel being supplied which could result in the interruption of homogenous fuel flow.

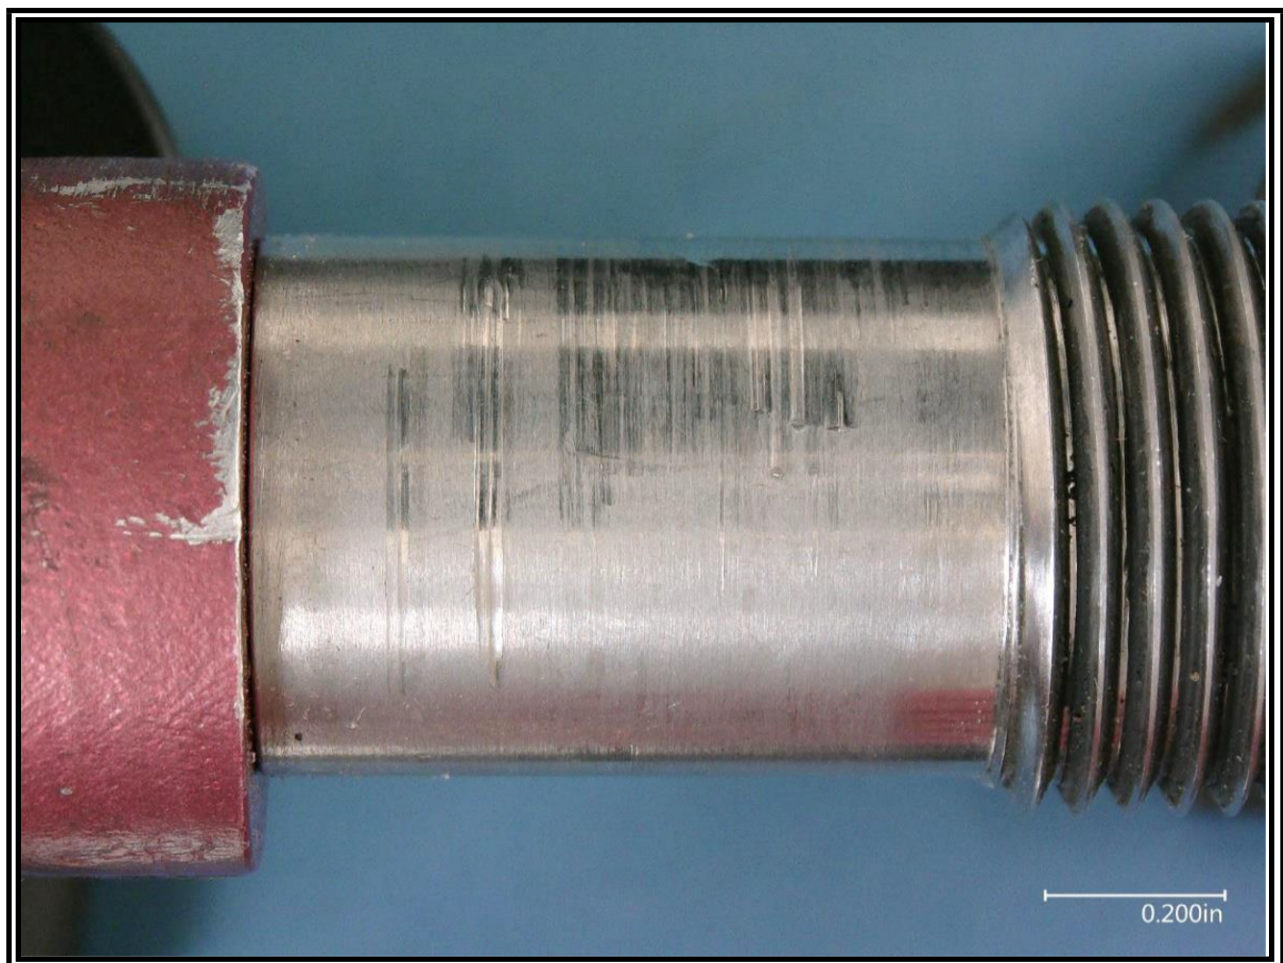
Postaccident examination of the helicopter revealed an air leak located in the fuel cell outlet valve near the firewall. Subsequent examination of the fuel cell outlet valve revealed circumferential scratch marks around the barrel of the pipe. Damage due to cross-threading was observed on the first two threads. When the O-ring was removed, metal chips were located embedded throughout the O-ring. A review of the maintenance records indicated that the fuel system components were inspected during the 100-hour inspection, along with correspondence from the maintenance facility that a vacuum check of the fuel system was conducted during that inspection, with no anomalies noted. No entries were found in the maintenance records of any work done to the fuel outlet valve. The approved maintenance manual for the helicopter contained multiple warnings that air in the fuel system will cause a power reduction or flame out. It could not be determined when, or how, the fuel cell outlet valve developed a leak.

The fuel cell outlet valve was examined by the NTSB Materials Laboratory. A pressure test utilized soapy water as part of its testing protocols; soap bubbles formed at the barrel of the pipe and fuel outlet valve, which indicated the presence of an air leak. Visual examination of the fitting had circumferential scratch marks on the barrel of the pipe, as seen in Figure 2. A visual examination of the fitting threads revealed that the first two threads were damaged due to cross-threading. The O-ring was removed with both outer and inner diameter surfaces flattened/compressed. Metal chips were found embedded in the O-ring; when the O-ring was removed, a metal chip dislodged and revealed an impression in the rubber.

Figure 2: View of optical microscope images showing circumferential scratch marks and pile-up material on the outer diameter surface of the pipe barrel (photo provided by NTSB)
