Aviation Investigation Final Report

Location:	San Antonio, Texas	Accident Number:	CEN20LA440
Date & Time:	September 4, 2020, 20:02 Local	Registration:	N362AE
Aircraft:	Swearingen SA227	Aircraft Damage:	Substantial
Defining Event:	Hard landing	Injuries:	1 None
Flight Conducted Under:	Part 135: Air taxi & commuter - Non-scheduled

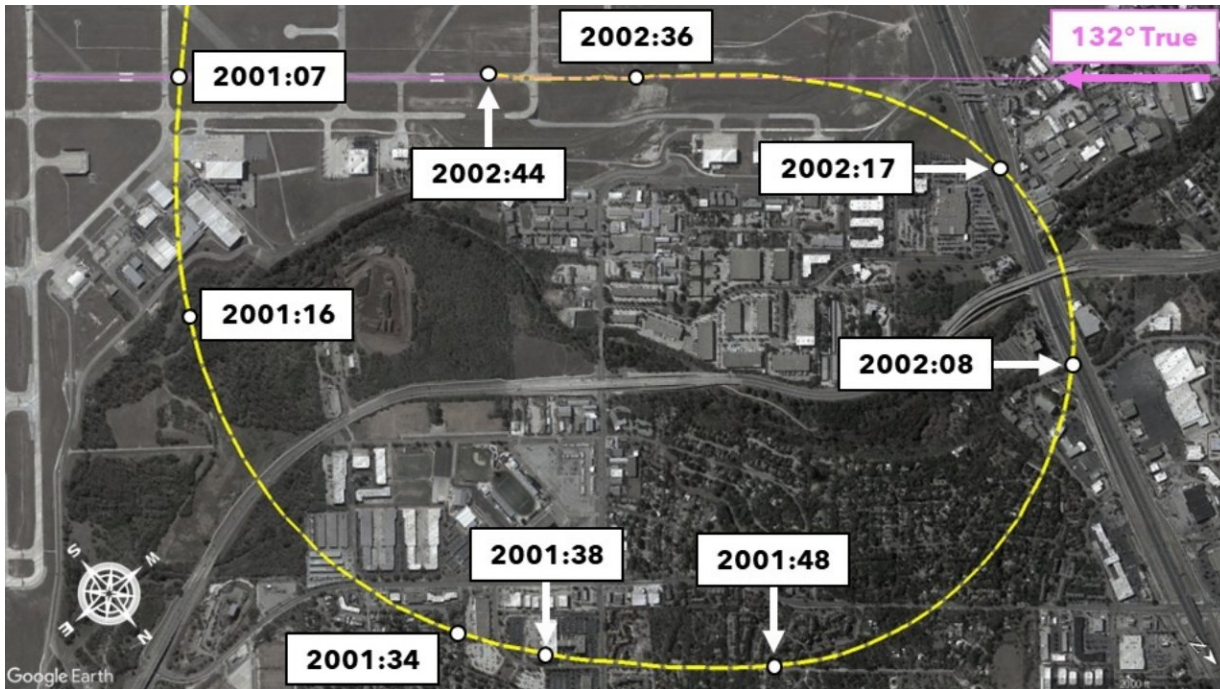
Figure 1 – Airplane's Ground Track During Traffic Pattern

According to automatic dependent surveillance-broadcast (ADS-B) data, at 2001:07, the airplane was on a northeast ground track as it crossed perpendicular over runway 13L at 2,677 ft mean sea level (msl) and 182 knots calibrated airspeed (KCAS), as shown in Figure 1 and Figure 3. At 2001:16, the airplane entered a left turn to join the downwind leg for runway 13L at 2,700 ft msl and 165 KCAS. At 2001:38, the airplane was abeam the runway 13L threshold while on a 1 nautical mile (nm) wide left downwind at 2,629 ft msl, 138 KCAS, and a 702 feet per minute (fpm) descent rate, as shown in Figure 2 and Figure 3. About 10 seconds later, the airplane was in a left turn toward the base leg descending about 1,976 fpm at 135 KCAS.

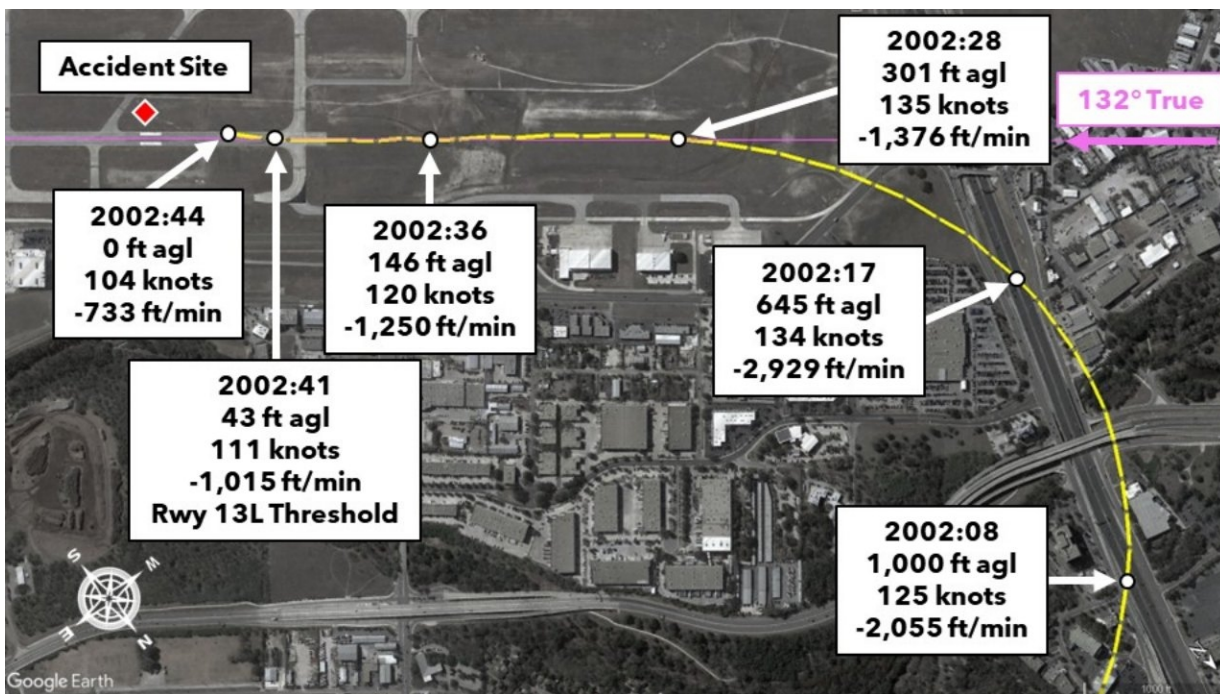
Figure 2 – Airplane's Final Approach to Runway 13L

According to ADS-B data, at 2002:08, the airplane was 1,000 ft above the runway 13L threshold while in a 2,055 fpm descent at 125 knots, as shown in Figure 2 and Figure 3. At this time, the airplane was descending more than double the operator's allowed descent rate and was 5 knots below the specified approach speed. At 2002:17, the airplane was descending at 2,929 fpm with an airspeed of 134 KCAS. At this time, the airplane was still in the left turn toward the final approach course with a 31° left-wing-down roll angle, as shown in Figure 4, and the descent rate was nearly 3 times the operator's limitation.
