Aviation Investigation Final Report

Location:	San Diego, California	Accident Number:	WPR21LA110
Date & Time:	February 13, 2021, 11:50 Local	Registration:	N823RC
Aircraft:	Dassault Falcon900EX	Aircraft Damage:	Substantial
Defining Event:	Runway excursion	Injuries:	5 None
Flight Conducted Under:	Part 91: General aviation - Personal

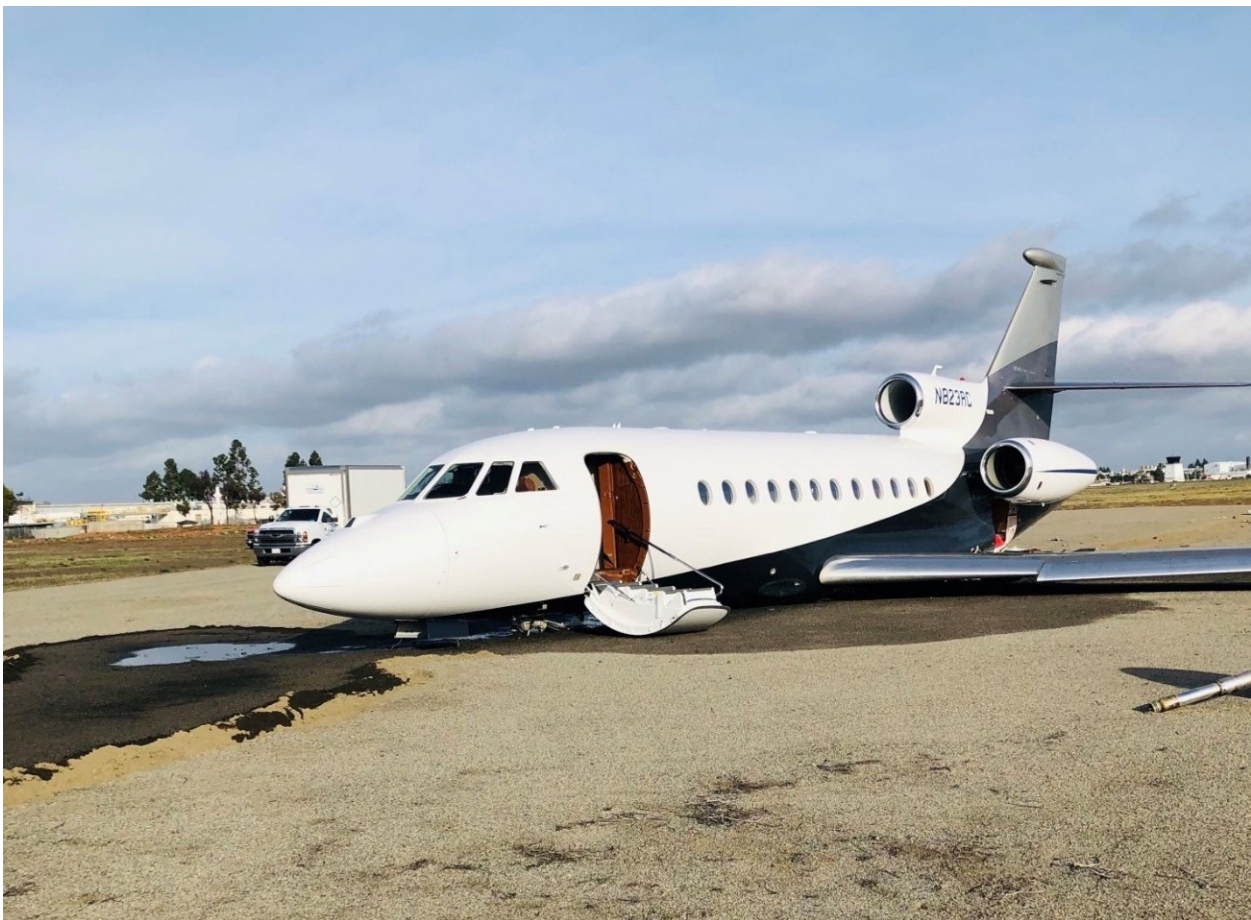
The airplane overran the departure end of the runway by about 315 ft and struck a berm, which sheared off all three-landing gear. The airplane slid an additional 230 ft and came to rest on a gravel overrun pad. The airplane sustained substantial damage to the wings and fuselage, and the fuel tanks were ruptured (see figure). Continuity was confirmed from the flight controls to the control surfaces, and significant fuel leakage was present, but no fire ensued.

Figure - View of Airplane Damage (Source: FAA)
