# Aviation Investigation Final Report

| <b>Location:</b> | San Diego, California | <b>Accident Number:</b> | WPR21LA110 |
| <b>Date &amp; Time:</b> | February 13, 2021, 11:50 Local | <b>Registration:</b> | N823RC |
| <b>Aircraft:</b> | Dassault Falcon900EX | <b>Aircraft Damage:</b> | Substantial |

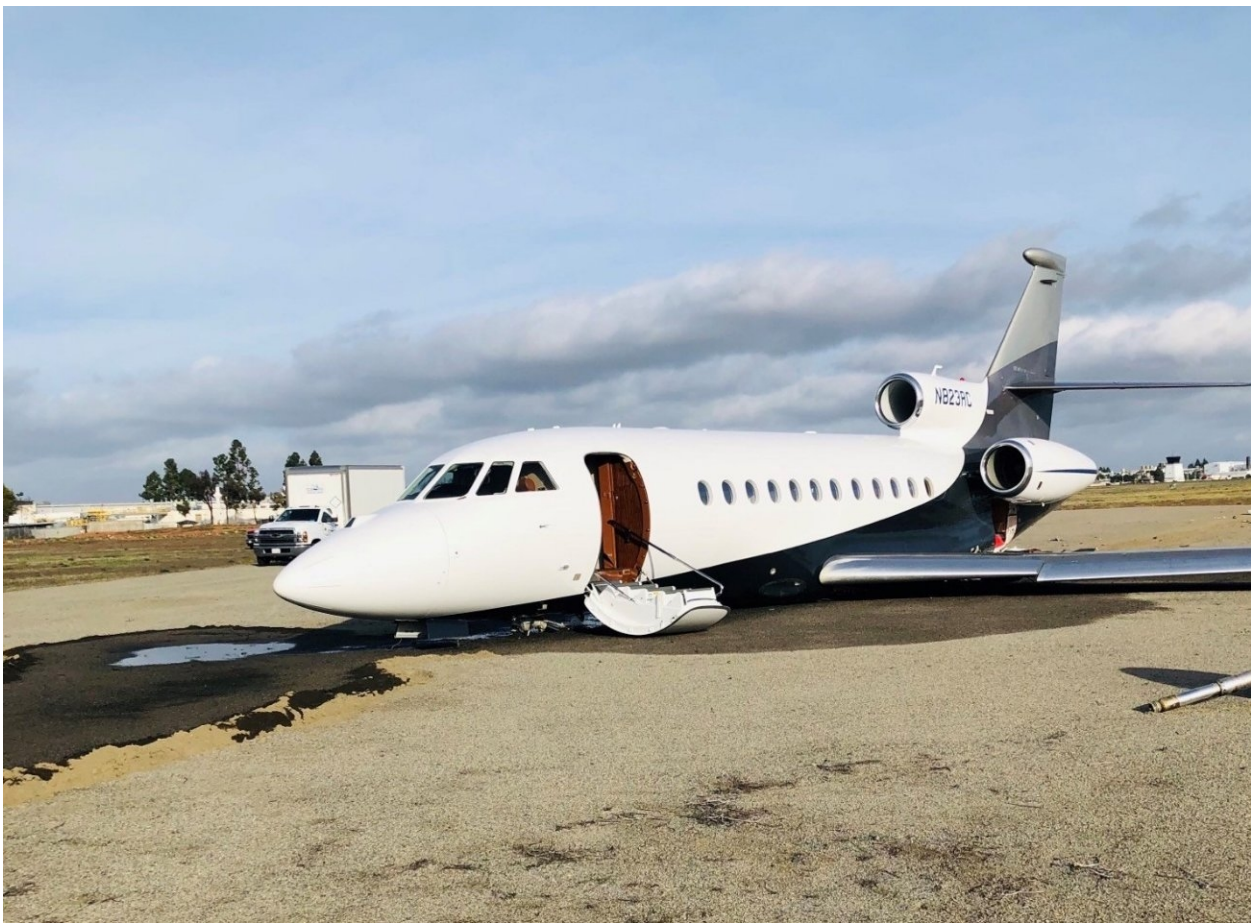
The flight crew's operation of the airplane outside of the manufacturer's specified weight and balance limitations and with an improper trim setting, which resulted in the airplane's inability to rotate during the attempted takeoff. Contributing to the accident, was the captain's lack of proper certification and the crew's lack of flight experience in the airplane make and model.

The airplane overran the departure end of the runway by about 315 ft and struck a berm, which sheared off all three-landing gear. The airplane slid an additional 230 ft and came to rest on a gravel overrun pad. The airplane sustained substantial damage to the wings and fuselage, and the fuel tanks were ruptured (see figure). Continuity was confirmed from the flight controls to the control surfaces, and significant fuel leakage was present, but no fire ensued.

Figure - View of Airplane Damage (Source: FAA)
