# Aviation Investigation Final Report

<b>Location:</b>	Larned, Kansas	<b>Accident Number:</b>	CEN21LA129
<b>Date &amp; Time:</b>	February 5, 2021, 12:00 Local	<b>Registration:</b>	N115FP
<b>Aircraft:</b>	COLUMBIA AIRCRAFT MFG LC42-550FG	<b>Aircraft Damage:</b>	Substantial
<b>Defining Event:</b>	Fire/smoke (non-impact)	<b>Injuries:</b>	2 None
<b>Flight Conducted Under:</b>	Part 91: General aviation - Personal

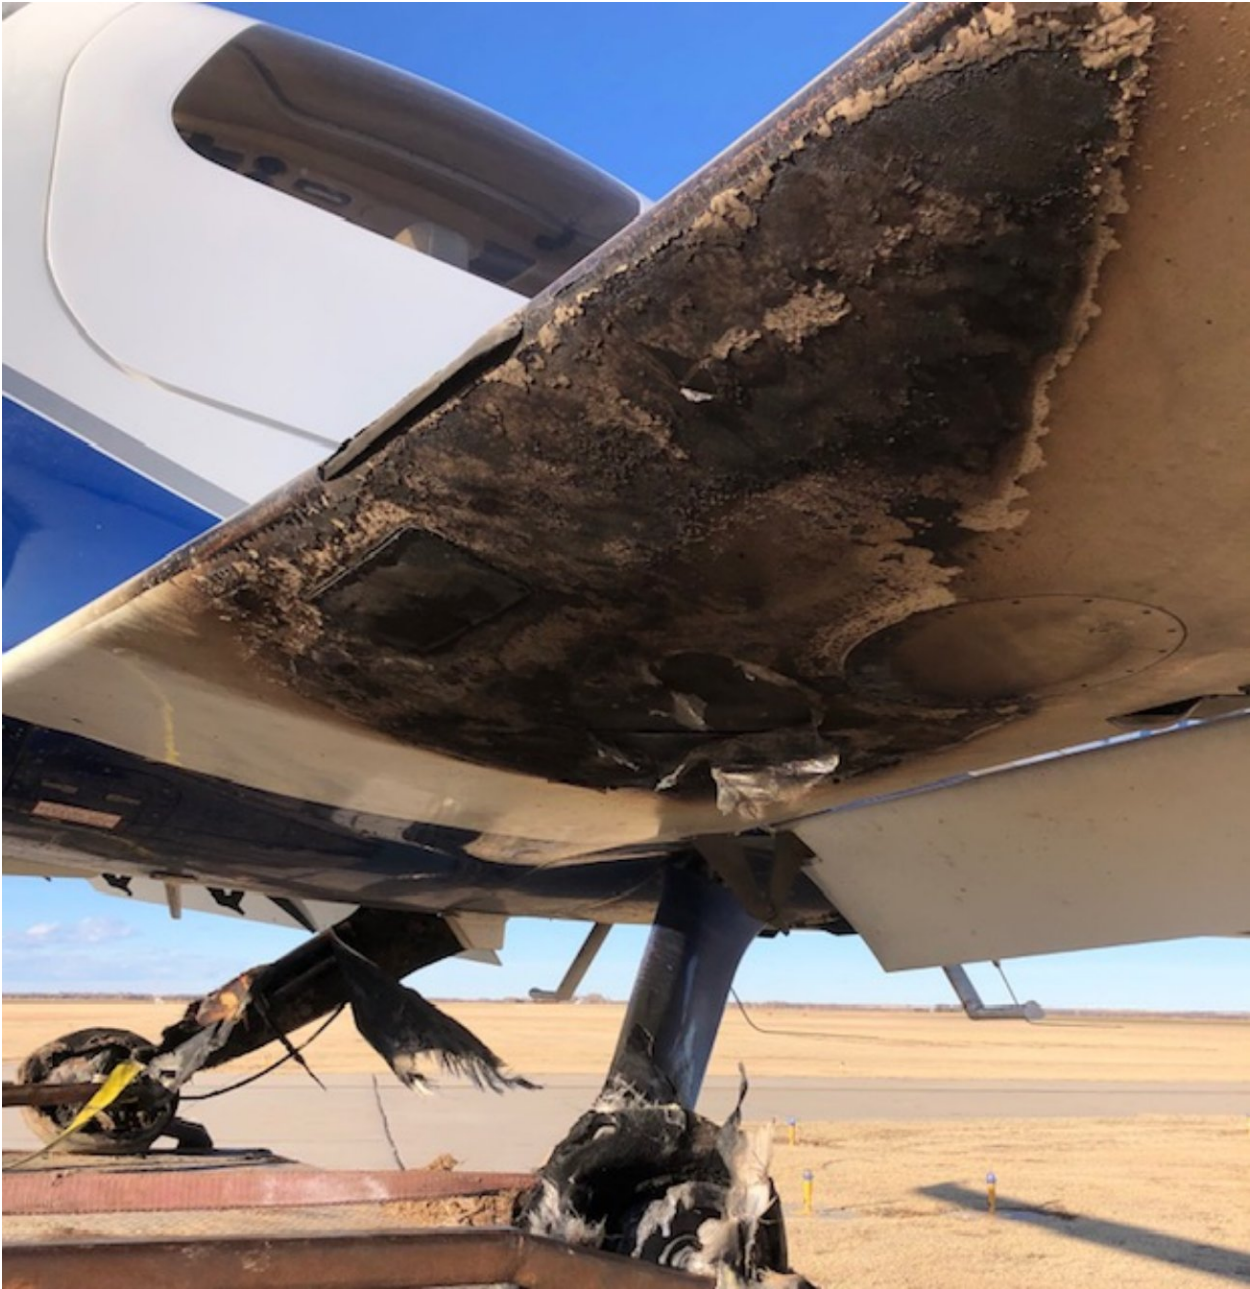
The fire appeared to originate from the wheel brakes. The time between the two attempted takeoffs was about 15 minutes. The pilot reported that he applied intermittent braking during the first aborted takeoffs. Thus, the brakes likely faded during the second aborted takeoff because they were hot from the consecutive aborted takeoffs and did not have enough time to cool. The fire was most likely caused by the hot wheel brakes entering a dry grassy area after the runway excursion.

The pilot's failure to allow sufficient time for the brakes to cool after a previous aborted takeoff, resulting in a runway excursion during a second aborted takeoff due to degraded braking performance. Contributing to the accident was the contact of the hot brakes with a dry grassy area during the second aborted takeoff.

The pilot reported that the engine and flight controls were operating normally during both takeoff attempts. The airplane came to rest on a 156° magnetic heading about 250 ft southeast of the end of runway 17. Both main landing gear wheel assemblies, brakes, wheel pants, strut coverings, and brake lines sustained severe fire damage. The underside of the left wing and fuselage were scorched, as shown in the figure below, resulting in structural damage to the left wing.

Figure. Fire damage to the main wheel assemblies and underside of the left wing (Source: Federal Aviation Administration).

Detailed examination of the airplane showed that both main landing gear brake and wheel assemblies had severe fire damage. The fire appeared to originate from the wheel brakes. Both brake and wheel assemblies were examined and found to be mechanically intact with no anomalies (other than the severe fire damage). The parking brake was not engaged. Flight control continuity was confirmed from the cockpit to all flight control surfaces. The airplane was determined to be under its maximum gross takeoff weight.
