Aviation Investigation Final Report

Location:	Larned, Kansas	Accident Number:	CEN21LA129
Date & Time:	February 5, 2021, 12:00 Local	Registration:	N115FP
Aircraft:	COLUMBIA AIRCRAFT MFG LC42-550FG	Aircraft Damage:	Substantial
Defining Event:	Fire/smoke (non-impact)	Injuries:	2 None
Flight Conducted Under:	Part 91: General aviation - Personal

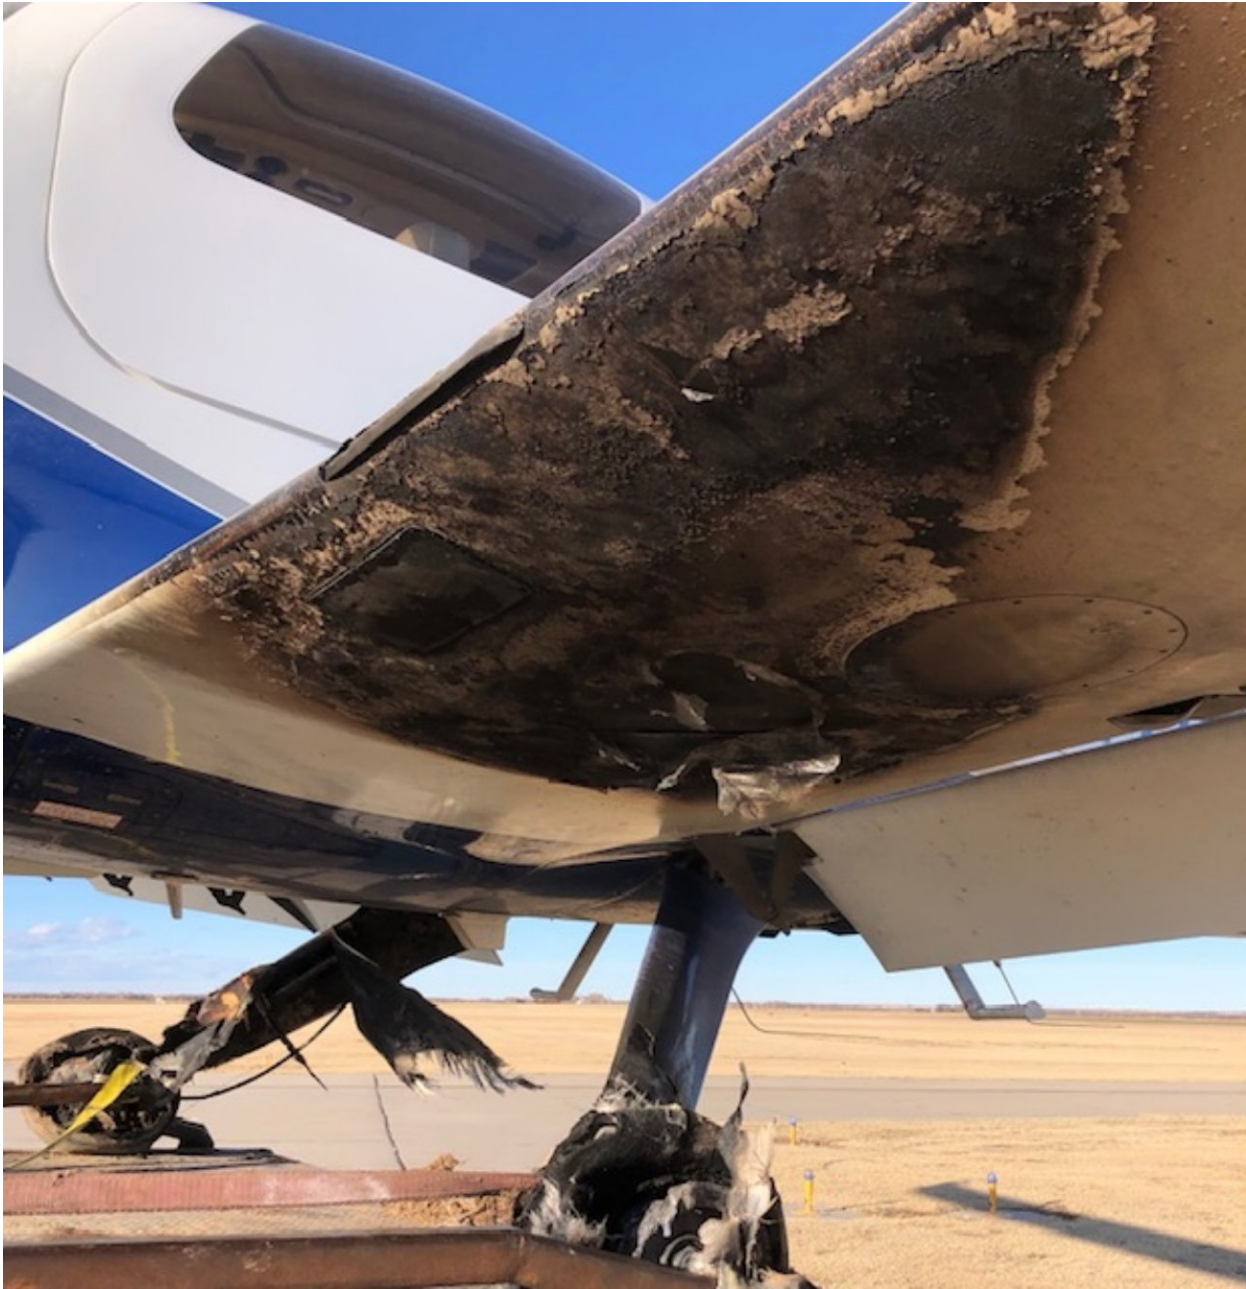
The fire appeared to originate from the wheel brakes. The time between the two attempted takeoffs was about 15 minutes. The pilot reported that he applied intermittent braking during the first aborted takeoffs. Thus, the brakes likely faded during the second aborted takeoff because they were hot from the consecutive aborted takeoffs and did not have enough time to cool. The fire was most likely caused by the hot wheel brakes entering a dry grassy area after the runway excursion.

The pilot's failure to allow sufficient time for the brakes to cool after a previous aborted takeoff, resulting in a runway excursion during a second aborted takeoff due to degraded braking performance. Contributing to the accident was the contact of the hot brakes with a dry grassy area during the second aborted takeoff.

The pilot reported that the engine and flight controls were operating normally during both takeoff attempts. The airplane came to rest on a 156° magnetic heading about 250 ft southeast of the end of runway 17. Both main landing gear wheel assemblies, brakes, wheel pants, strut coverings, and brake lines sustained severe fire damage. The underside of the left wing and fuselage were scorched, as shown in the figure below, resulting in structural damage to the left wing.

Figure. Fire damage to the main wheel assemblies and underside of the left wing (Source: Federal Aviation Administration).

Detailed examination of the airplane showed that both main landing gear brake and wheel assemblies had severe fire damage. The fire appeared to originate from the wheel brakes. Both brake and wheel assemblies were examined and found to be mechanically intact with no anomalies (other than the severe fire damage). The parking brake was not engaged. Flight control continuity was confirmed from the cockpit to all flight control surfaces. The airplane was determined to be under its maximum gross takeoff weight.
