# Aviation Investigation Final Report

<b>Location:</b>	Broomfield, Colorado	<b>Incident Number:</b>	DCA21FA085
<b>Date &amp; Time:</b>	February 20, 2021, 13:09 Local	<b>Registration:</b>	N772UA
<b>Aircraft:</b>	Boeing 777-222	<b>Aircraft Damage:</b>	Minor
<b>Defining Event:</b>	Powerplant sys/comp malf/fail	<b>Injuries:</b>	239 None
<b>Flight Conducted Under:</b>	Part 121: Air carrier - Scheduled

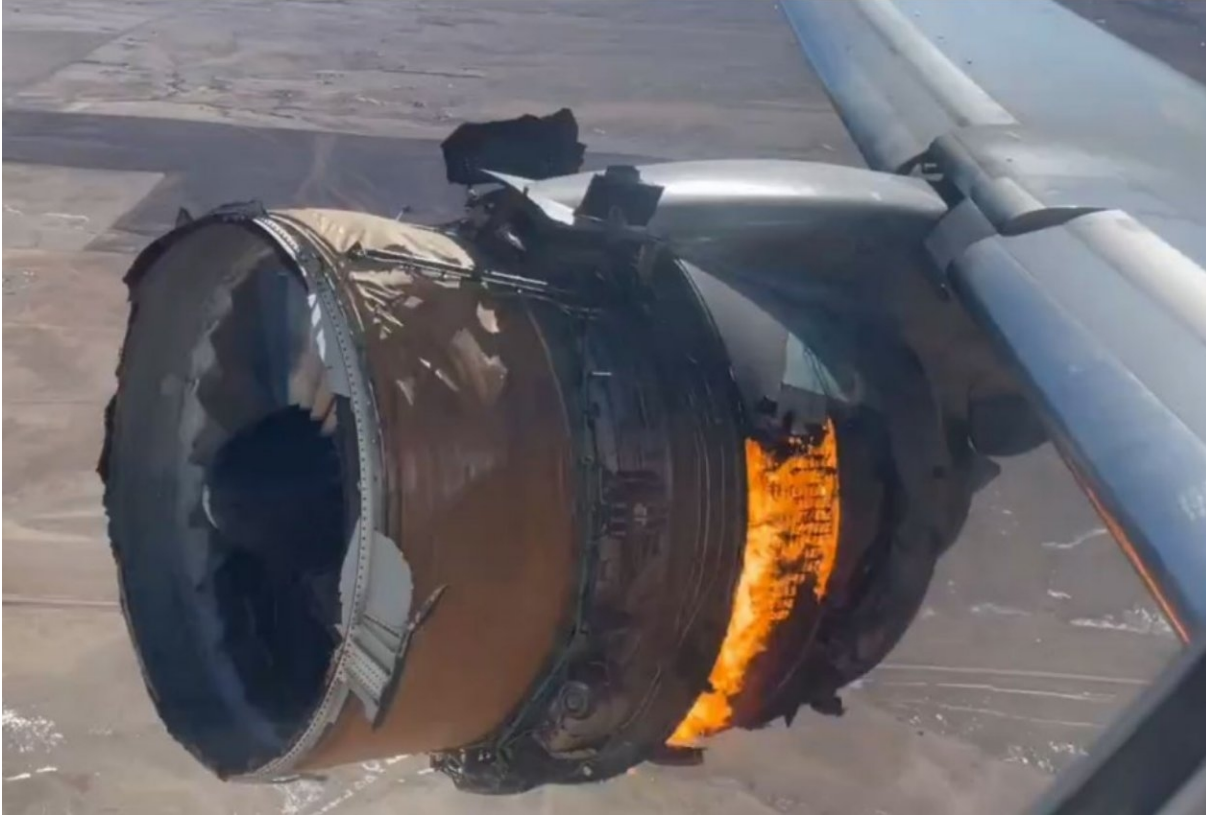
The flight crew declared an emergency with air traffic control (ATC) and completed multiple checklists, including the engine fire checklist. As part of the engine fire checklist, the crew discharged both right engine fire extinguishing bottles; however, the engine fire warning continued to display on the EICAS until shortly before landing. The crew landed the airplane on runway 26 at DEN at 1328 and the airplane was met by aircraft rescue and firefighting (ARFF), which applied water and foaming agent to the right engine for about 40 minutes. The airplane was then towed off the runway, where the passengers disembarked via air stairs and were bussed to the terminal. Figure 1 below, a still image captured from in-flight video recorded by a passenger, shows the damage to the engine nacelle as well as the under-cowl fire about 11 minutes after the fan blade separation.

**Figure 1.** Still image from passenger in-flight video showing engine nacelle damage and under-cowl fire about 11 minutes after fan blade separation (Courtesy Boeing via YouTube).

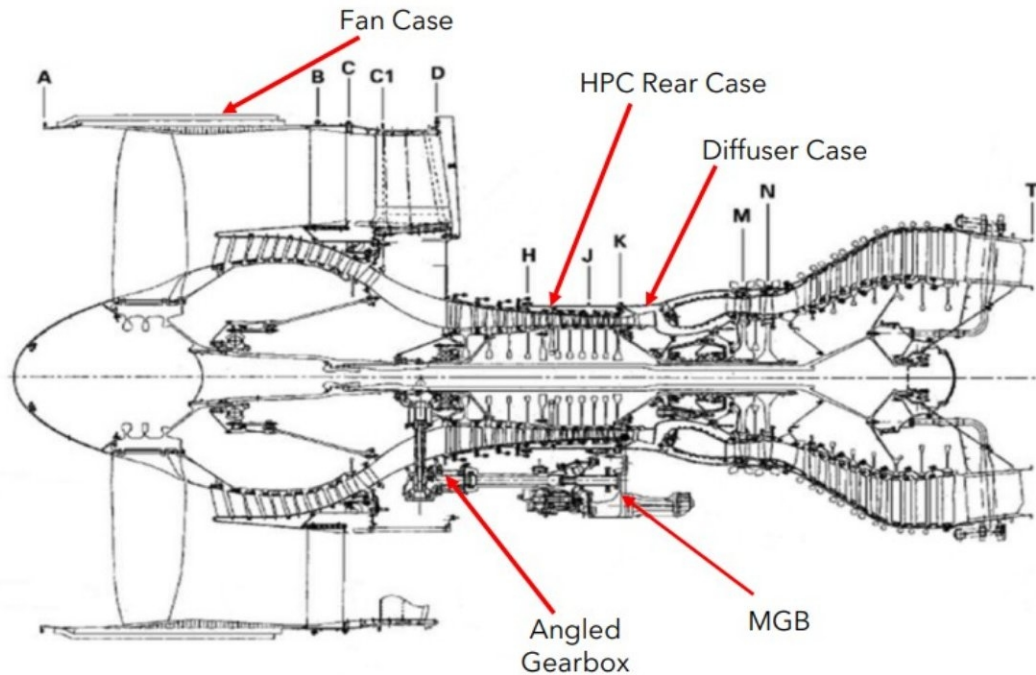
**Figure 3.** PW4000 112-inch significant engine flanges (Source: Pratt & Whitney)

The "K" flange joins the HPC rear case with the diffuser case, which contains the internal hot gases of the operating engine (refer to Figure 3 for location of the "K" flange). Examination revealed that the "K" flange was separated, and all the fastening bolts had failed. Most of the bolt holes were empty; in the locations where bolt remnants were found, the bolts were sheared in the plane of the aft face of the forward flange. Some of the fractured bolts or nut ends were retained by case features. At the location of the "K" flange near the HPC discharge plane, the compressed air temperature exceeds 1,000°F. In the event of a "K" flange separation, the leaking high temperature HPC discharge gas could provide an ignition source of any fuel present in the nacelle.

Pratt & Whitney is evaluating actions to improve the strength of the "K" flange and expects hardware to be available in 2025.
