Aviation Investigation Final Report

Location:	Broomfield, Colorado	Incident Number:	DCA21FA085
Date & Time:	February 20, 2021, 13:09 Local	Registration:	N772UA
Aircraft:	Boeing 777-222	Aircraft Damage:	Minor
Defining Event:	Powerplant sys/comp malf/fail	Injuries:	239 None
Flight Conducted Under:	Part 121: Air carrier - Scheduled

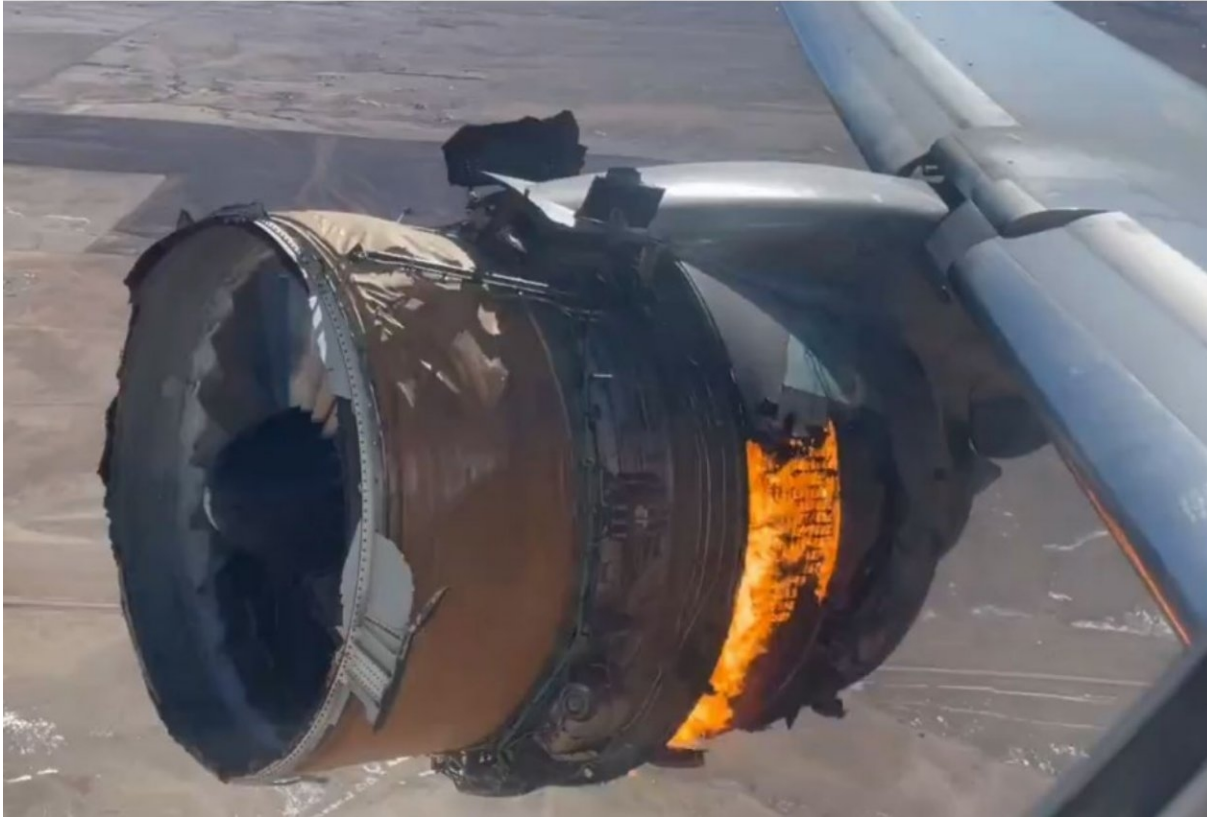
Figure 1. Still image from passenger in-flight video showing engine nacelle damage and under-cowl fire about 11 minutes after fan blade separation (Courtesy Boeing via YouTube).

At the time of the event, the airplane was over Broomfield, Colorado; multiple pieces of the engine inlet, fan cowls, and thrust reversers separated from the airplane and were found scattered over an area of about 40 acres, including a public park and residential areas. There were no ground injuries reported.
