Aviation Investigation Final Report

Location:	Purcellville, Virginia	Accident Number:	ERA21FA148
Date & Time:	March 4, 2021, 15:10 Local	Registration:	N67013
Aircraft:	Beech C23	Aircraft Damage:	Substantial
Defining Event:	Controlled flight into terr/obj (CFIT)	Injuries:	1 Fatal
Flight Conducted Under:	Part 91: General aviation - Personal

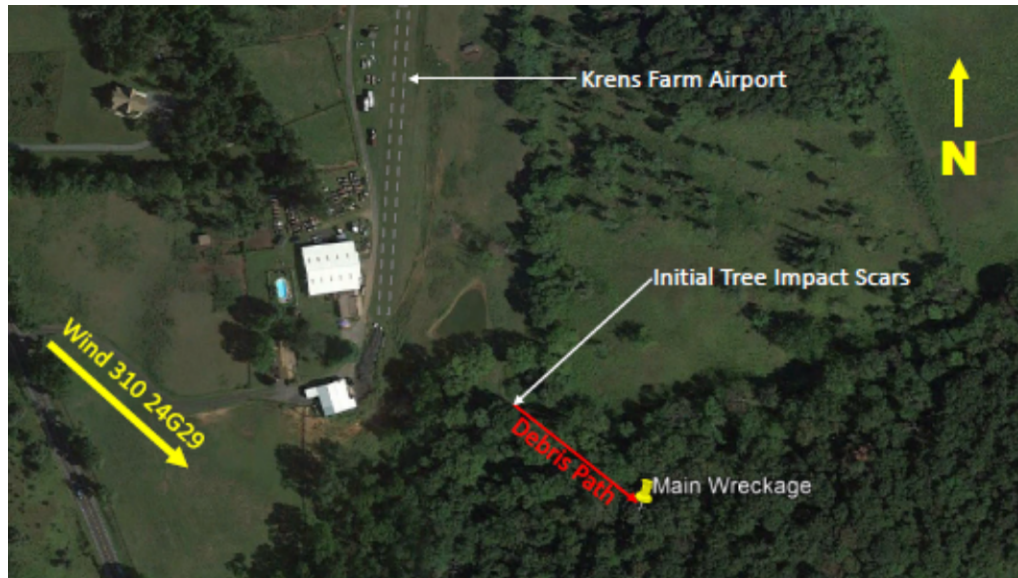
The airplane struck several trees beginning about 326 feet southeast of the departure end of runway 19 at an elevation of about 690 ft mean sea level. (see Figure 1.) From the area of the initial tree strikes, there was a debris field that was 306 ft long, oriented along a 128° magnetic heading. The main wreckage, comprised of the fuselage and right wing, came to rest in a heavily wooded area at the end of the debris field. There was no post impact fire and an odor of 100LL aviation fuel was noted at the site. All major components of the airplane were located in the vicinity of the main wreckage.

Figure 1 - Accident site diagram depicting runway (dashed white lines), the initial tree impact scars, the debris path, and the main wreckage of the airplane. Also annotated is the reported wind direction and velocity at JYO.
