# Aviation Investigation Final Report

<b>Location:</b>	Phoenix, Arizona	<b>Accident Number:</b>	WPR21LA142
<b>Date &amp; Time:</b>	March 18, 2021, 14:27 Local	<b>Registration:</b>	N469KS
<b>Aircraft:</b>	DAVIS DAN B LANCAIR EVOLUTION	<b>Aircraft Damage:</b>	Substantial
<b>Defining Event:</b>	Part(s) separation from AC	<b>Injuries:</b>	1 None
<b>Flight Conducted Under:</b>	Part 91: General aviation - Personal

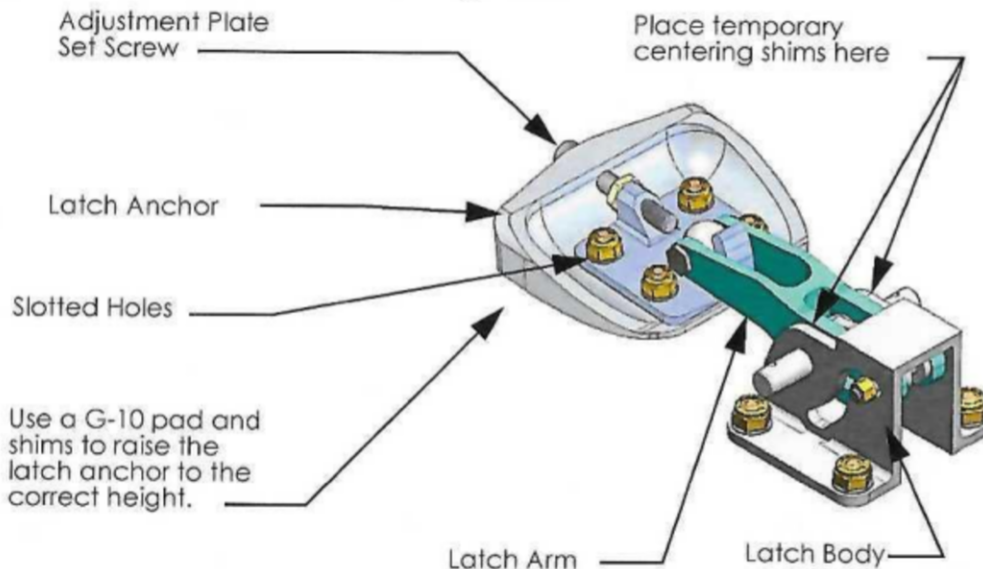
Figure 1: Lancair Evolution Door Latch and Anchor Alignment

The airplane was equipped with one 42-lb main cabin door located on the left side of the cockpit that opened and closed by two hinges at the top of the door frame. When closed, the door locked the pressurized cabin through eight latches: three at the lower frame, two on the front door post, and three on the rear door post. Each latch mechanism comprised a steel latch arm and ball attached to an aluminum latch body, which was bolted to the door. The door was closed and locked when each latch arm and ball aligned and connected with its respective socket at the steel latch anchor, which is connected to the door frame. The locking mechanism was operated by a single handle rotated clockwise to lock the door, which latched the anchors through a series of sprockets and chains. Moving the handle in the opposite direction would unlatch the latches. (see figure 1)

According to the kit manufacturer, two potential main door failures had been reported to the company. The first failure occurred in 2010 on another airplane that resulted when a latch was not aligned over center and failed to secure to the latch body. This forced the adjacent latch mechanisms to carry the load, which caused one of the adjacent latches to fail at the aluminum latch body. Another failure occurred in November 2020 and resulted in an explosive decompression during cruise flight as the lower rear latches were not secured. According to the manufacturer, the cause was likely attributed to a failure of the lower rear latch to secure before takeoff. Once the load overstressed the forward latches, they failed in a domino effect that resulted in an explosive decompression. This prompted the manufacturer to issue an inspection advisory that required an inspection of the main door latches for cracks or other physical damage within the next 10 hours of flight. The advisory was issued to all maintenance facilities that regularly serviced their airplanes about three months before the accident airplane received its most recent service. The airplane's maintenance logbooks did not indicate that the airplane had been inspected in accordance with the advisory and the maintenance facility that regularly serviced the airplane reported that they were not aware of the advisory.

Although the main door was not recovered, the airplane manufacturer issued a service bulletin on April 20, 2021, that required the latch mechanism to be inspected to ensure that the eight latch balls seated properly within their sockets without any clearance between the ball and socket. The service bulletin also required an inspection of the hinges at the next condition inspection and for the aluminum latch bodies to be replaced with structural stainless steel alloy bases.
