# Aviation Investigation Final Report

<b>Location:</b>	Palmer, Alaska	<b>Accident Number:</b>	WPR21FA143
<b>Date &amp; Time:</b>	March 27, 2021, 18:36 Local	<b>Registration:</b>	N351SH
<b>Aircraft:</b>	Airbus Helicopters AS350-B3	<b>Aircraft Damage:</b>	Substantial
<b>Defining Event:</b>	Loss of visual reference	<b>Injuries:</b>	5 Fatal, 1 Serious
<b>Flight Conducted Under:</b>	Part 135: Air taxi & commuter - Non-scheduled

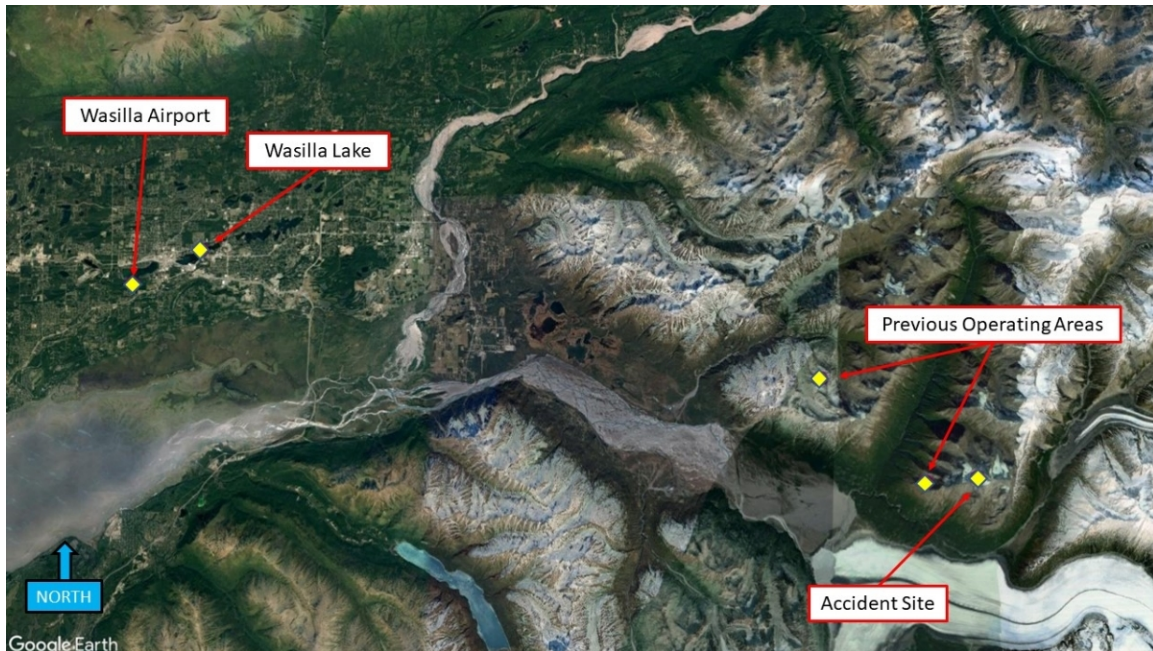
GPS data showed that the helicopter departed for the last run of the day at 1827:05 on a northwest heading and climbed to about 5,900 ft mean sea level (msl). The helicopter's final movements began about 1833 over a ridgeline at an altitude of 6,266 ft msl (about 14 ft above ground level) and at a groundspeed of 1 knot. The helicopter maintained its low altitude and groundspeed as it maneuvered over the ridgeline. The data track ceased at 1836:42 near the location of the accident site, which is shown in figure 1.

Figure 1. Location of departure point, previous operating areas, and the accident site.

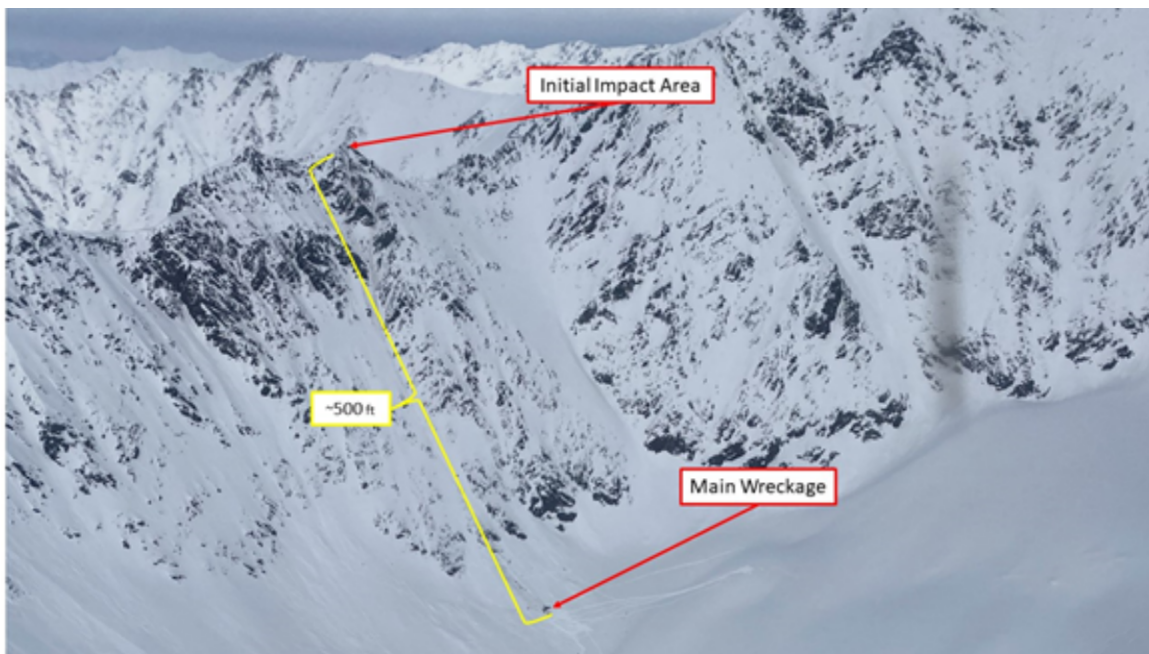
Aerial assessment of the accident site on the day after the accident revealed that the helicopter impacted terrain about 15 to 20 ft below the top of the ridgeline. The main wreckage came to rest on its right side about 500 ft downslope from the initial impact area, as shown in figure 2. The debris field extended about 900 ft downslope from the top of the ridgeline.

Figure 2. Accident site (Source: Alaska State Troopers).

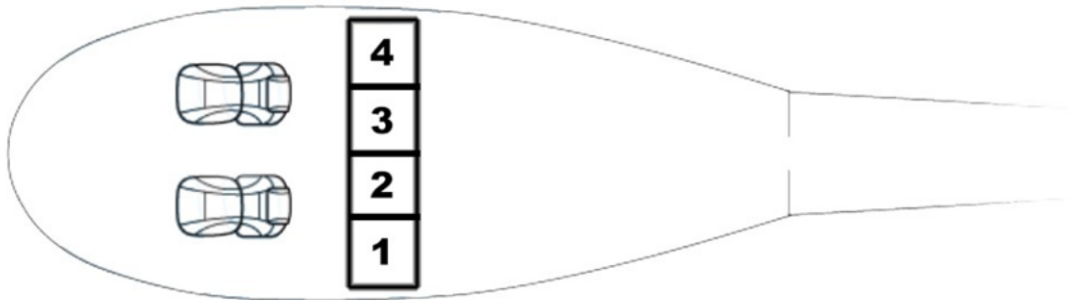
The helicopter was configured with the pilot's seat in the front right seat position. Passenger seats were located in the front left seat position and a bench in the cabin with four seating positions. Figure 3 shows the helicopter seating configuration. The senior lead guide was in the left front seat; the other lead guide was in aft seat No. 1. The deceased passengers were in aft seat Nos. 2 and 4; the surviving passenger was in aft seat No. 3.

Figure 3. Simplified drawing of the accident helicopter showing seating positions with rear bench seat position numbers annotated.
