# Aviation Investigation Final Report

| <b>Location:</b> | Marana, Arizona | <b>Accident Number:</b> | WPR21LA145 |
| <b>Aircraft:</b> | CIRRUS DESIGN CORP SR22 | <b>Aircraft Damage:</b> | Substantial |

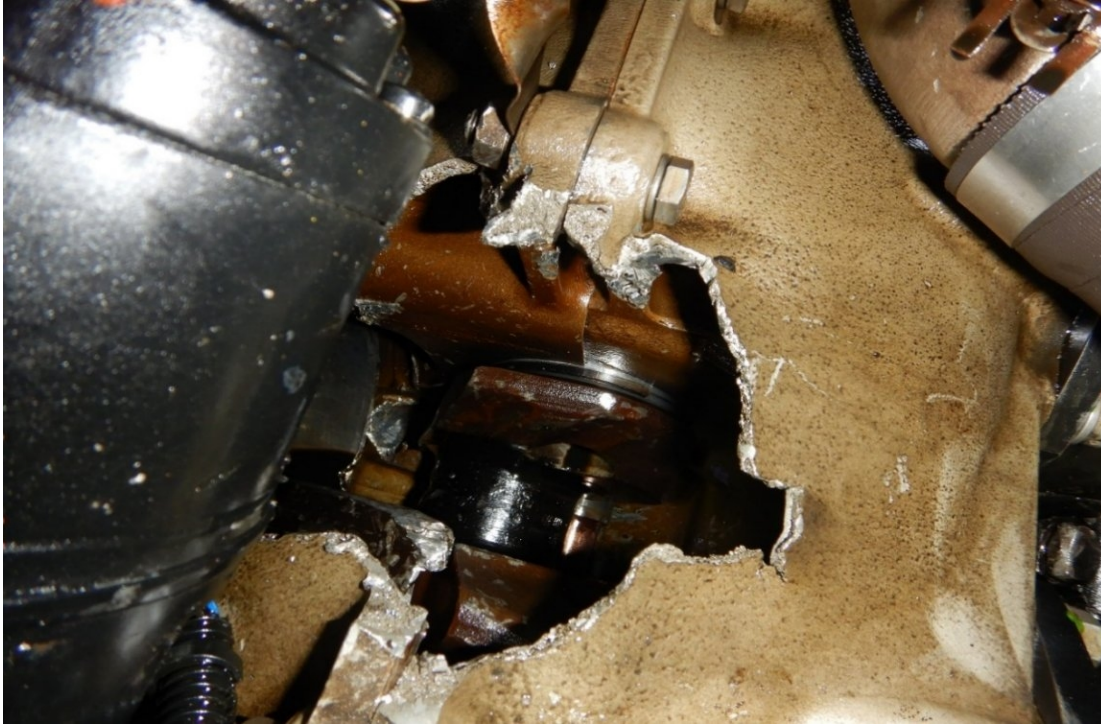
A postaccident examination revealed that about 5 quarts of dark oil were drained from the oil sump. The oil sump was removed, and it contained broken aluminum and steel engine components. The Nos. 1 and 3 cylinders through bolt and deck stud nuts had torque seal. The remaining cylinders did not have torque seal applied. The 8-through bolts nuts were retorqued to the manufacturer’s specified torque setting and none of the nuts tightened before the specified torque was reached. The Nos. 2 and 4 cylinders could not be removed from the crankcase due to internal mechanical damage to their cylinder skirts.

*Figure 1. – Crankcase damage and view of interior engine components.*

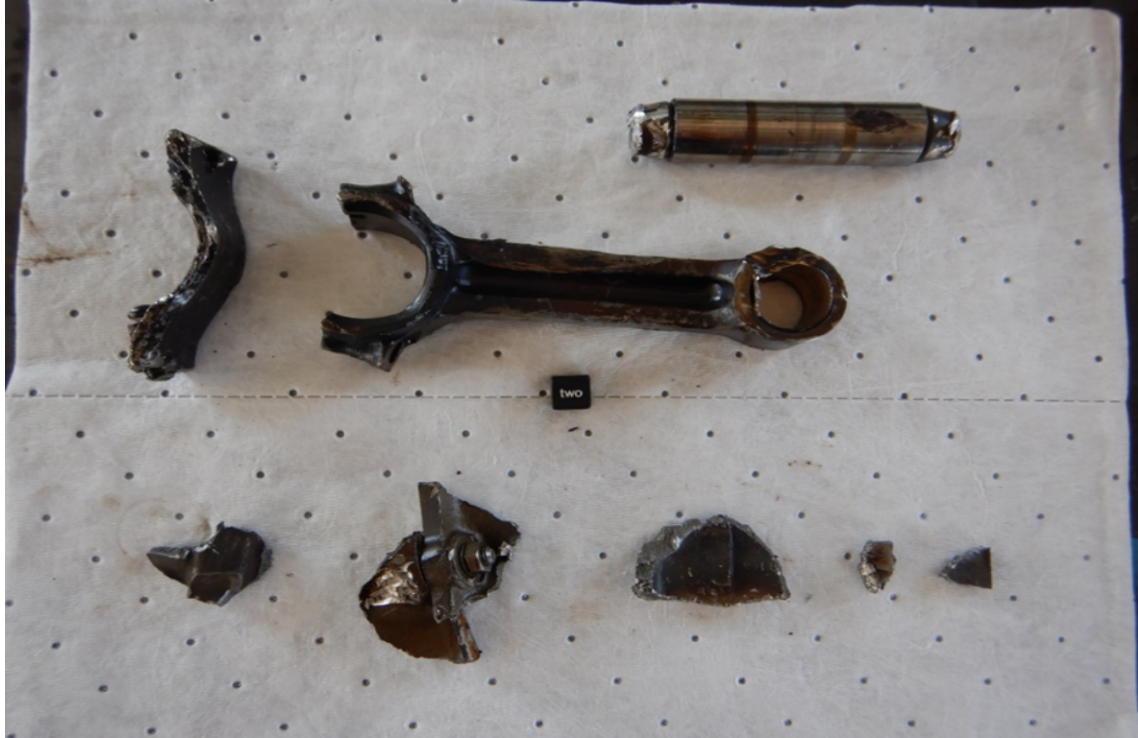
The No. 2 connecting rod and piston were separated from the crankshaft. The left half of the No. 2 main bearing was found rotated about 15° within the saddle area and overlapping the right half of No. 2 bearing. The left bearing half was shifted forward about 1/8 of an inch from its original position.

The corresponding main bearing seal was not positioned properly in the saddle bearing support, which resulted in a lack of oil lubrication and the discoloration of the connecting rod journal.

*Figure 2. No. 2 connecting rod, piston, crankcase pieces, and piston material.*

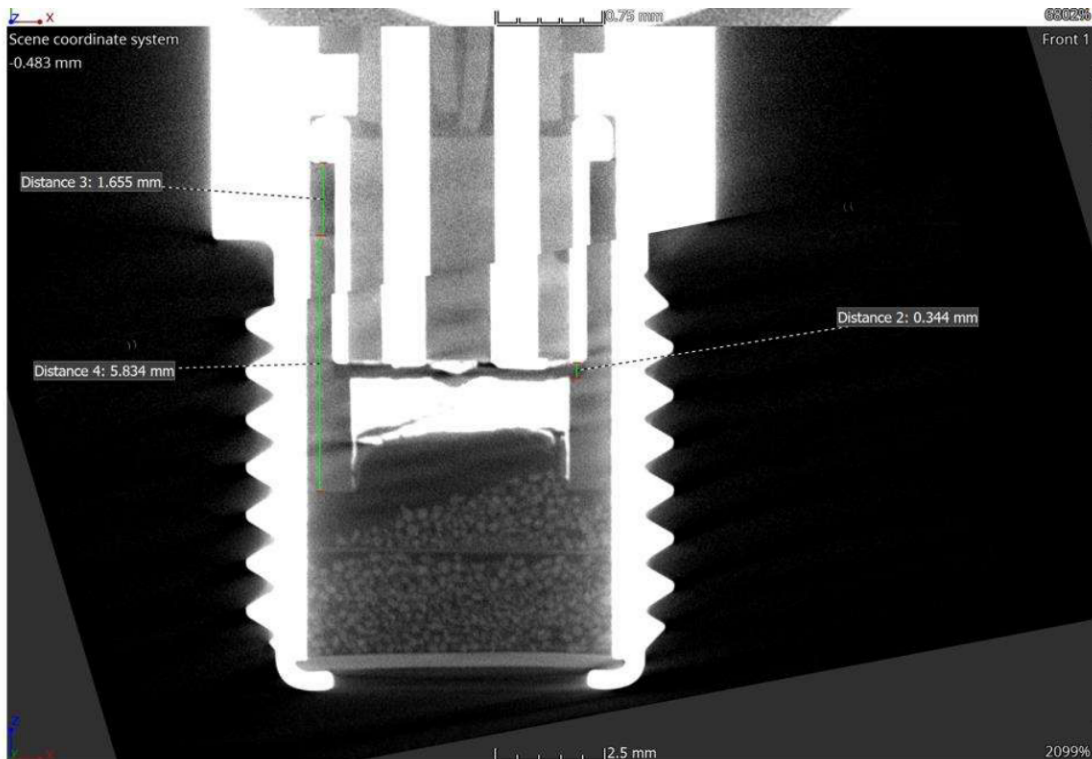
*Figure 4. CT Scan of squib showing B1 and B3 powder and void in cap.*

CT scans of the squib revealed the bridge wire was broken/activated (fused); however, the B1 did not ignite properly which subsequently prevented the  $\text{BKNO}_3$  from igniting. The specific reason for the failure of the B1 to properly ignite was not determined during this investigation; however, several possible factors were identified.

The ration of boron versus barium chromate used in squib manufactured in 2015 was different and provided a different fuel/oxygen ratio.

It was noted that pieces of boron were larger in the B1 produced in 2015 which could have provided for a less homogenized mixture.

The accident squib recorded high moisture levels, although this may have resulted from when the squib was opened.

On June 9, 2021, Cirrus issued SB2X-95-27, "SNS SUBJECT SPECIAL PURPOSE EQUIPMENT – Replacement of CAPS Rocket Igniter." This service bulletin called for the removal of 25 squib assemblies produced from the same lot as the accident squib. Testing of the returned parts demonstrated additional "no-ignition" squibs from the same lot. On December 10, 2021, SB2X-95-27R2 was subsequently issued, which expanded the number of recalled squibs to 347. These squibs had been installed in SR20 and SR22 airplanes and were manufactured with the same batch of B1 as the accident squib.
